CORROSION ASSOCIATED WITH FLUORINATION  
IN THE OAK RIDGE NATIONAL LABORATORY  
FLUORIDE VOLATILITY PROCESS

A. P. Litman  
A. E. Goldman

METALLURGY DIVISION

JUN - 5 1961

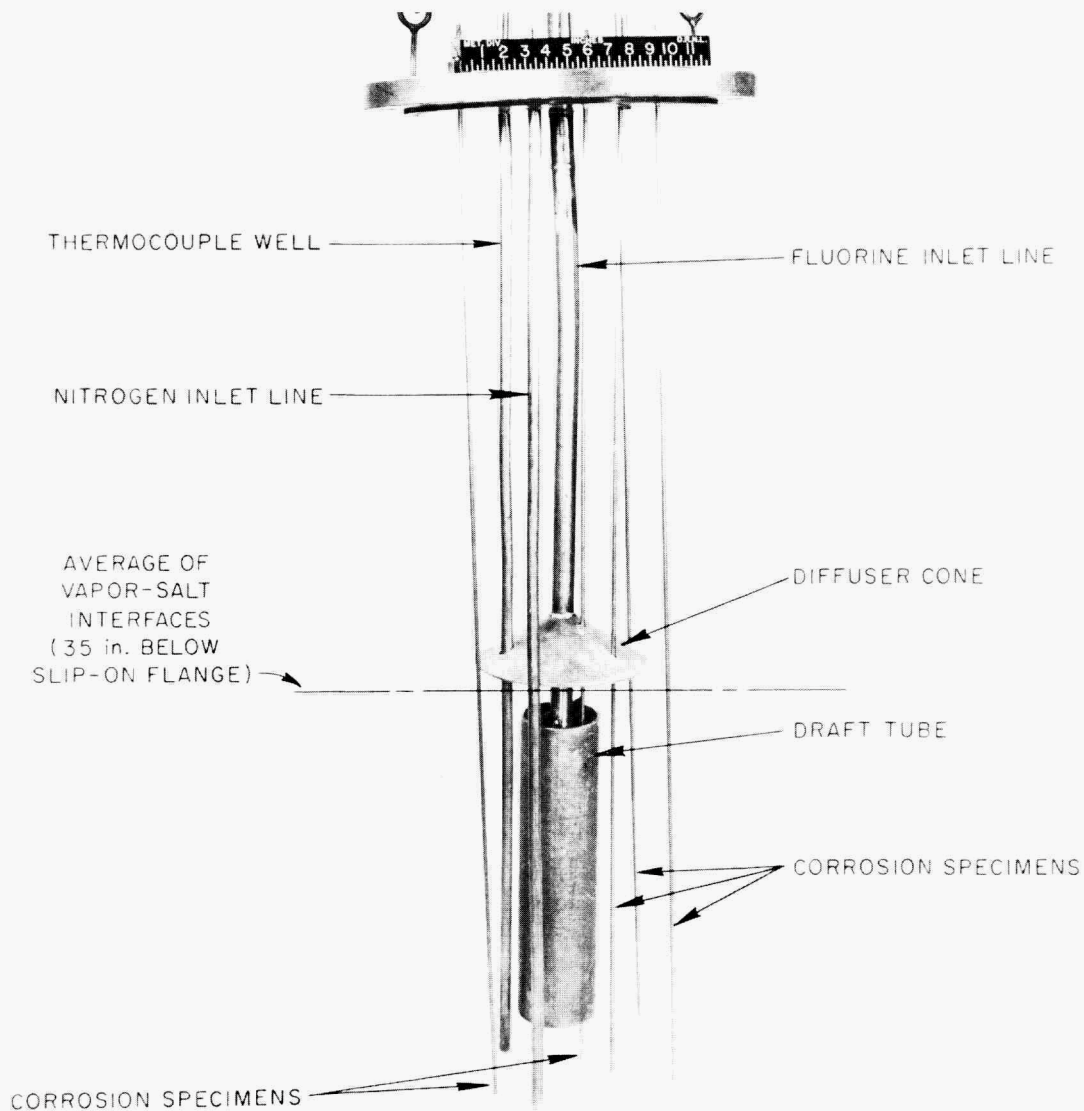
Fig. 3. Interior Piping, Gas Dispersion Assembly, and Placement of an Early Group of Corrosion Specimens in the Mark I VPP Fluorinator.

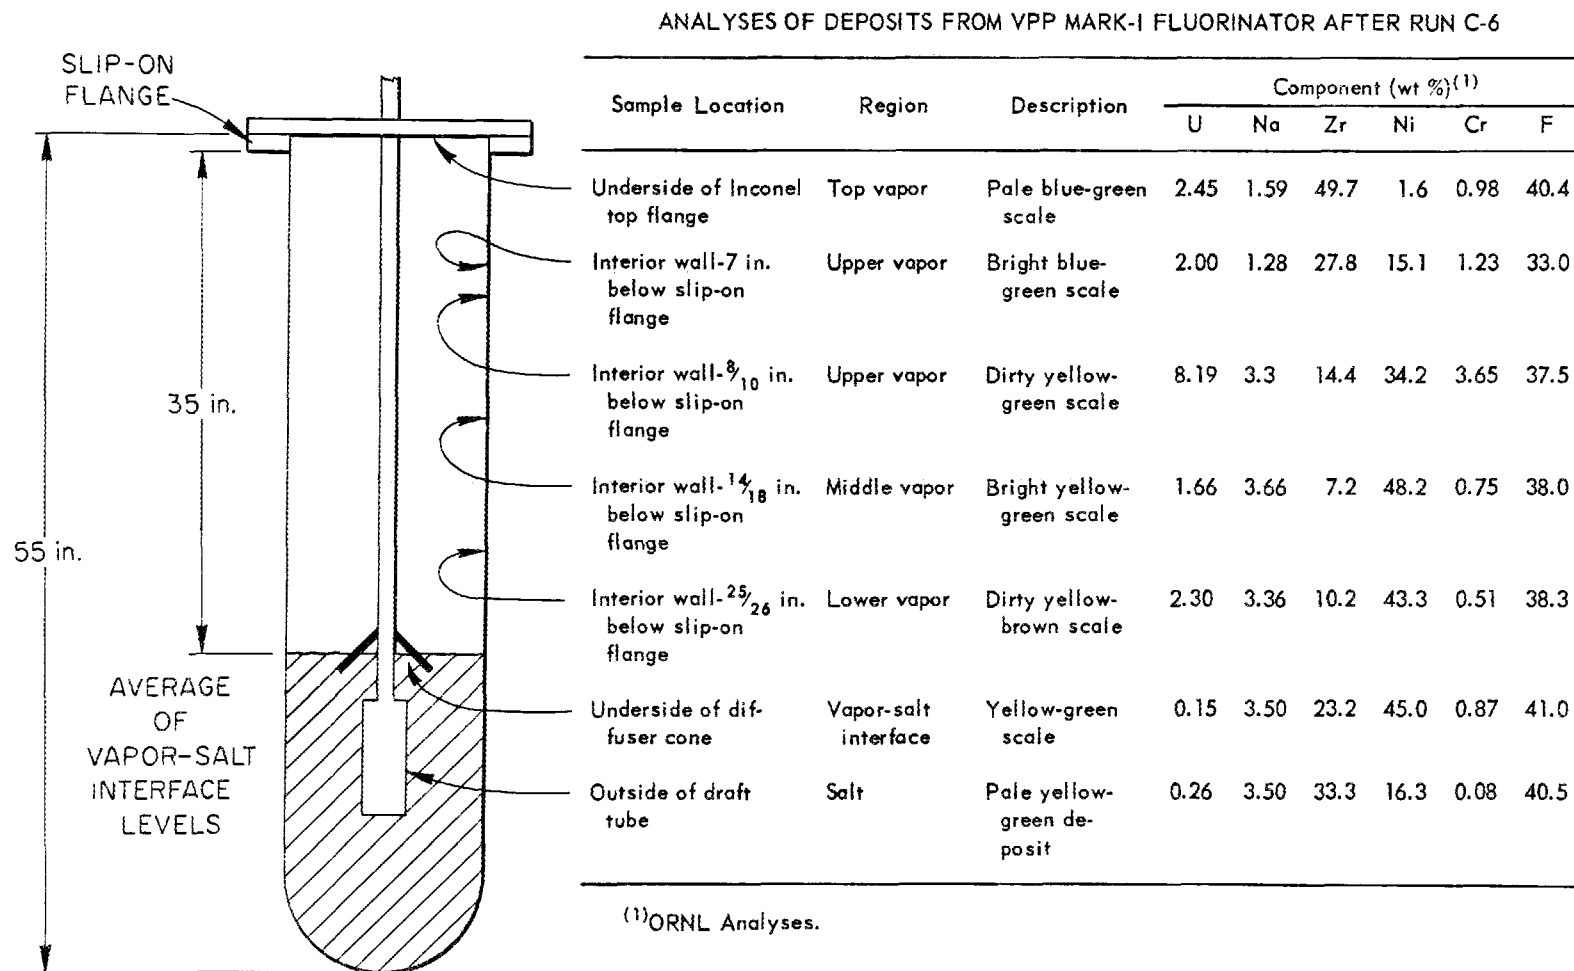
During VPP Run C-6, a study was made of the interior deposits which formed on the wall of the fluorinator. Figure 4 shows the location and subsequent chemical analyses of these deposits. These data indicate a tendency for chromium, presumably from impure feed salts, and uranium to collect in the middle vapor region of the vessel. The values shown for nickel indicate that extensive corrosive attack had occurred in the system during operations.

Fig. 4. Analyses of Deposits from Mark I VPP Fluorinator After Run C-6.

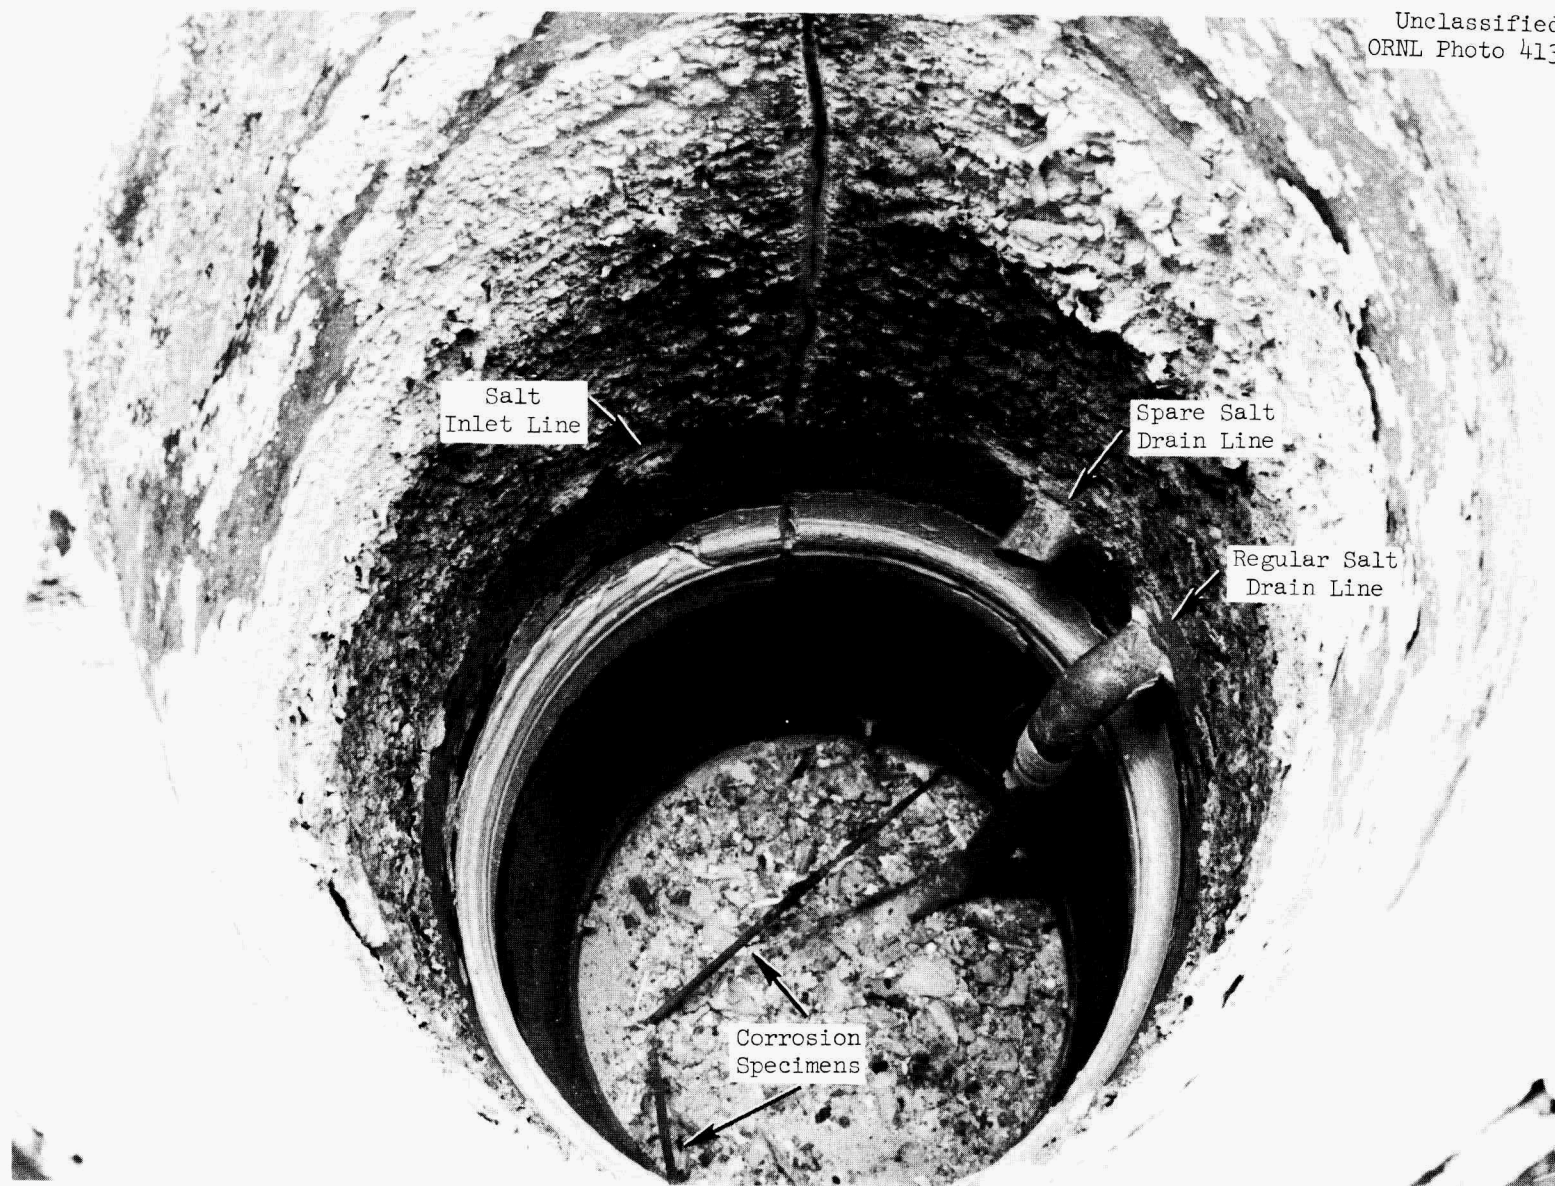
After completion of the "M" and "C" runs described in Table I, the Mark I fluorinator was turned over to Metallurgy for corrosion evaluation. Figure 5 shows the interior of the fluorinator after retirement. Most of the interior walls of the vessel below the molten salt levels were free of surface

Fig. 5. Interior of the Mark I Volatility Pilot Plant Fluorinator After Run C-15.

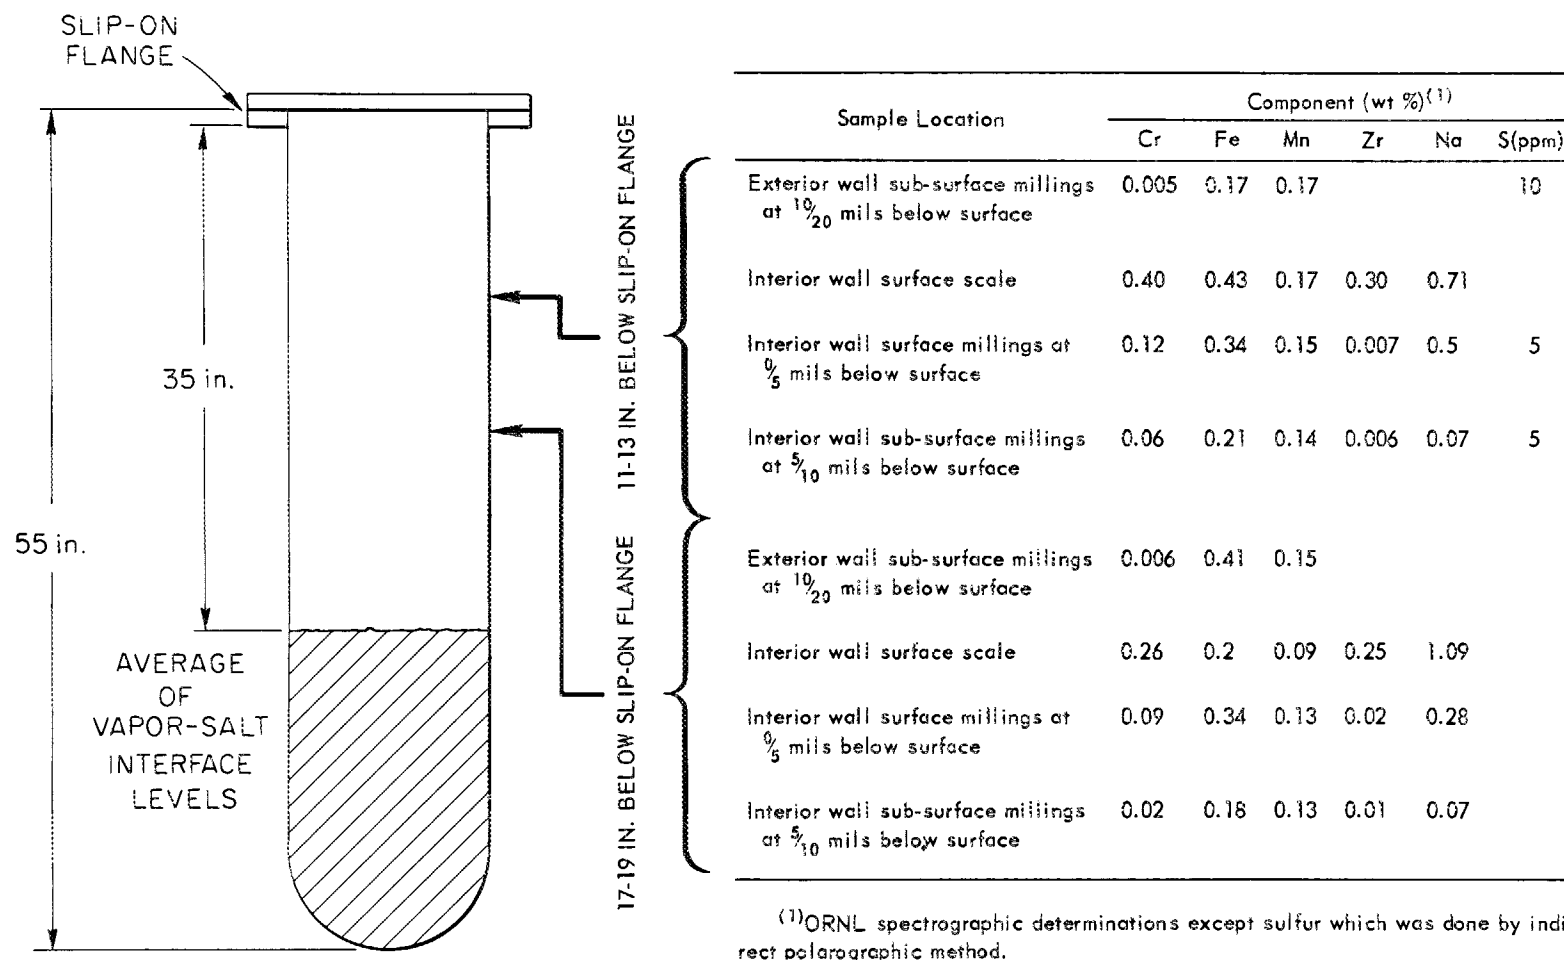
Fig. 6. Analyses of Scale and Millings From VPP Mark I Nickel Fluorinator After Run C-15 and Vessel Decontamination.

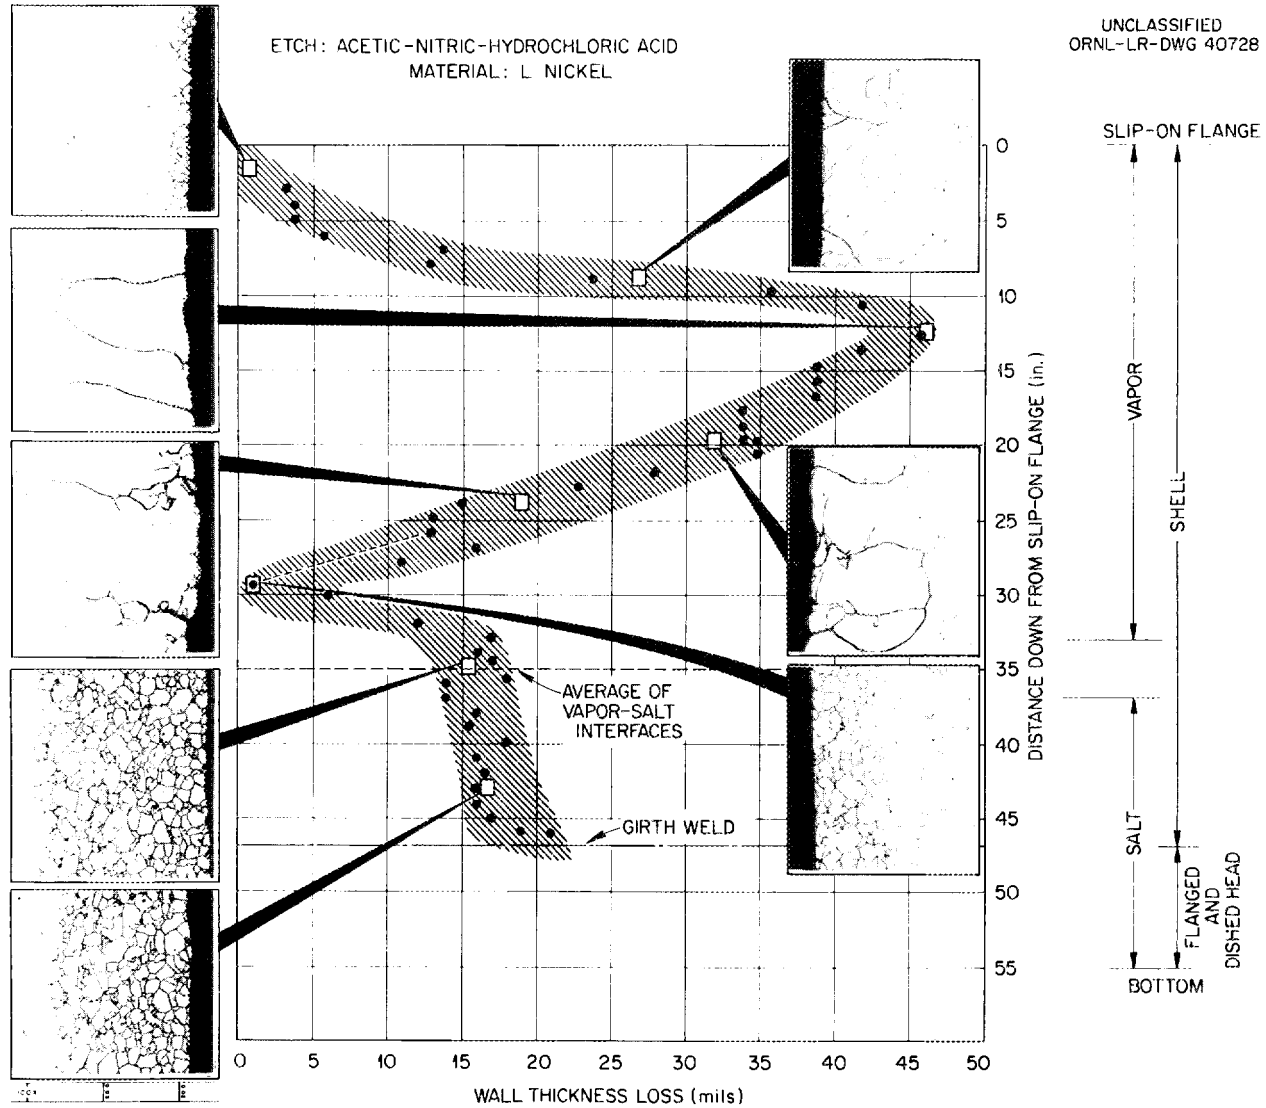
Micrometer measurements were taken in the three major regions of the fluorinator in all quadrants and show the greatest wall-thickness losses to be concentrated in the vapor region of the vessel shell. Figure 7 shows a schematic drawing of the vessel and denotes the sections that were removed from the vessel for these measurements and for metallographic study. The loss data are given in Table III. A full-length vessel section was removed from the northeast-by-east quadrant and micrometer measurements taken every vertical inch to establish a corrosion wall-thickness-loss profile. Figure 8 shows this plot and pinpoints the maximum metal loss of 47 mils as approx 12 in. below the bottom of the slip-on flange.

Fig. 8. Corrosion Profile and Typical Microstructures from the Mark I VPP Fluorinator. (Profile based on micrometer measurements from northeast quadrant full-length shell section.)

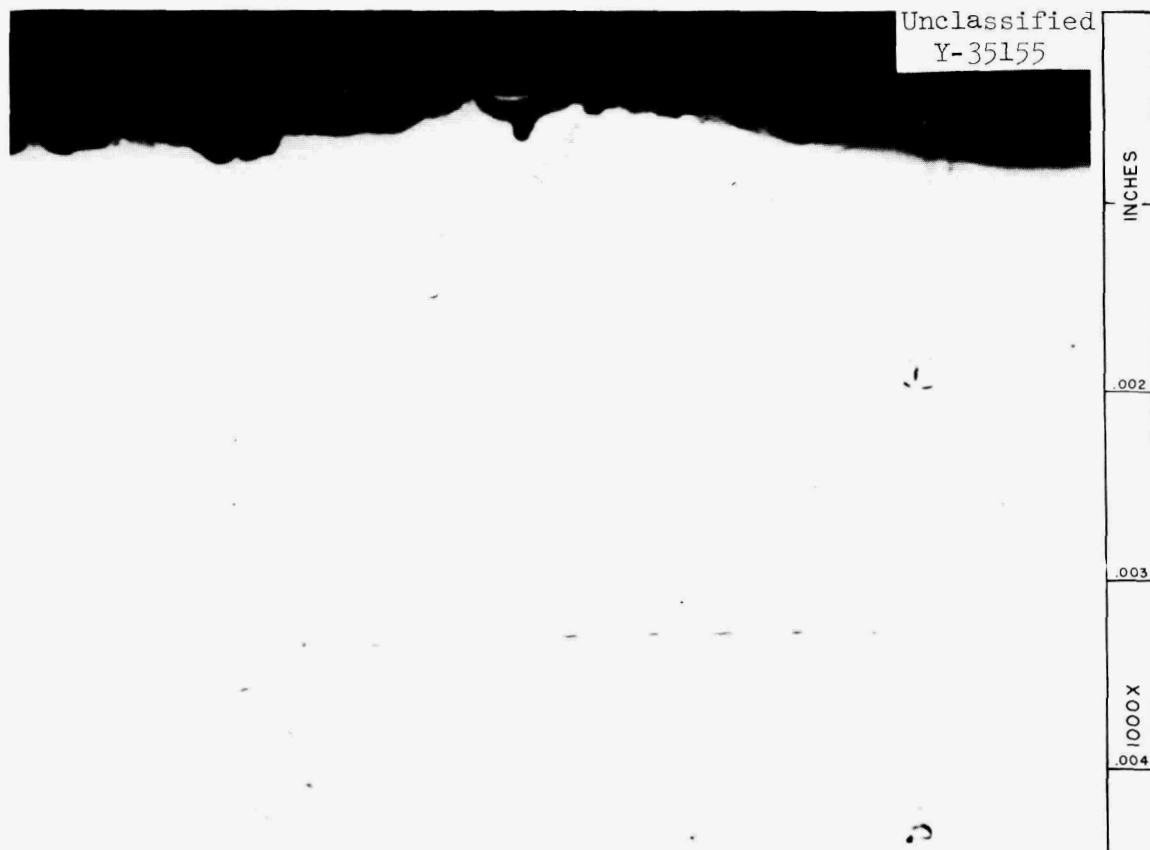
Fig. 10. Photomicrograph of Sample from Interior Surface of Mark I VPP L Nickel Fluorinator 12 in. Below Slip-on Flange (Vapor Phase) Showing Grain Boundary Deposit. Deposit was pale yellow under nonpolarized illumination and black under polarized light in accordance with Hall's method for identifying nickel sulfide deposits. Etchant: Potassium cyanide-ammonium persulfate, partially repolished. 1000X. Reference: A. M. Hall, "Sulfides in Nickel and Nickel Alloys," Trans. Met. Soc. AIME 152, 283, 1943.

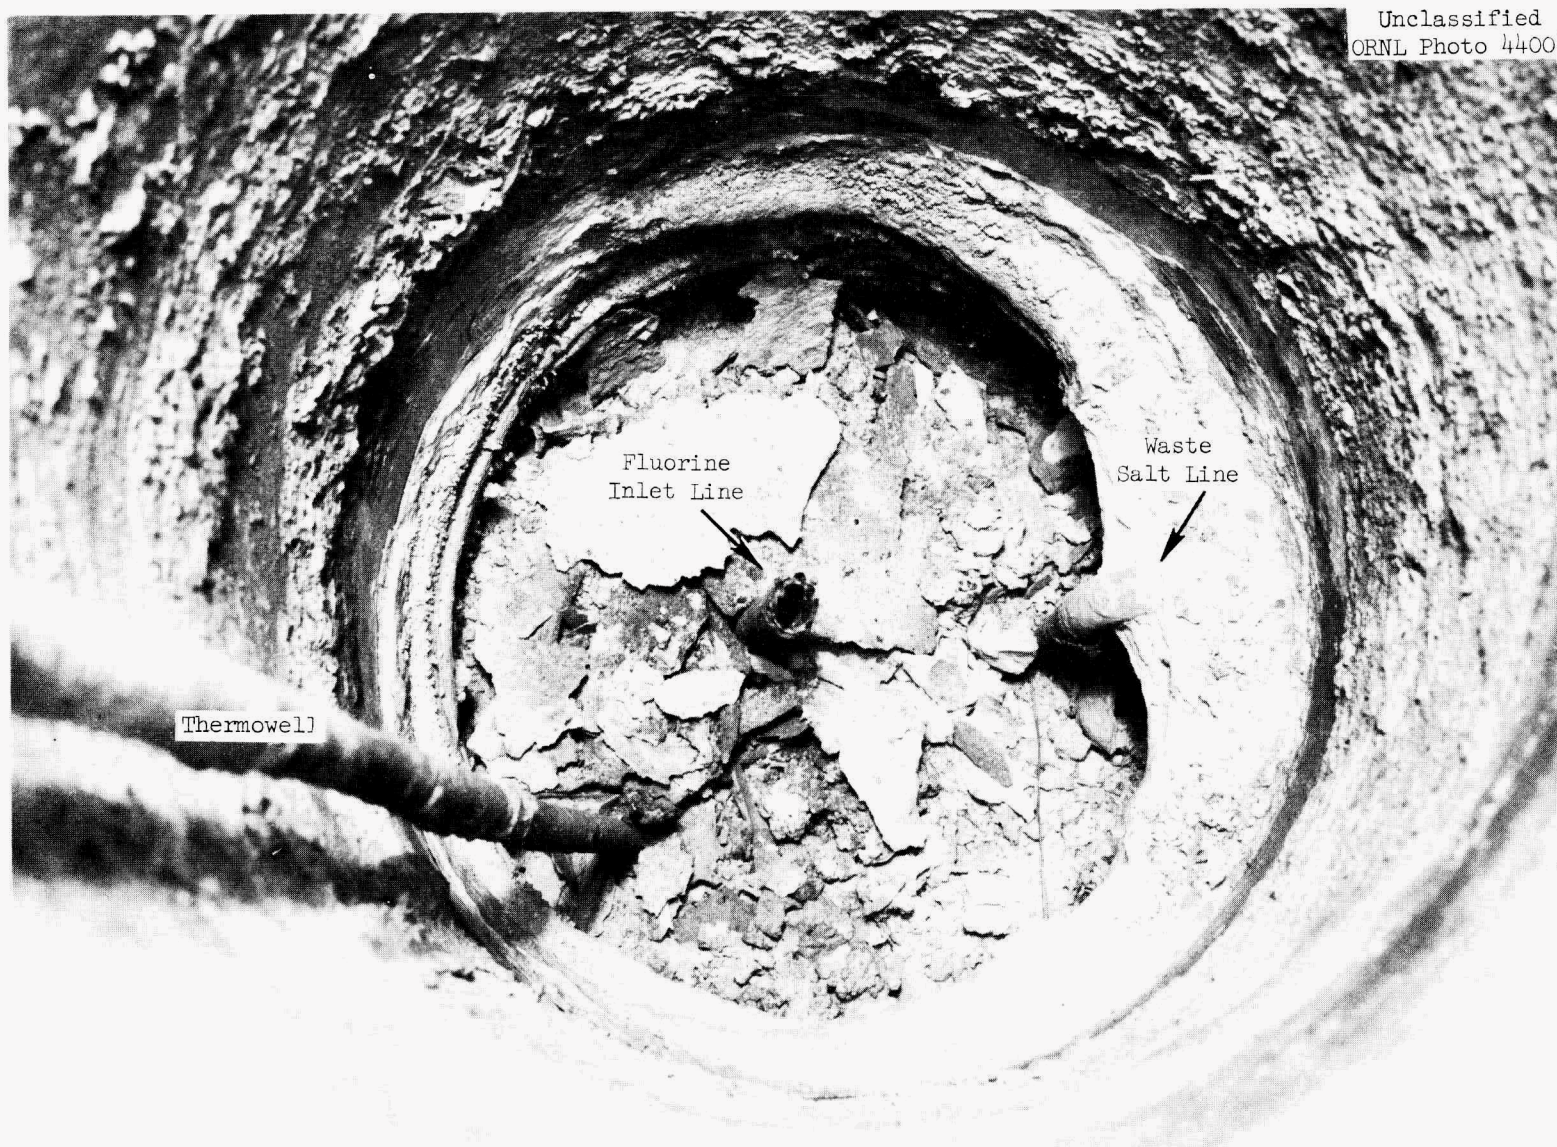
Fig. 14. Interior of Mark II VPP Fluorinator After Run L-4. (Fluorine inlet cut off prior to taking of photograph.)

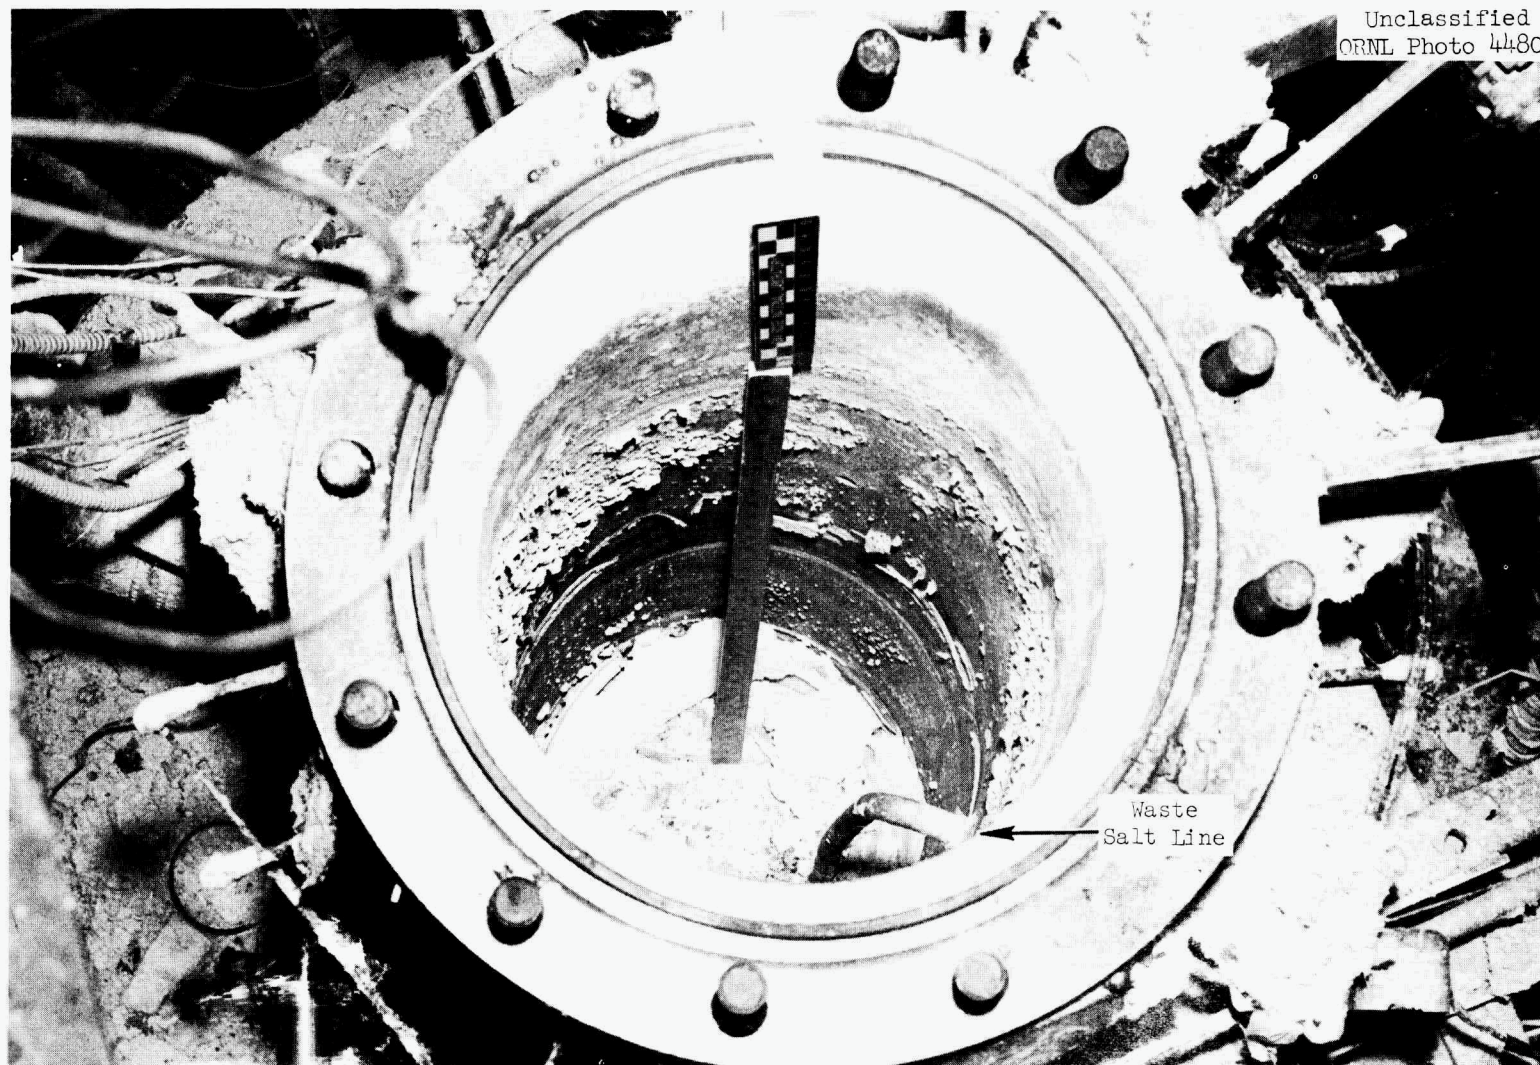
Fig. 15. Interior of the Mark II VPP Fluorinator After Run L-9.

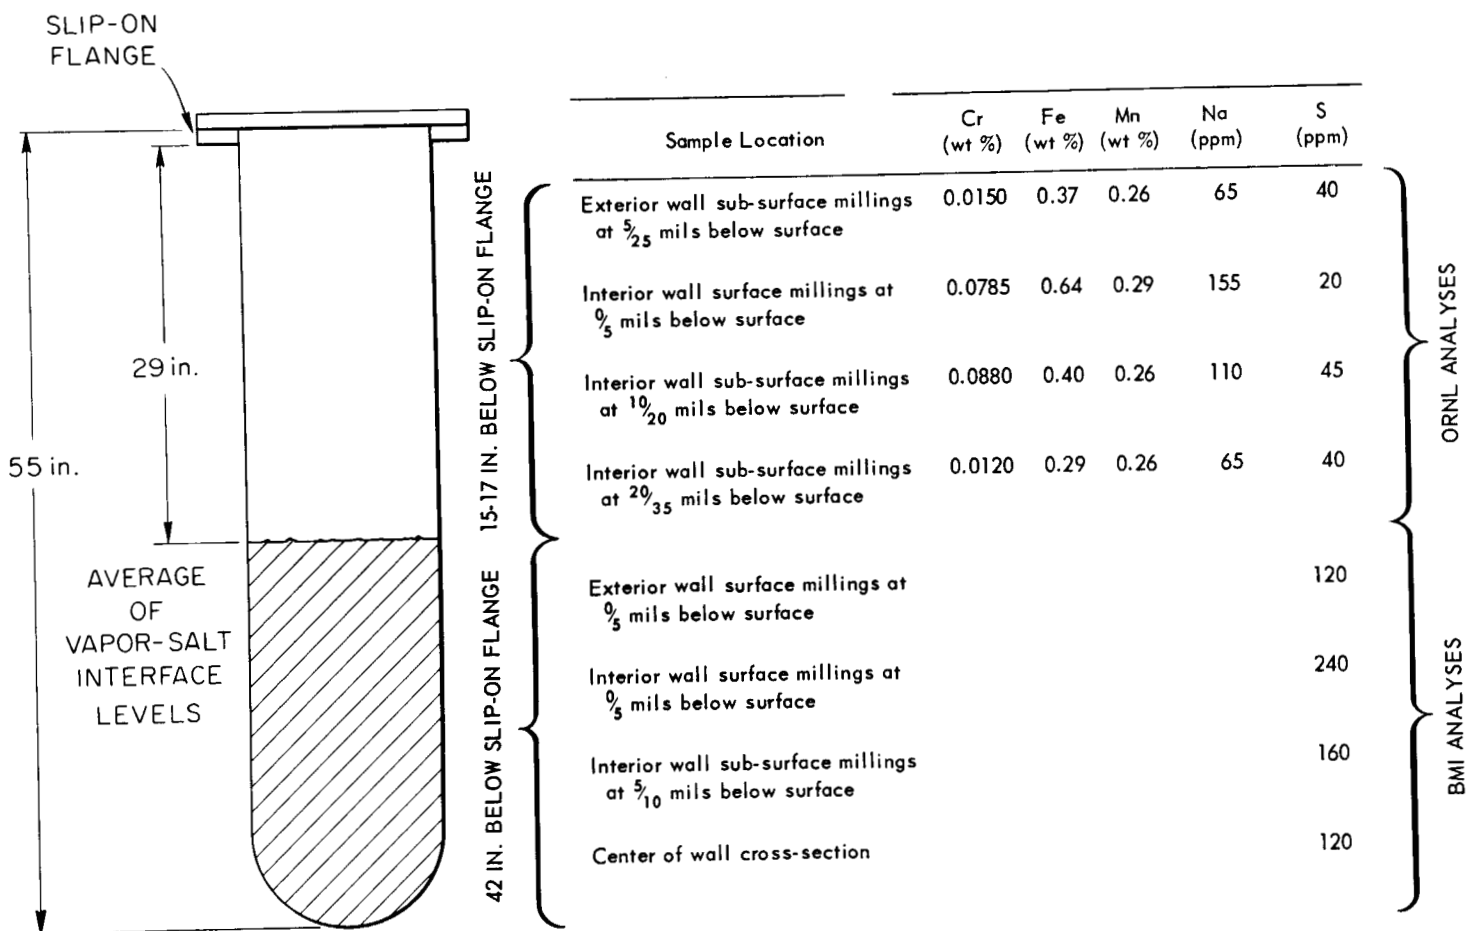
Surface and subsurface millings were taken from the interior wall of the vessel in the region where the green deposit seemed thickest, 15-17 in. below the bottom of the slip-on flange, and submitted for additional chemical analyses. For comparison purposes, subsurface millings were also taken from the exterior vessel wall at the same elevation. The results of the metal chemistry are shown in Fig. 16, and indicate an increase in chromium concentration in the millings near the surface of the interior wall of the vessel. No significant increase in sulfur in the vapor region of the fluorinator over that quantity present in the base material was found. However, on specimens removed from the salt region of the Mark II fluorinator, which were later analyzed by Battelle Memorial Institute (BMI), an increase in the sulfur content of the interior wall specimens was noted. Figure 16 also shows these results.

Fig. 16. Analyses of Millings from Mark II VPP L Nickel Fluorinator After Run L-9 and Vessel Decontamination.

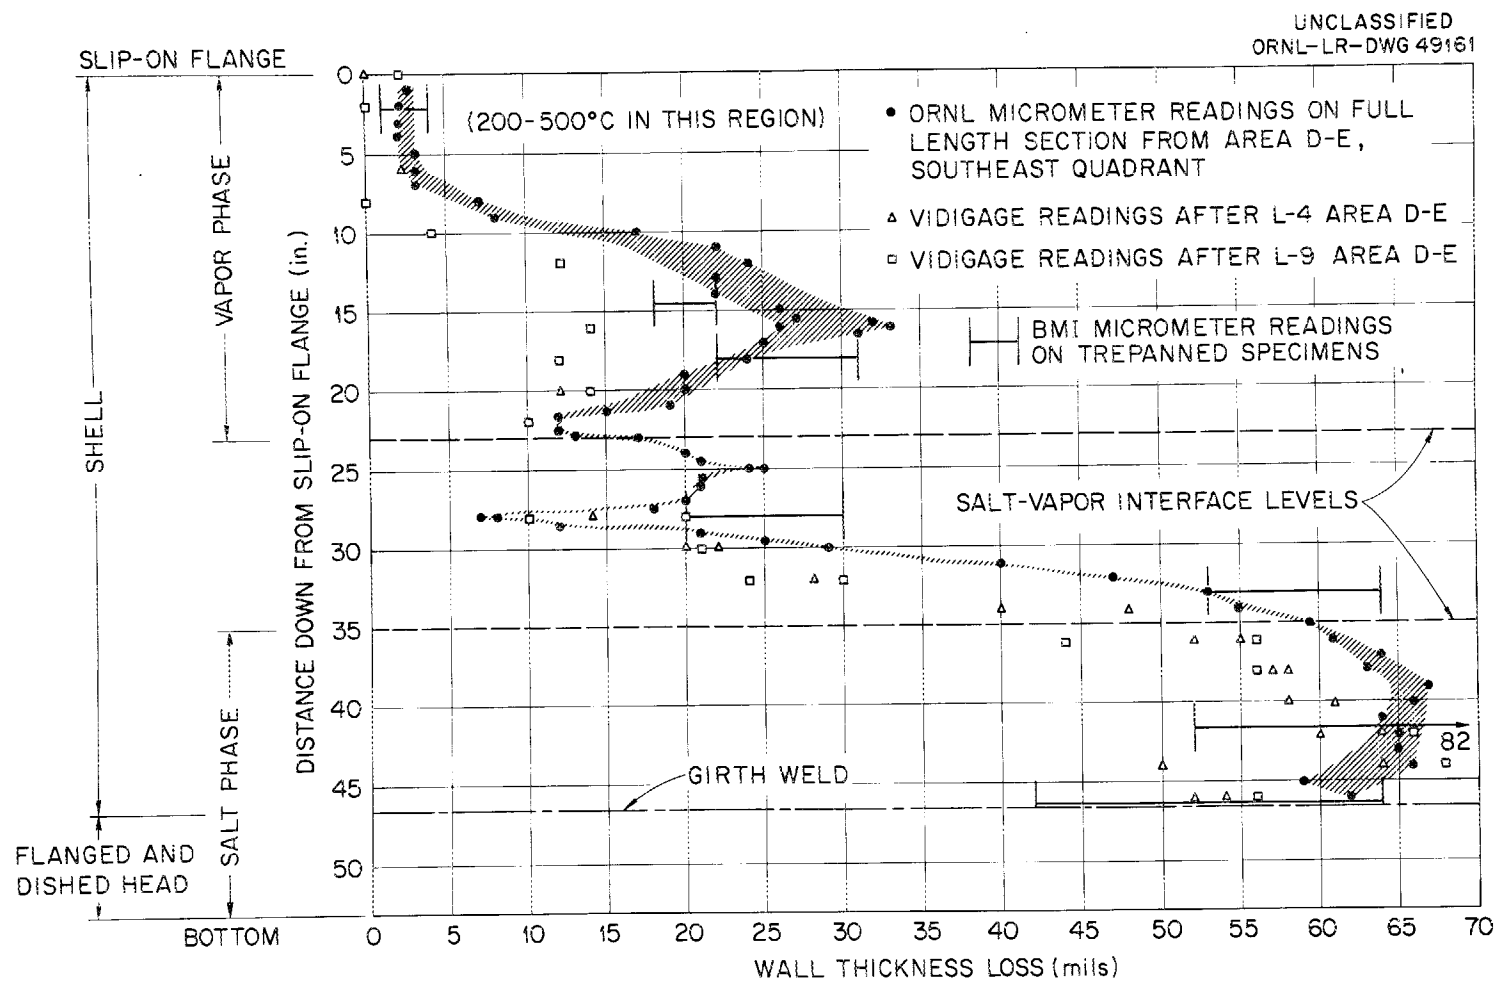
Fig. 18. Corrosion Profile of Mark II VPP L Nickel Fluorinator.

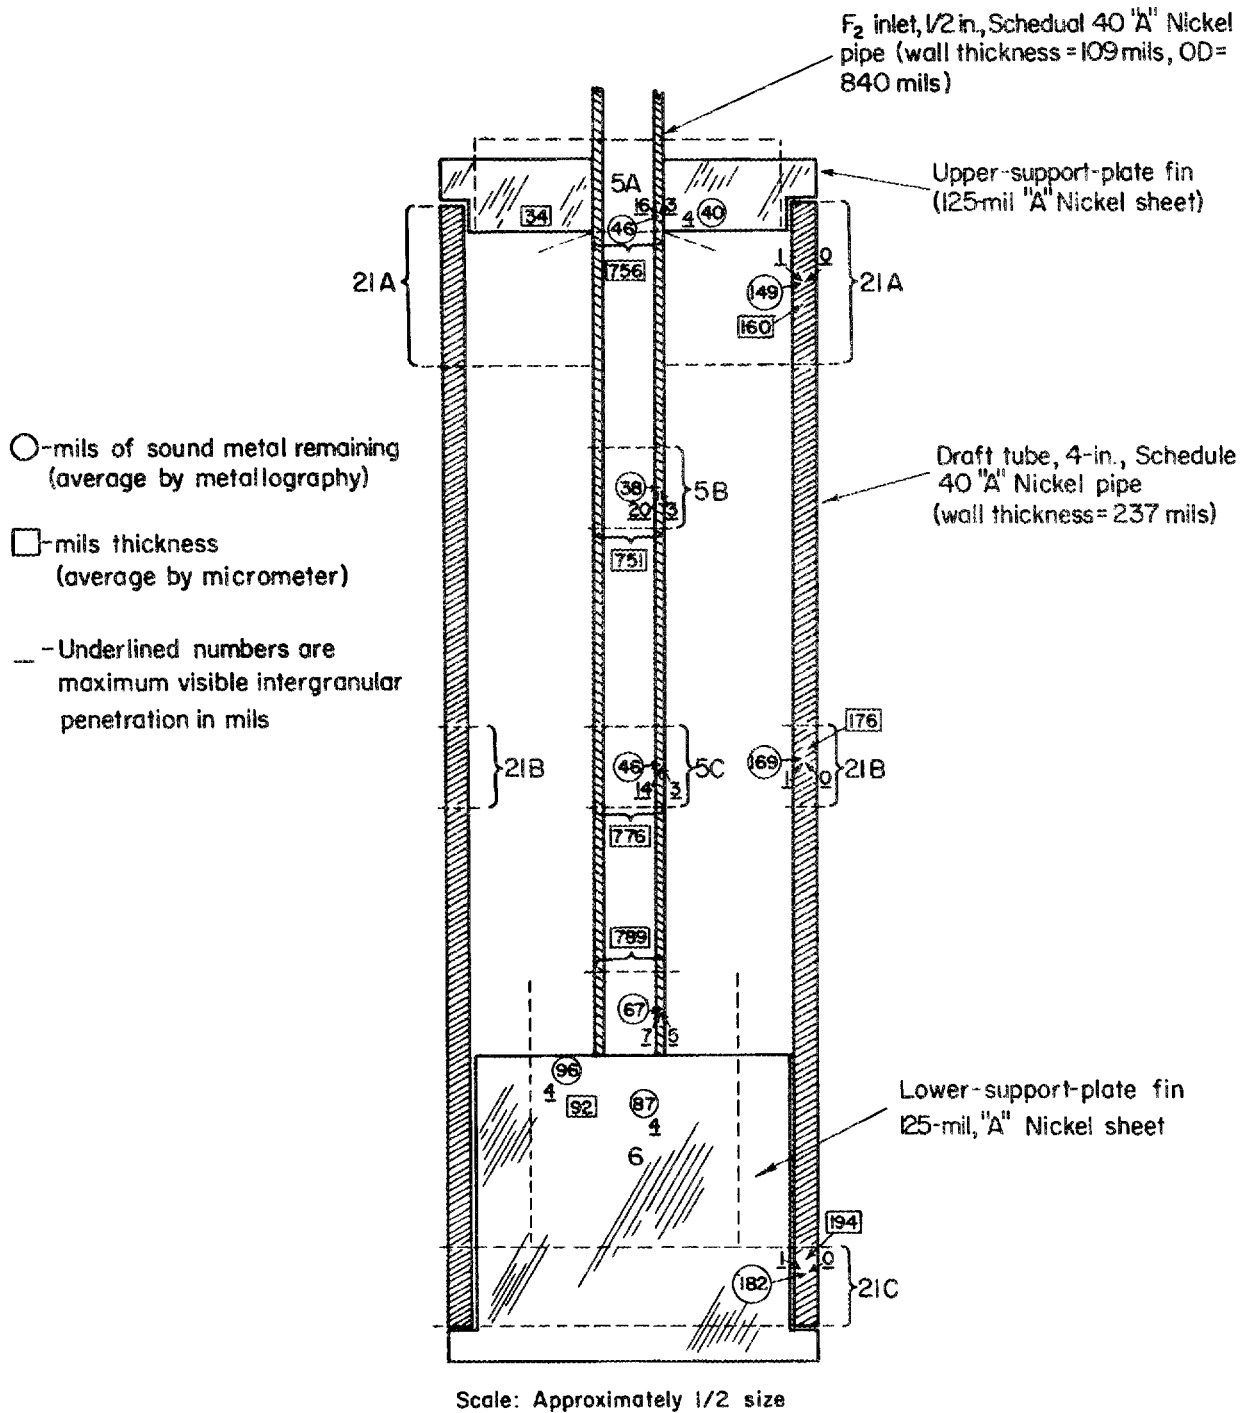
Fig. 29. Corrosion Losses on the Mark IIA Draft Tube and Fluorine Inlet from the Mark II VPP Fluorinator. Considerable metal loss has occurred at all areas but most of the intergranularly attacked grains appear to have sloughed off.

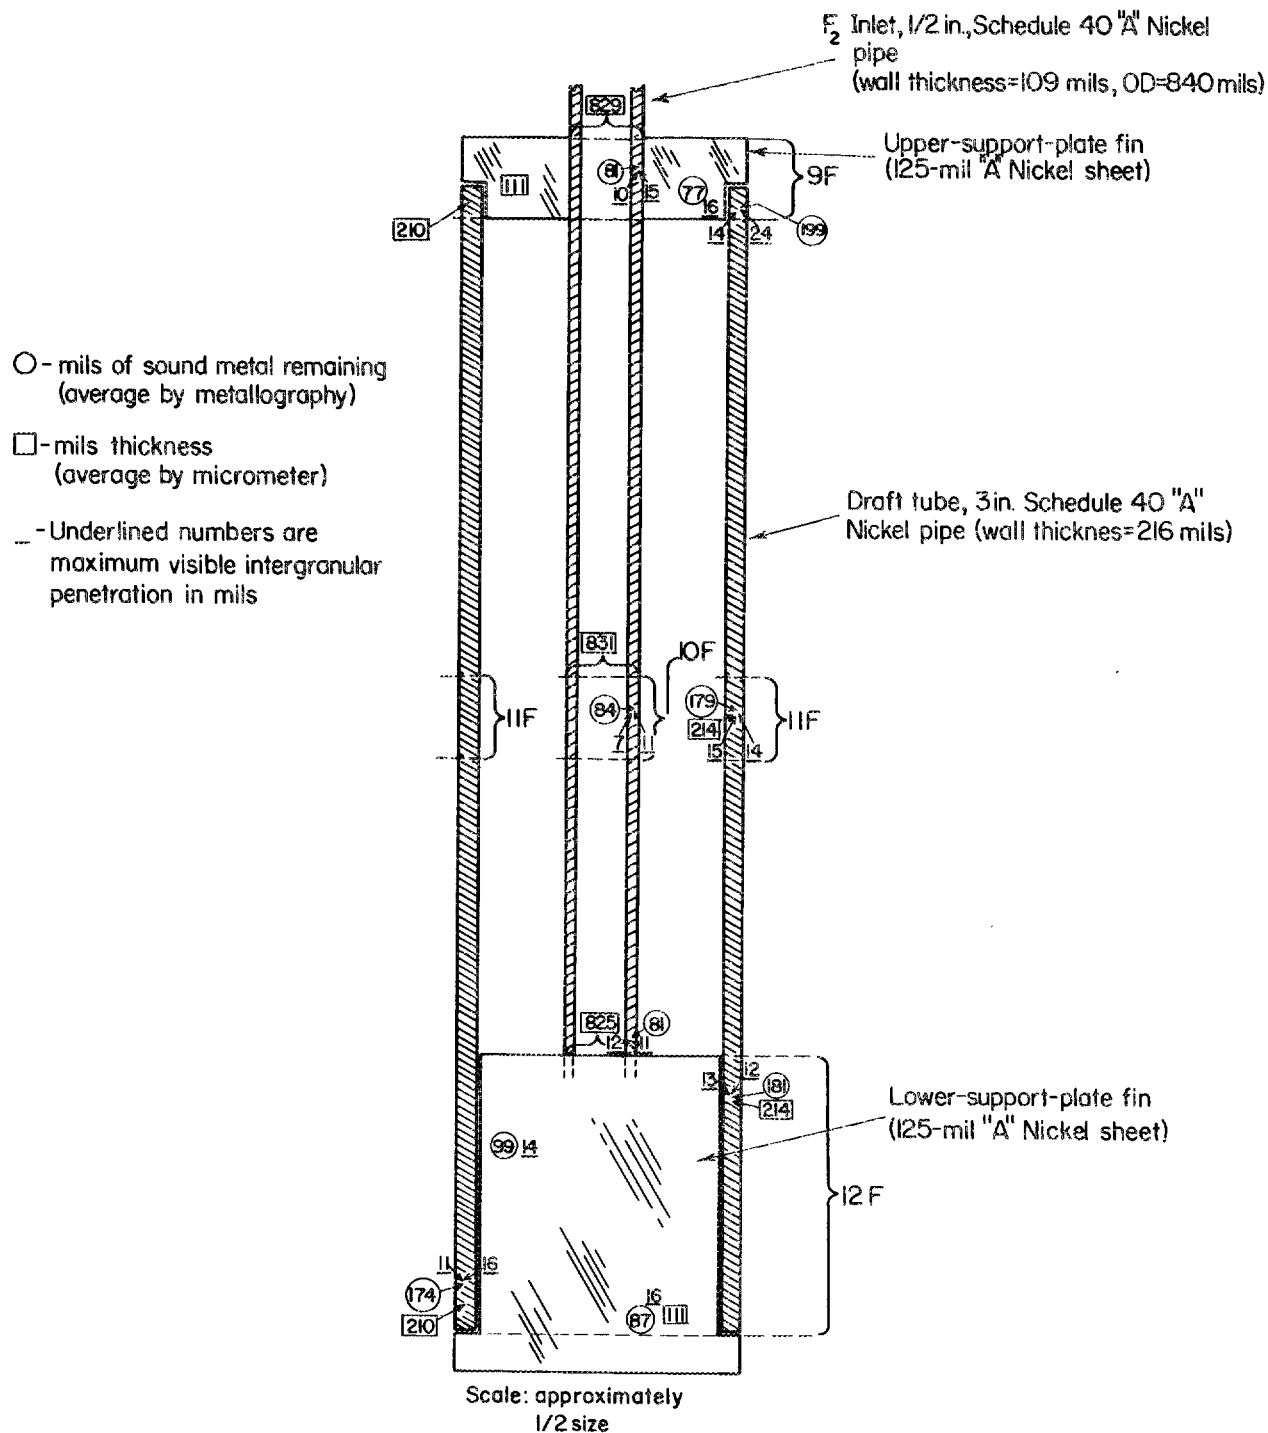
Fig. 30. Corrosion Losses on the Mark IIB Draft Tube and Fluorine Inlet from the Mark II VPP Fluorinator. Metal loss was not as severe as in the case of the Mark IIA assembly and more intergranular penetration was noted.

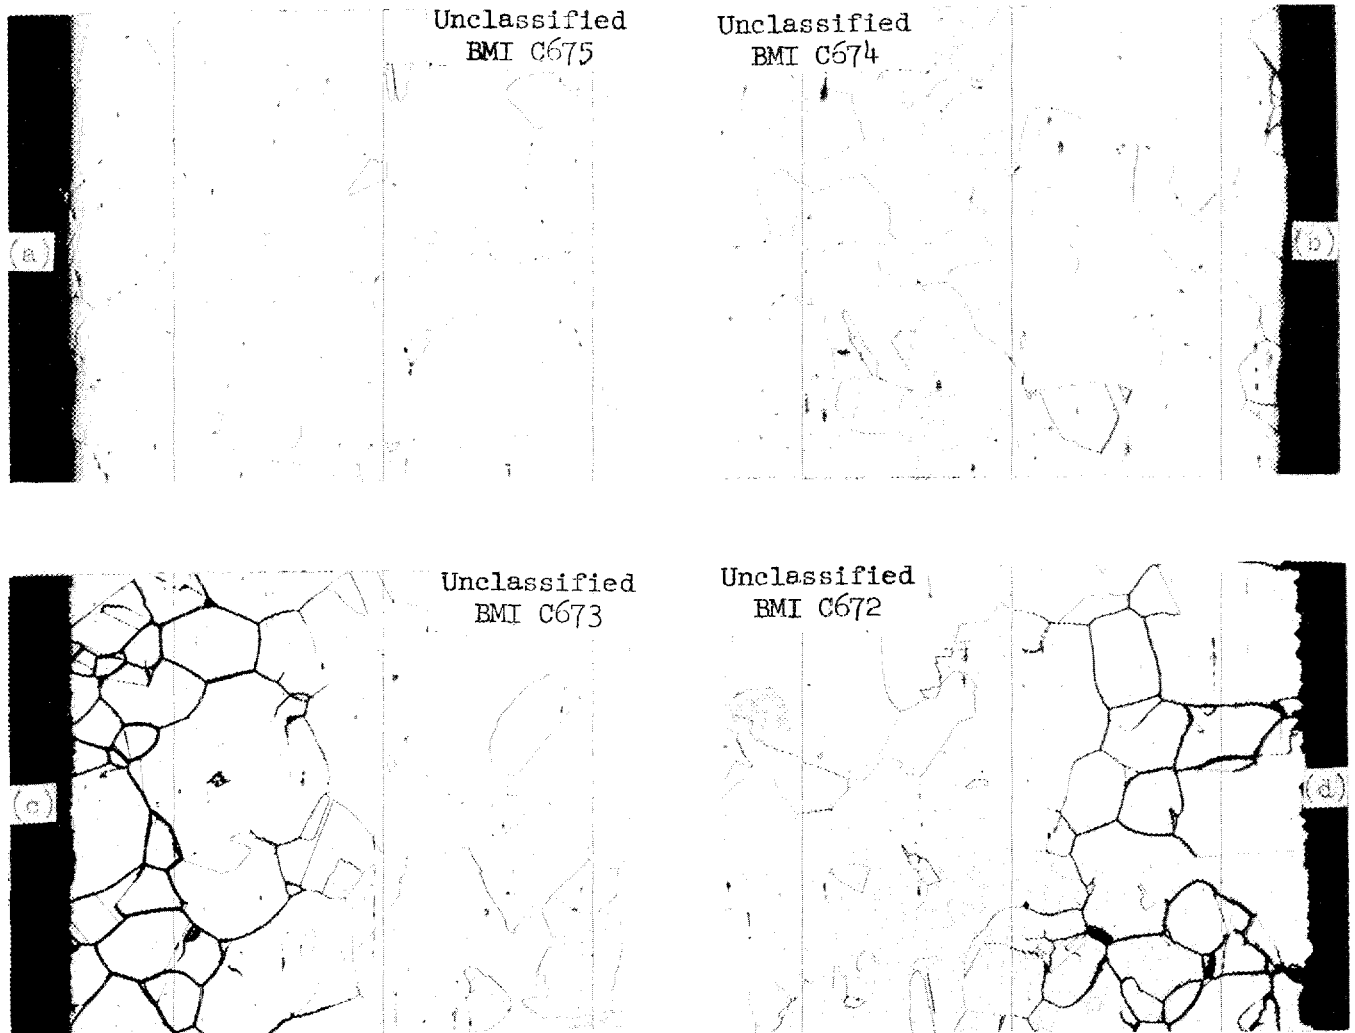
Fig. 31. Microstructures of Samples from A Nickel Draft Tubes Used in Mark II VPP Fluorinator. (a) and (b) exterior and interior surfaces of Mark IIA draft tube at Section 21B; (c) and (d) exterior and interior surfaces of Mark IIB draft tube at Section 11F. Etchants: (a) and (b) Hydrochloric-nitric acid, (c) and (d) Nitric-acetic acid. 100X.

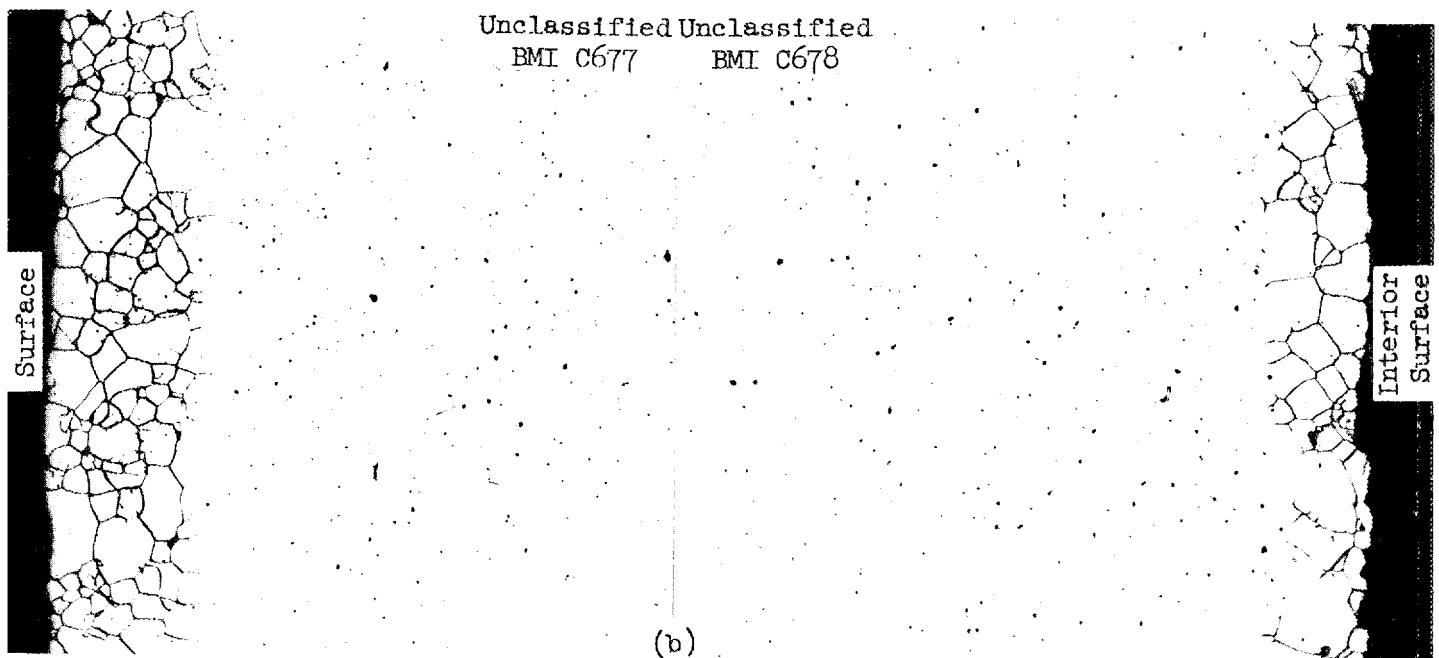
Fig. 32. Microstructures of Cross Sections Through A Nickel Fluorine Inlet Tubes from (a) Mark IIA Draft Tube (b) Mark IIB Draft Tube. Etchants: Nitric-acetic acid. 70X.
