CORROSION ASSOCIATED WITH FLUORINATION  
IN THE OAK RIDGE NATIONAL LABORATORY  
FLUORIDE VOLATILITY PROCESS

A. P. Litman  
A. E. Goldman

METALLURGY DIVISION

JUN - 5 1961

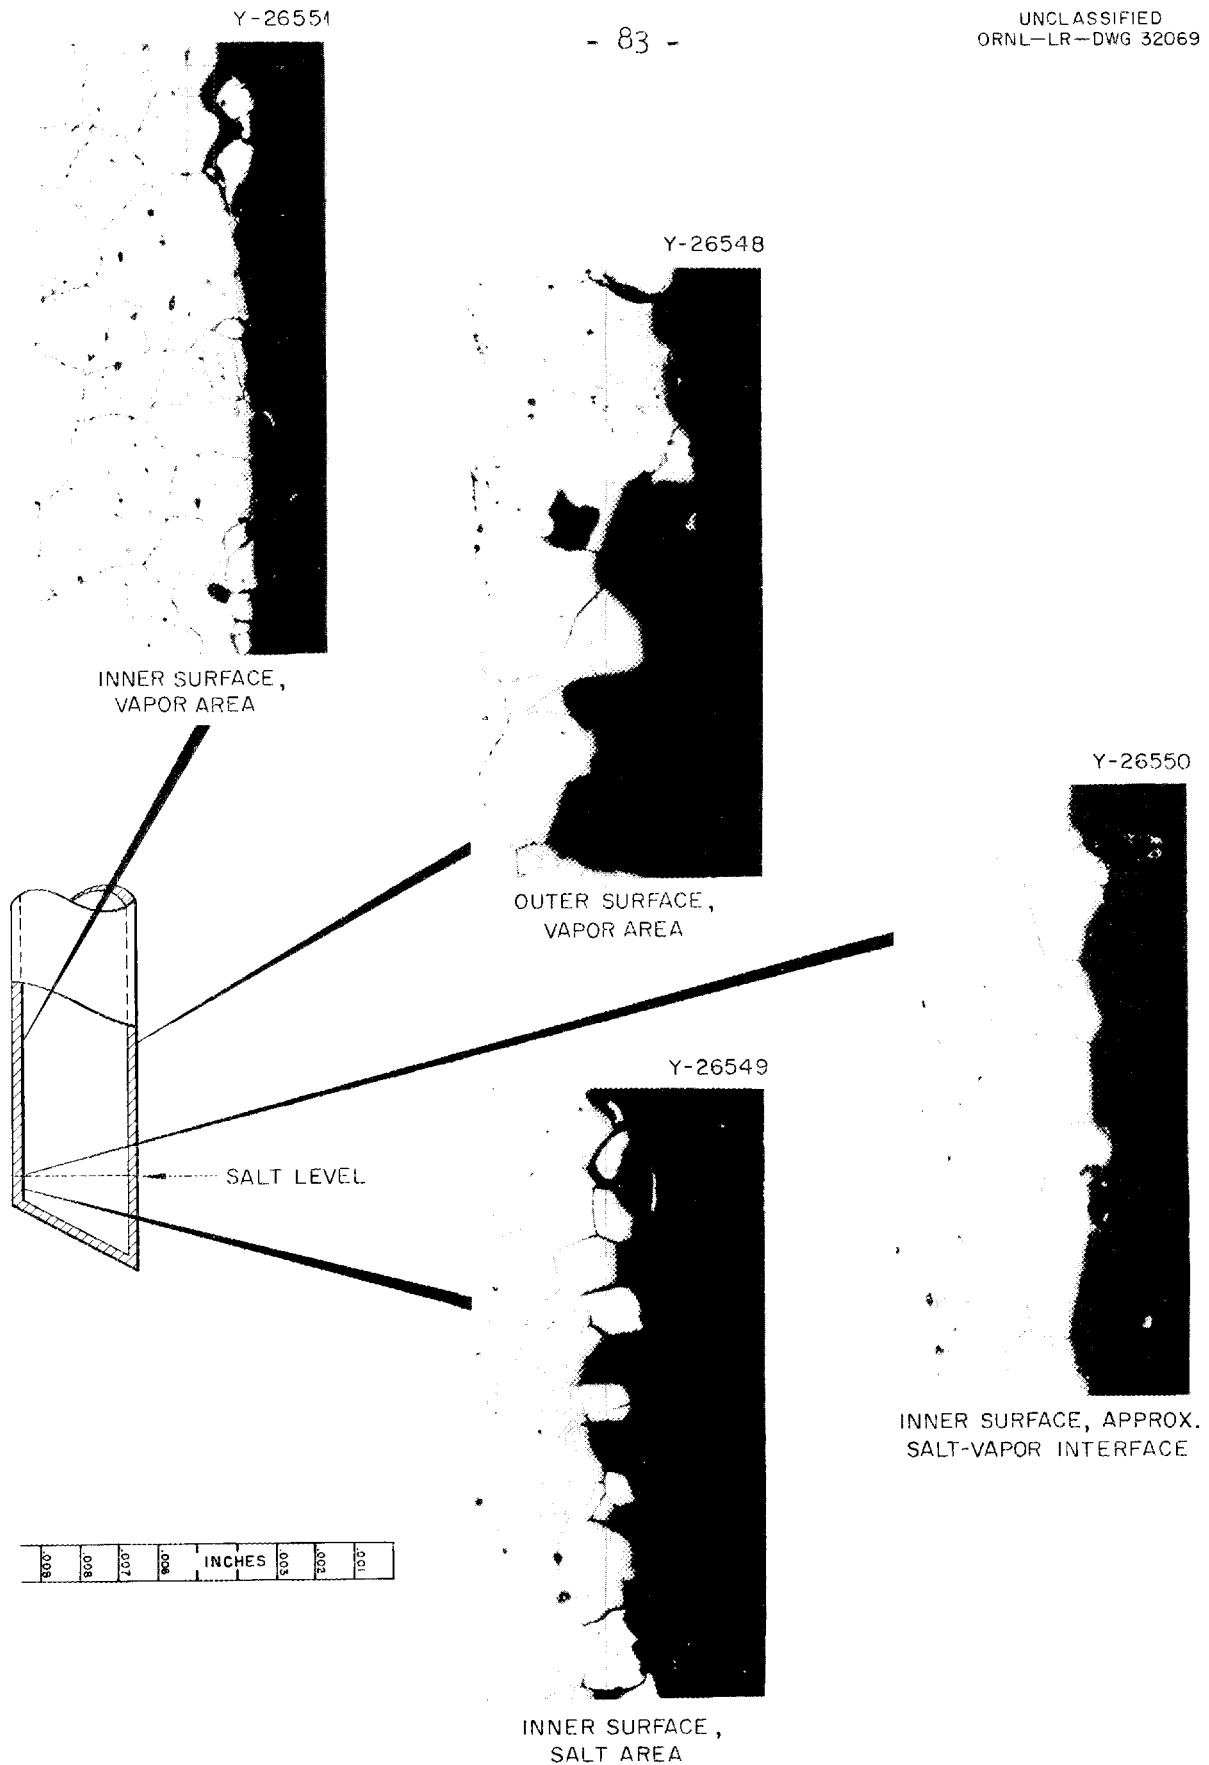
Fig. 34. Typical Microstructures of Samples Removed from Chemical Development Inconel Fluorinator. Etchant: Glyceria regia. 250X. Reduced 32%.

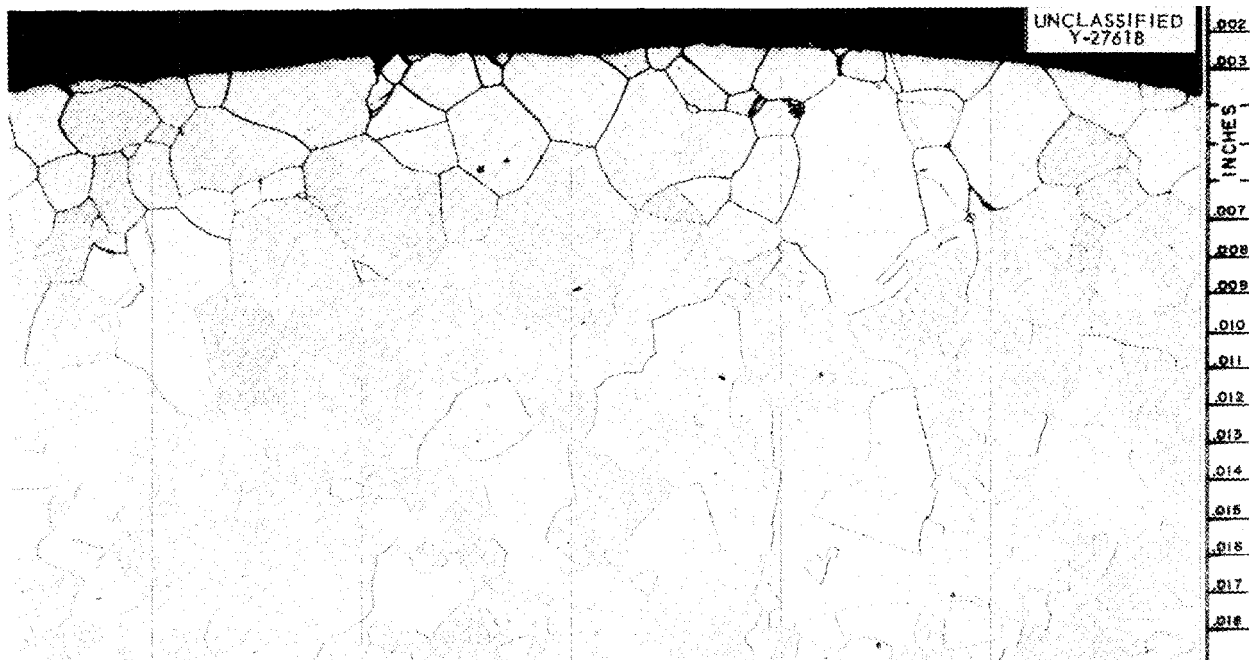
Fig. 59B. Portion of Fig. 59A. Typical Surface and Microstructure. Note intergranular attack. Etchant:  $\text{KCN}-(\text{NH}_4)_2\text{S}_2\text{O}_8$ . 200X.

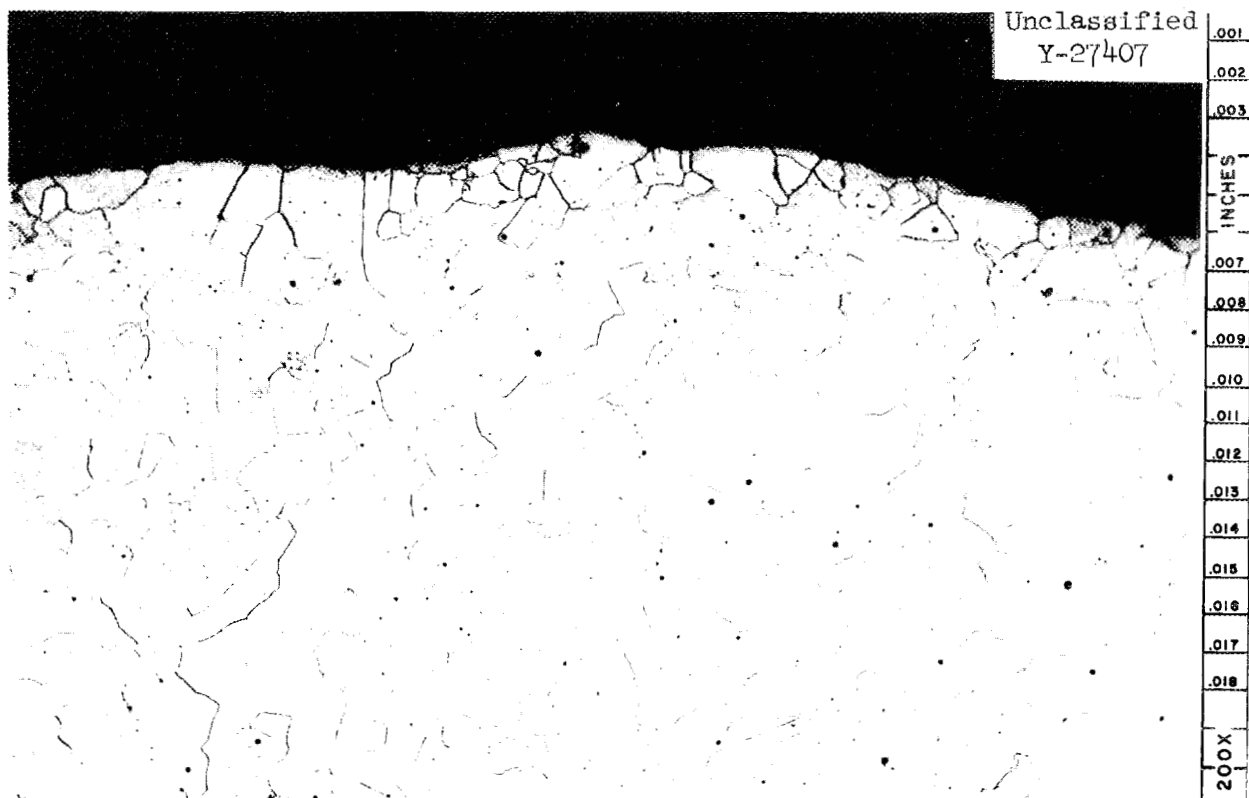
Fig. 60B. Portion of Fig. 60A. Typical Surface and Microstructure. Intergranular attack. Etchant:  $\text{HNO}_3\text{-H}_2\text{SO}_4$ . 200X.

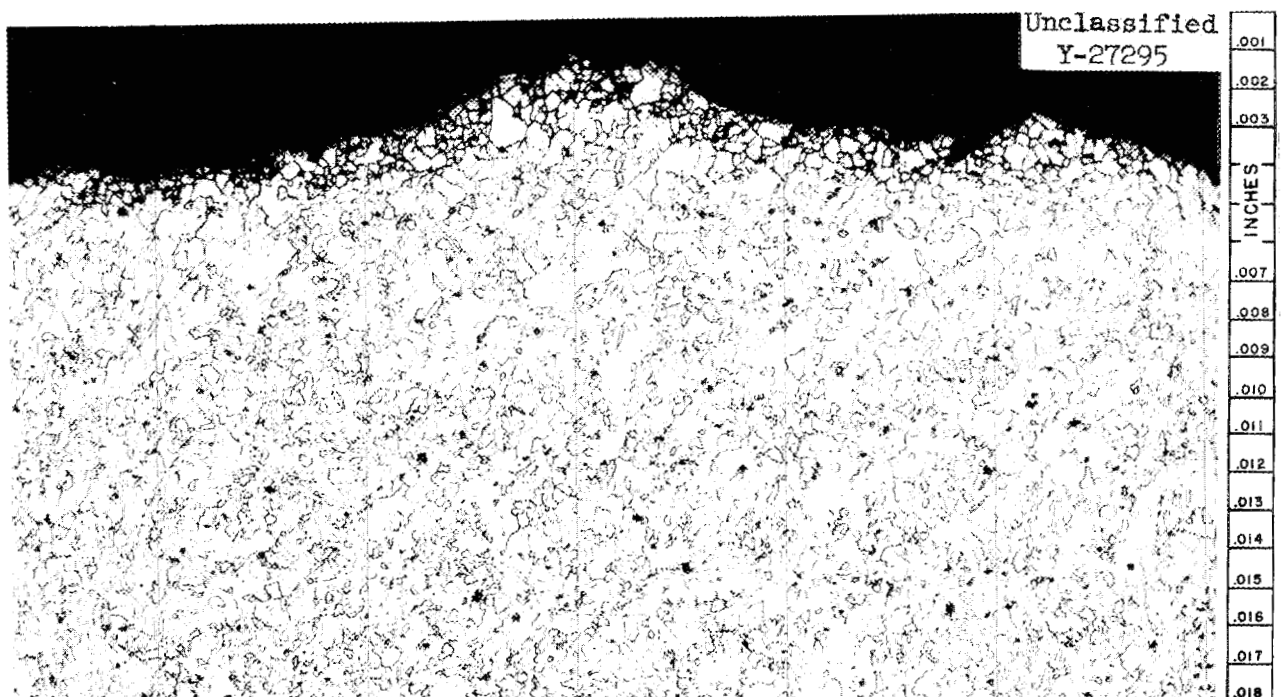
Fig. 73B. Portion of Fig. 73A. Typical Microstructure and Surface Showing intergranular attack. Etchant: Chromium regia. 200X.

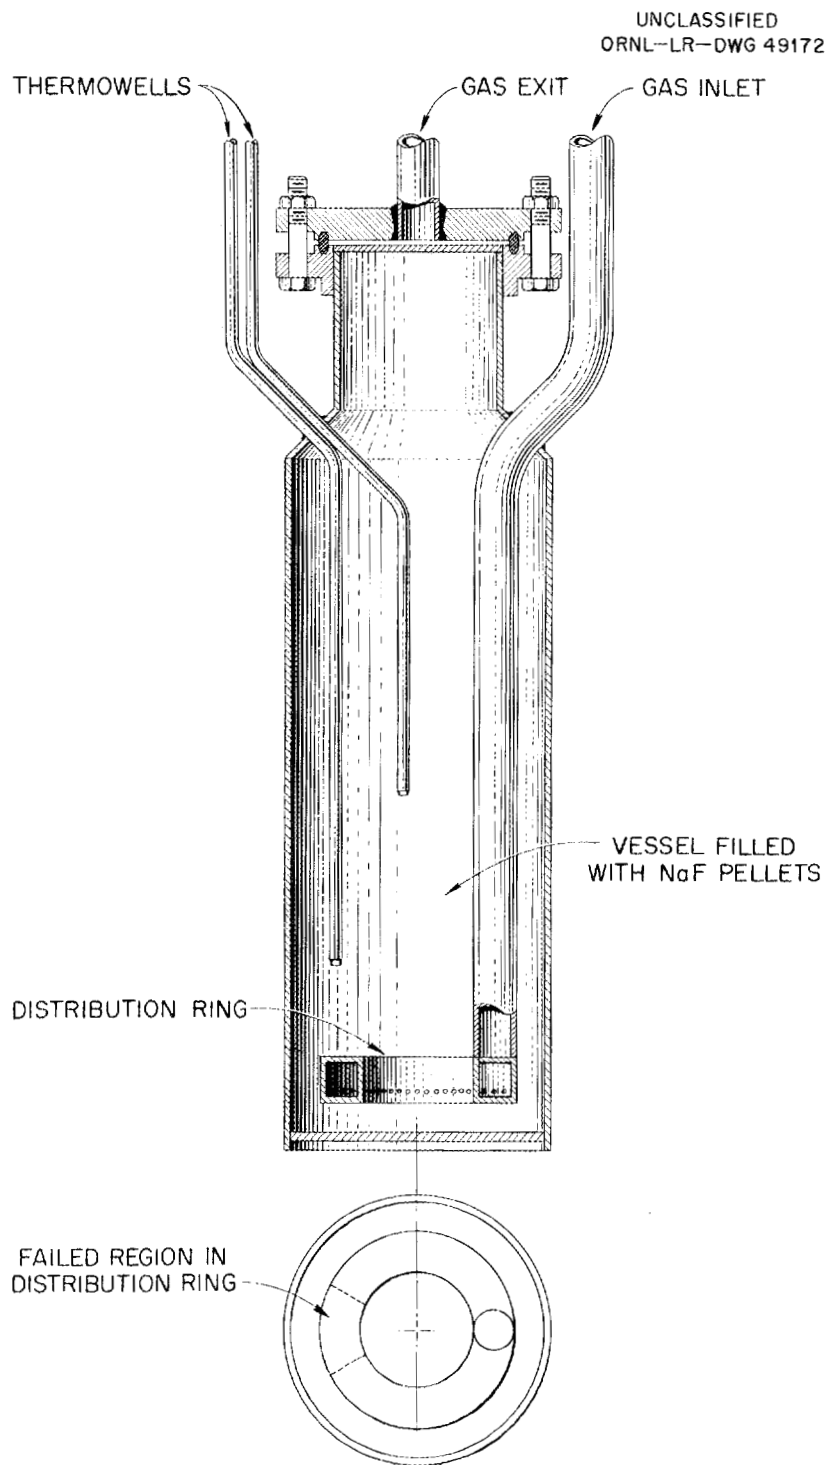
Fig. 84. Schematic View of VPP Inconel Absorber and Gas-Distribution Ring Illustrating Area of Failure.

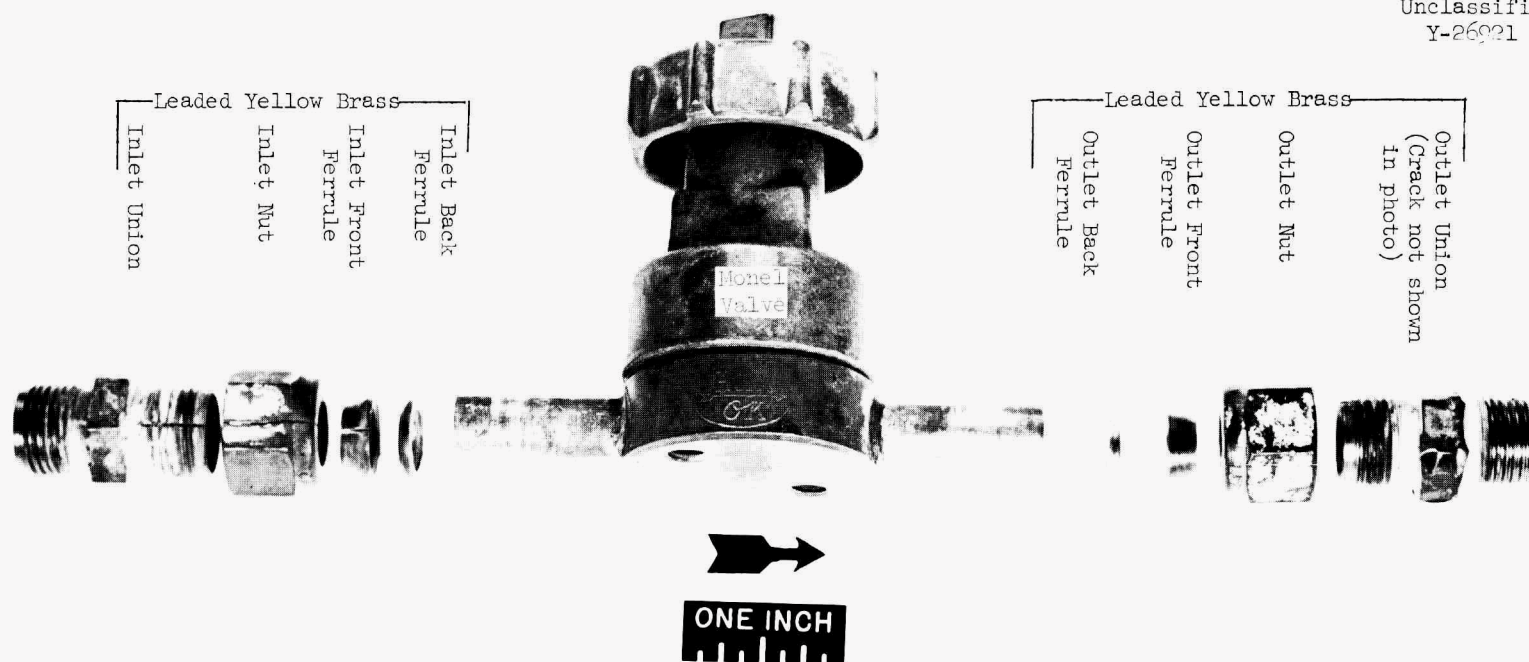
Fig. 88. Photograph of Gas Purge Line (PE-34) Valve and Attached Fittings. (Note fractures in inlet union, inlet nut, and inlet front ferrule.)

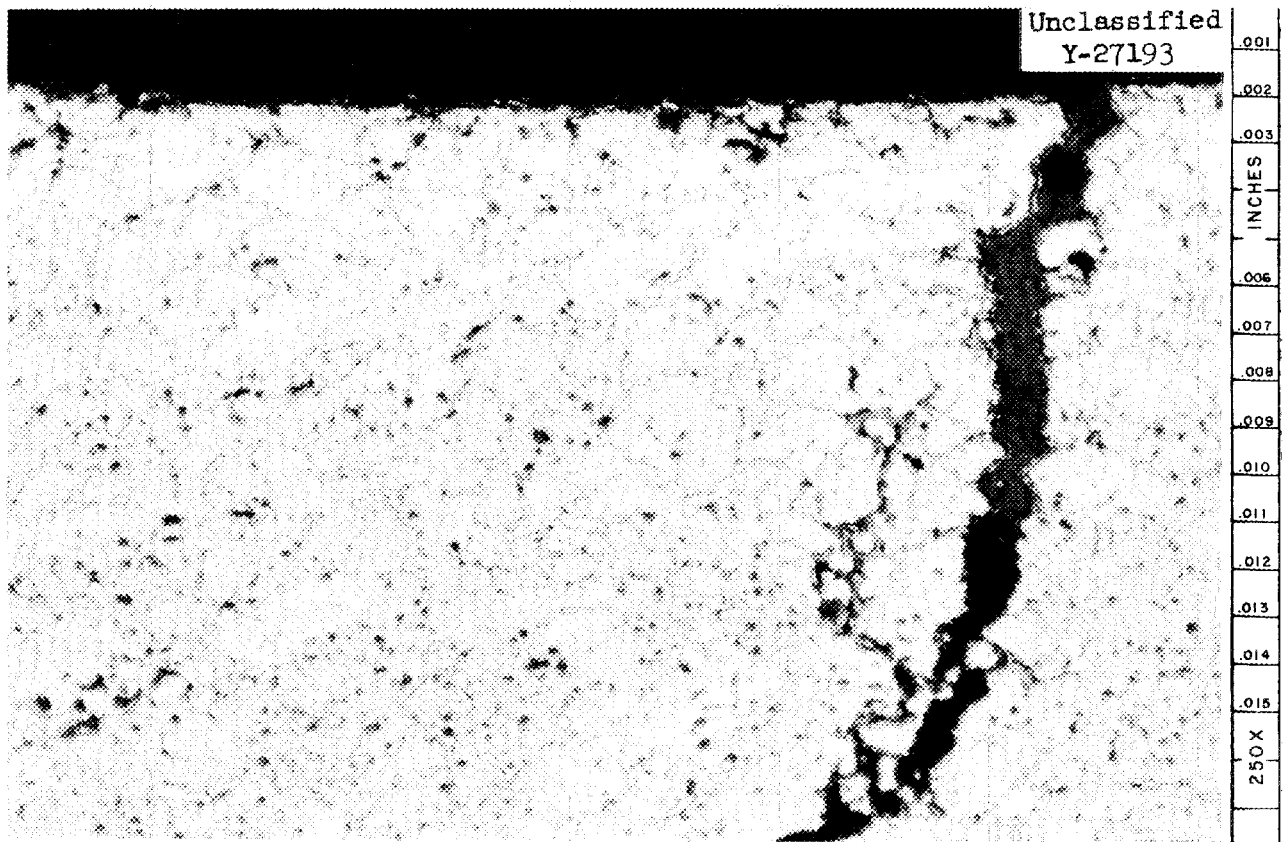
Fig. 89. VPP Leaded, Yellow Brass Inlet Back Ferrule Showing Intergranular Fracture Lined with Copper-Rich Deposits Indicative of Dezincification. Etchant:  $\text{NH}_4\text{OH}-\text{H}_2-\text{H}_2\text{O}$ . 250X.

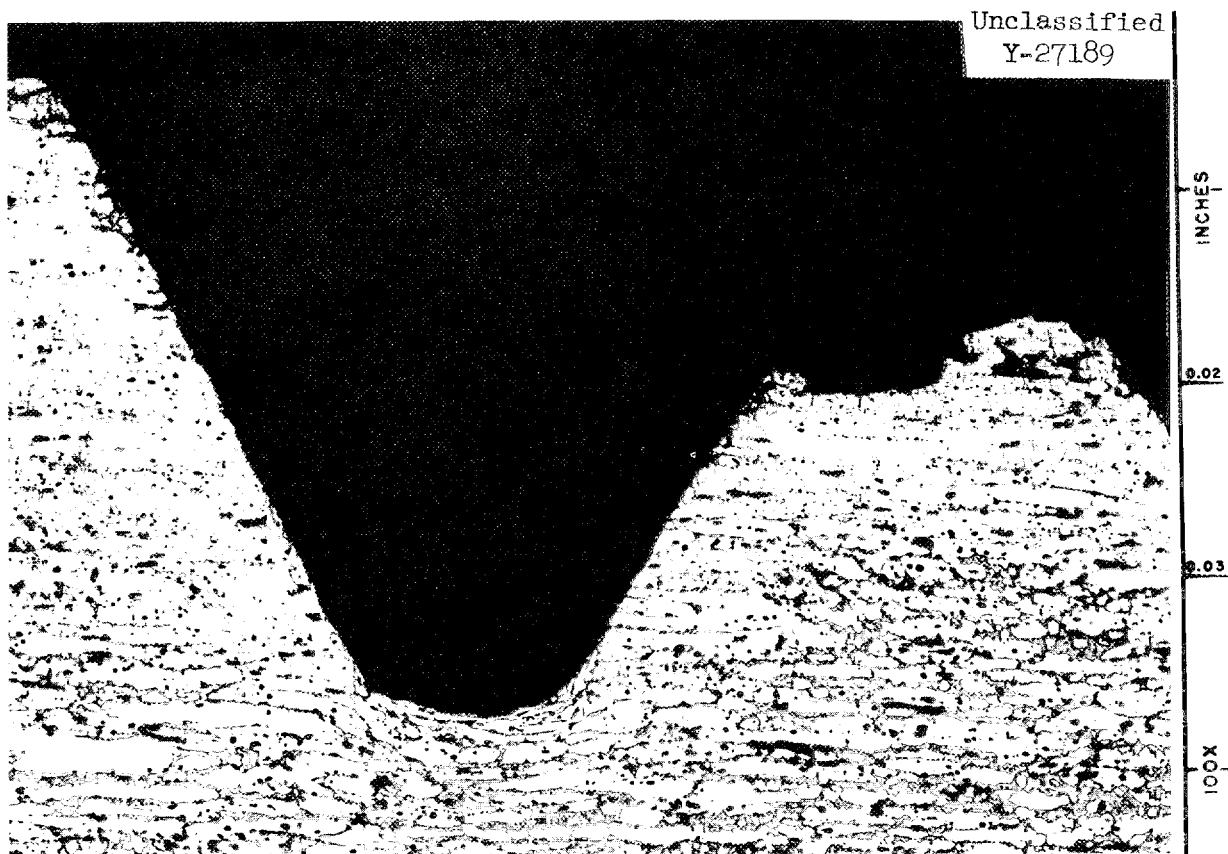
Fig. 90. VPP Leaded, Yellow Brass Inlet Union Showing General Corrosive Attack. Etchant:  $\text{NH}_4\text{OH}-\text{H}_2\text{O}_2-\text{H}_2\text{O}$ . 100X.

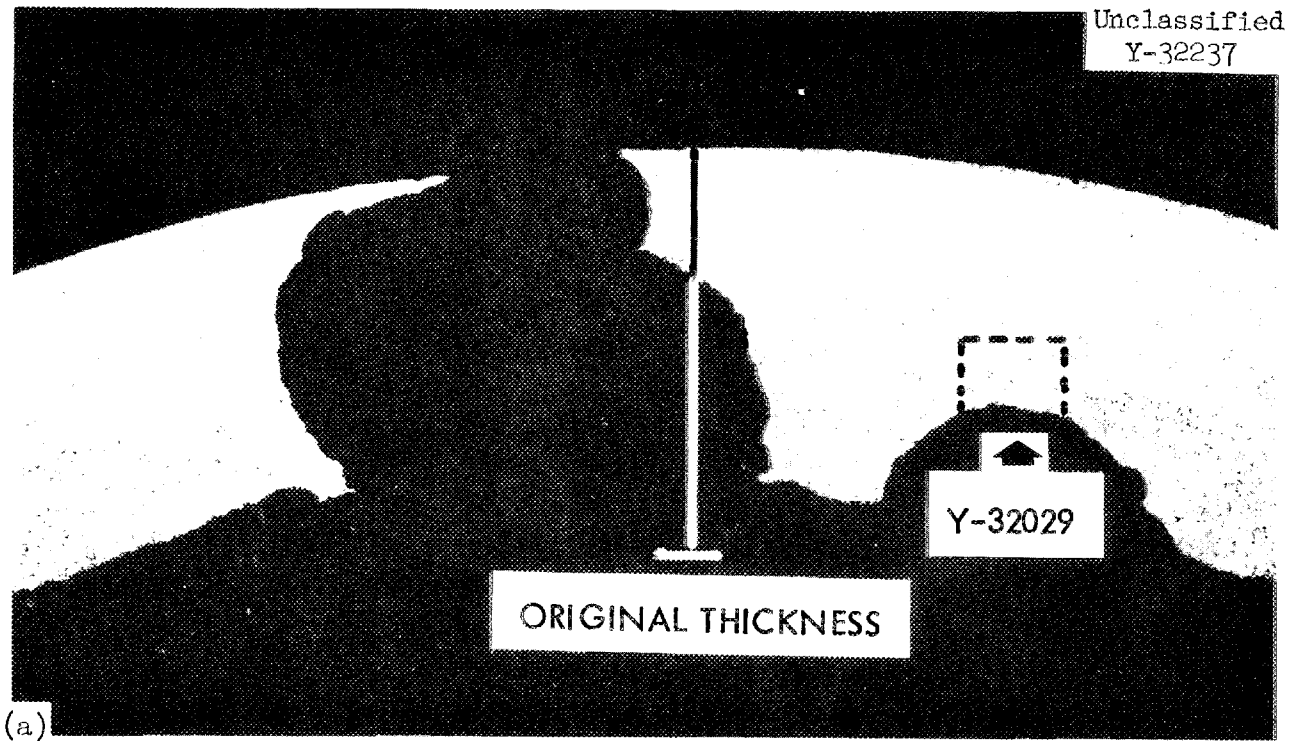
Fig. 93. Cross Sections of Gas Disposal Unit Inlet Pipe (a) Photomicrograph Showing Severe Pitting Attack. 15X. (b) Portion of Fig. 93A showing typical surface at base of pit. 500X. Etchant: Acetic-nitric-hydrochloric acid.
