POSTIRRADIATION EXAMINATION OF MATERIALS FROM THE MSRE

H. E. McCoy
B. McNabb

METALS AND CERAMICS DIVISION

DECEMBER 1972

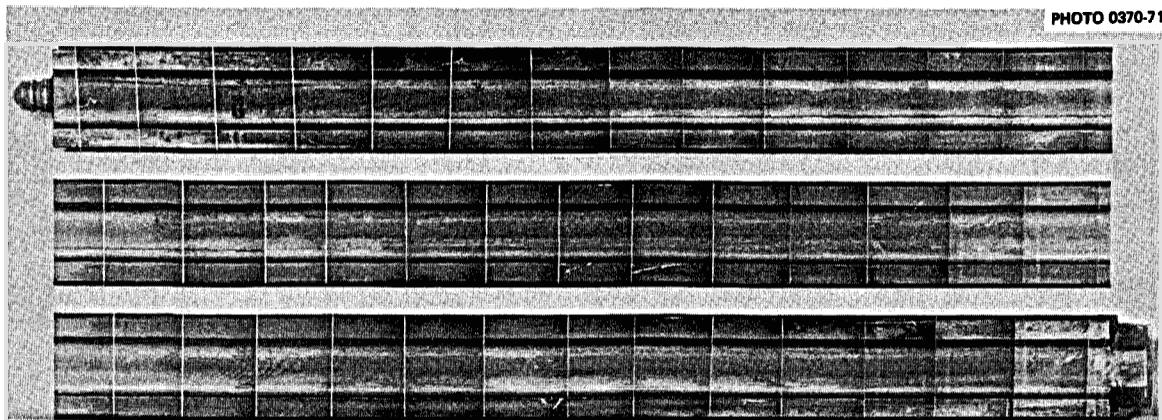
One of the five removable graphite core moderator elements (1184) was examined in the High-Radiation-Level Examination Laboratory (HRLEL) after completion of the operation of the MSRE. Visual examination revealed machining marks still plainly visible in the fuel channels and on surfaces not exposed directly to flowing fuel salt, indicating little if any change during operation. Figure 6 is a photograph of the fuel channel facing the center of the reactor, and it shows the excellent condition of the core block. The small thumbnail flaw in the fuel channel about 39 in. from the top is likely a small crack that was in the bar during fabrication, since tool marks are on the top of the flaw and skip over an area at the end of the flaw. The few scratches on the surface are not very deep and were likely caused by handling.

Fig. 6. One of the removable graphite moderator elements after operation in the MSRE, showing the fuel channel facing the center of the reactor. Machining marks are plainly visible in the fuel channel, showing excellent condition of the core block.

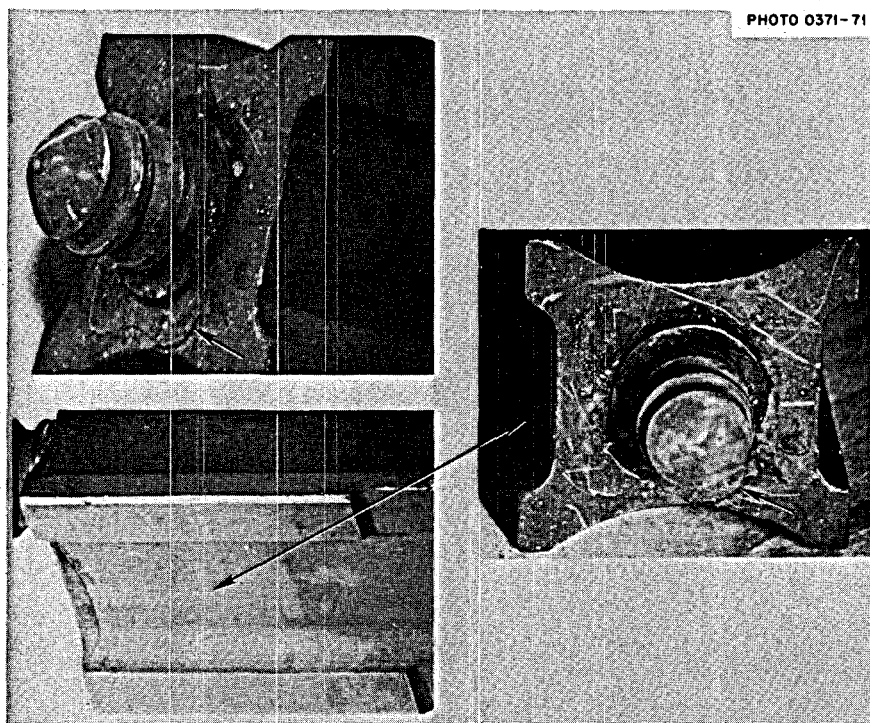
There was a crack in the graphite around the INOR-8 lifting stud that was screwed into the top of the bar. This crack extended about halfway around the bar, as shown by the short arrows in Fig. 7. The long arrow indicates the same channel in the different views. The small punch mark visible in the top view was made to indicate the fuel channel toward the center of the reactor, with a control rod on one side and the surveillance sample basket on the other side. The crack in the graphite did not affect the integrity of the bar, since it was on the end, and several threads remained to secure the lifting stud. The crack was probably caused by the approximate twofold difference in thermal expansion of graphite and INOR-8.

Fig. 7. Top of the graphite moderator element. The short arrows show the crack originating at the INOR-8 lifting stud and extending partway around the graphite block. The long arrow indicates the same channel in the different views. The crack was probably caused by the approximate twofold difference in thermal expansion between the INOR-8 and the graphite during thermal cycling of the reactor.

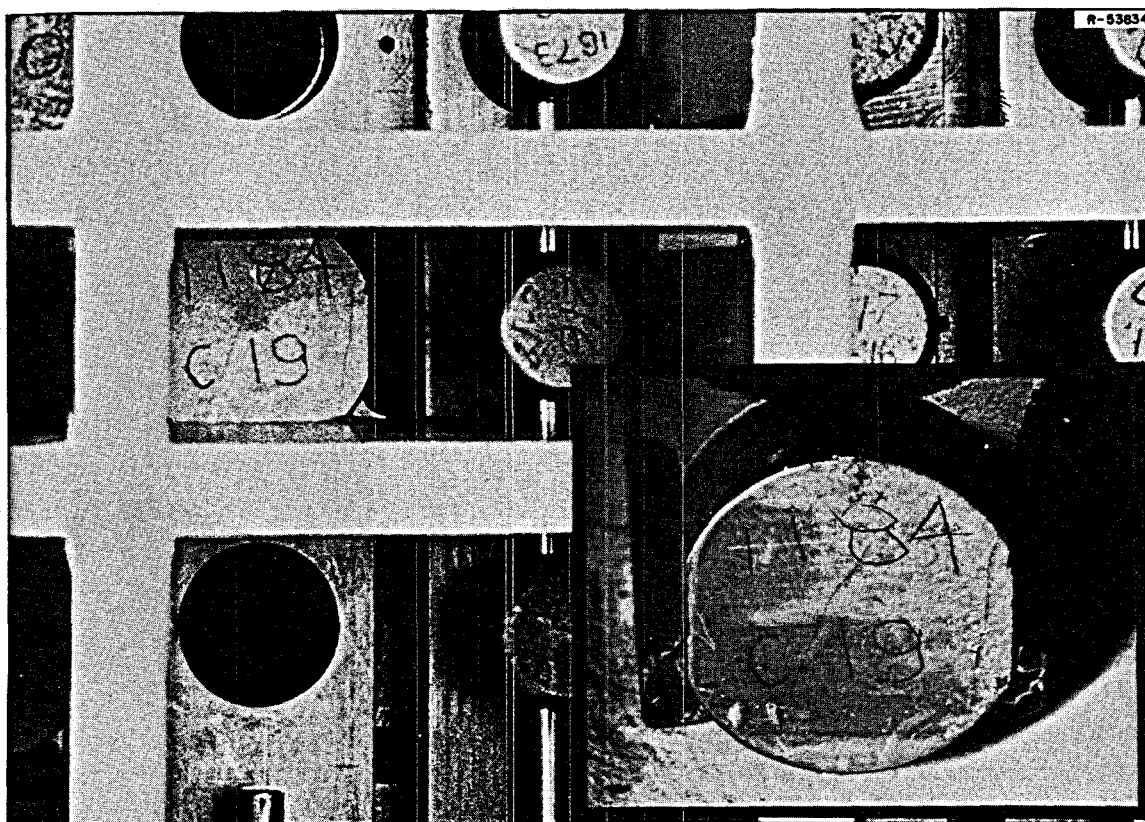
Fig. 8. Comparison of the bottom positioning stud on the graphite moderator element when initially installed in the MSRE and after operation. The large picture was made before the reactor was operational, and the small picture in the lower right corner was made in the hot cells after the moderator element had been at temperature for over three years.

exposure to molten salt). There is no apparent change, as the small cracks and the small chip missing from the bottom are apparent in both photographs, and the numbers are just as legible as before operation.

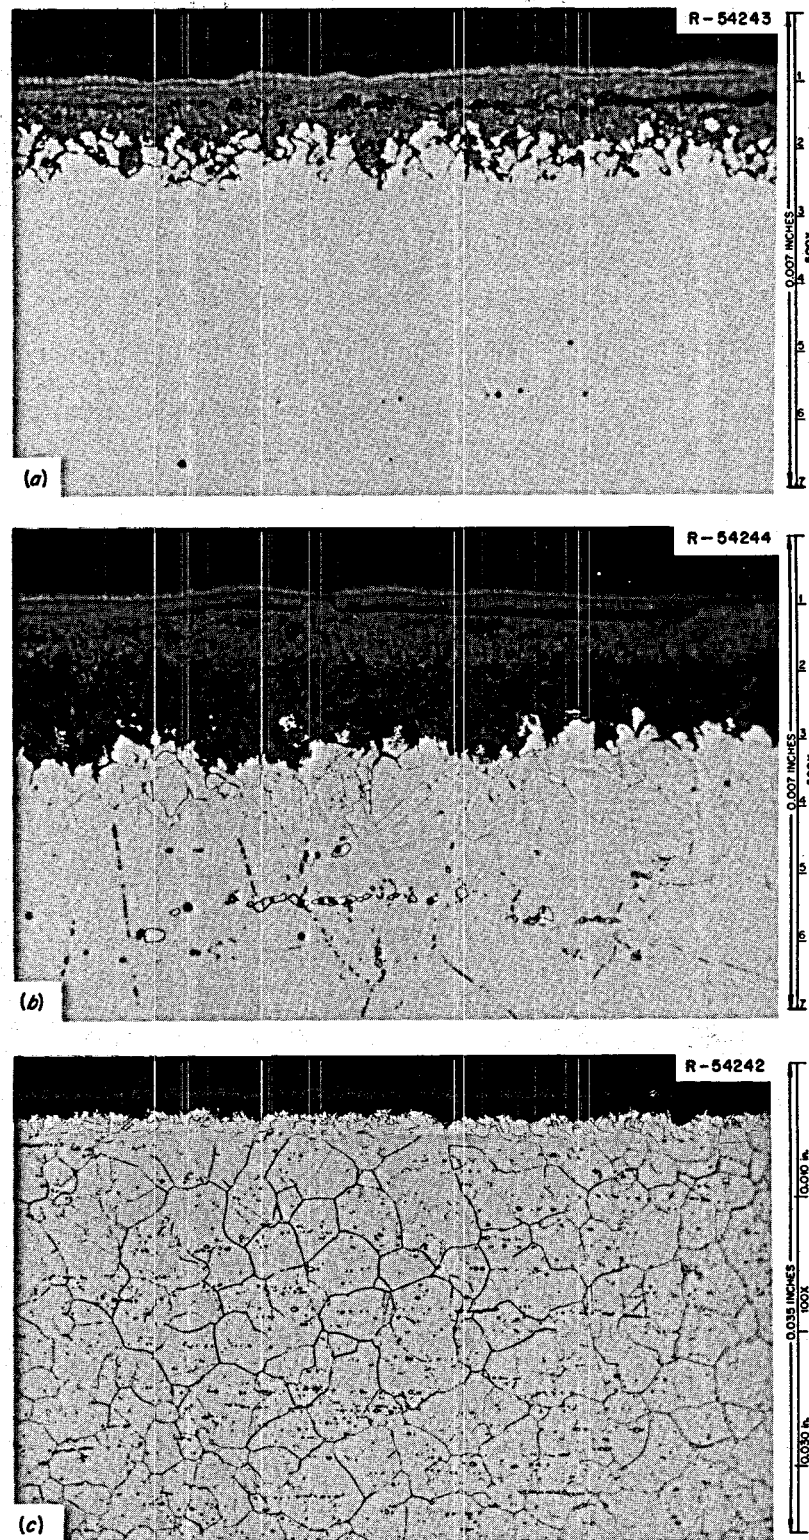
Samples of the control rod thimble and the spacer sleeve were cut and examined to determine their condition at the end of service. Typical photomicrographs of the inside of the thimble tube are shown in Fig. 13. This surface was oxidized to a depth of about 2 mils by the cell environment of nitrogen containing 2 to 5% O_2 . The oxidation process modified the microstructure to a depth of 4 mils, likely by the selective removal of chromium.

Fig. 13. Inner surface of INOR-8 control thimble in as-removed condition. This surface was exposed to cell environment of N_2 containing 2 to 5% O_2 . (a) As polished; (b) etched; (c) etched, typical microstructure. Etchant: aqua regia. Reduced 30.5%.

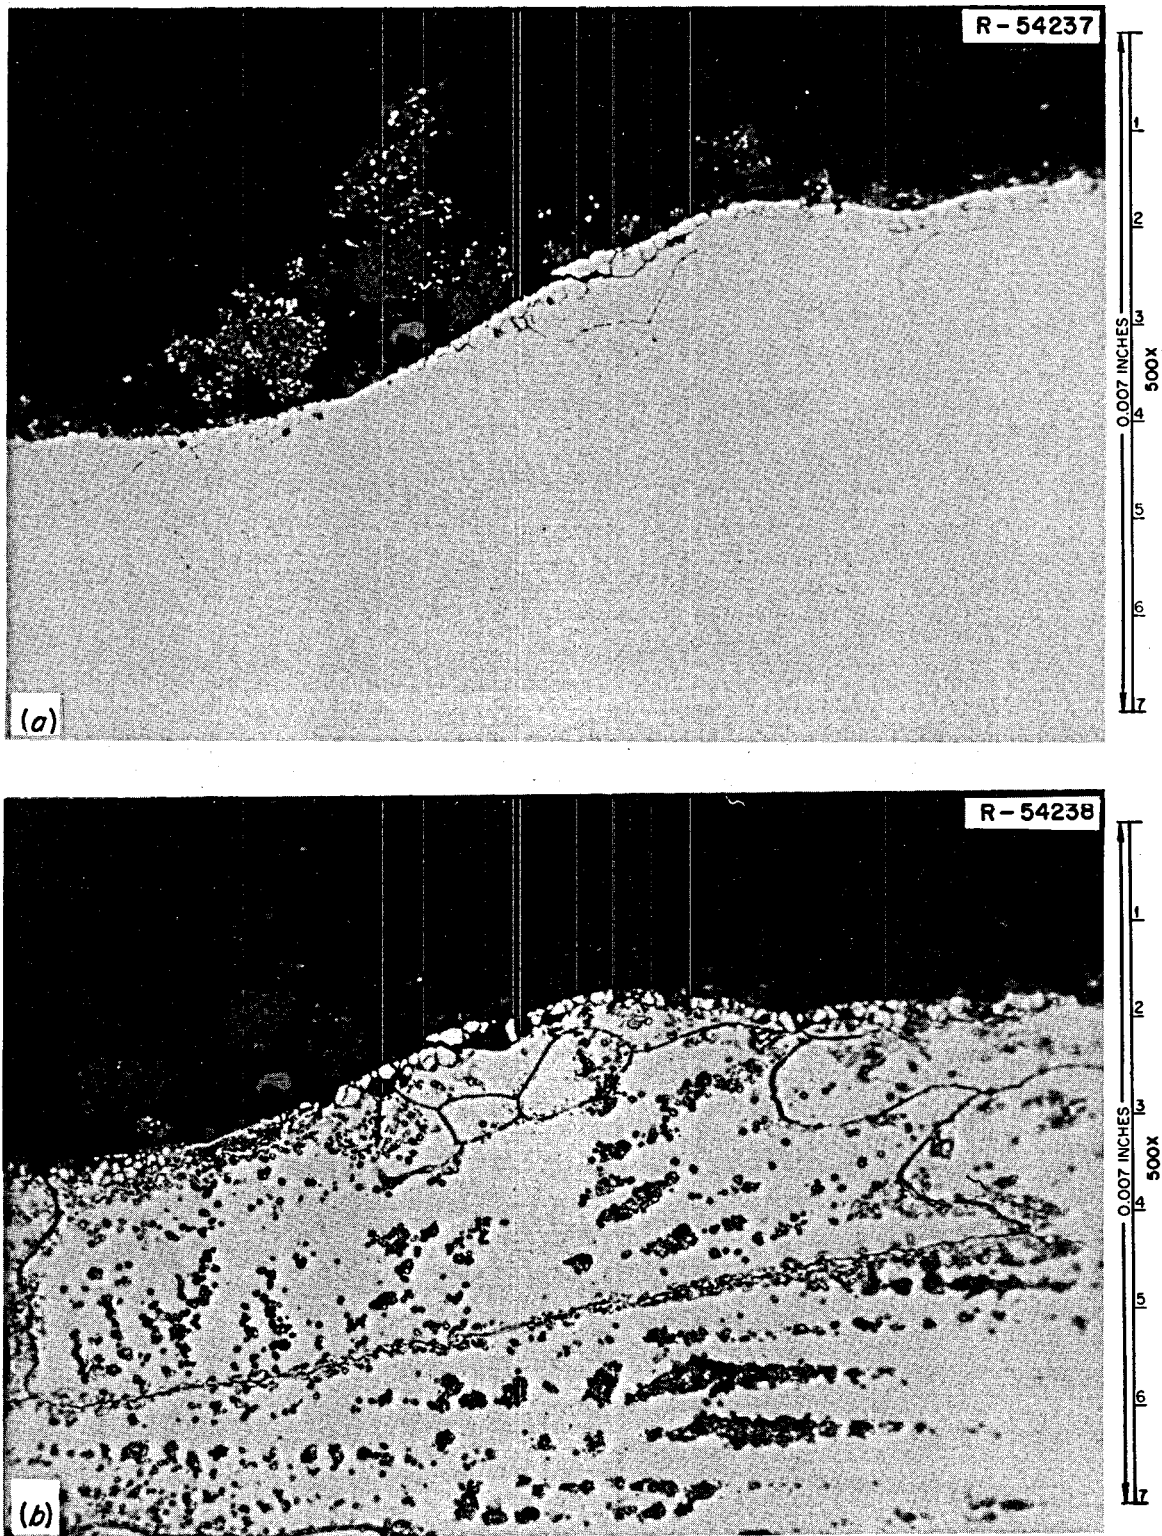
Photomicrographs of one of the weld beads are shown in Fig. 14. All of the surface shown was exposed to flowing fuel salt. Some grains were dislodged near the surface, and grain boundaries are visible in the as-polished condition to a depth of 1 to 1.5 mils.

Fig. 14. Outer surface of INOR-8 control rod thimble showing weld deposit made to hold spacer sleeve. The weld surface was exposed to flowing salt. (a) As polished; (b) etched with aqua regia.

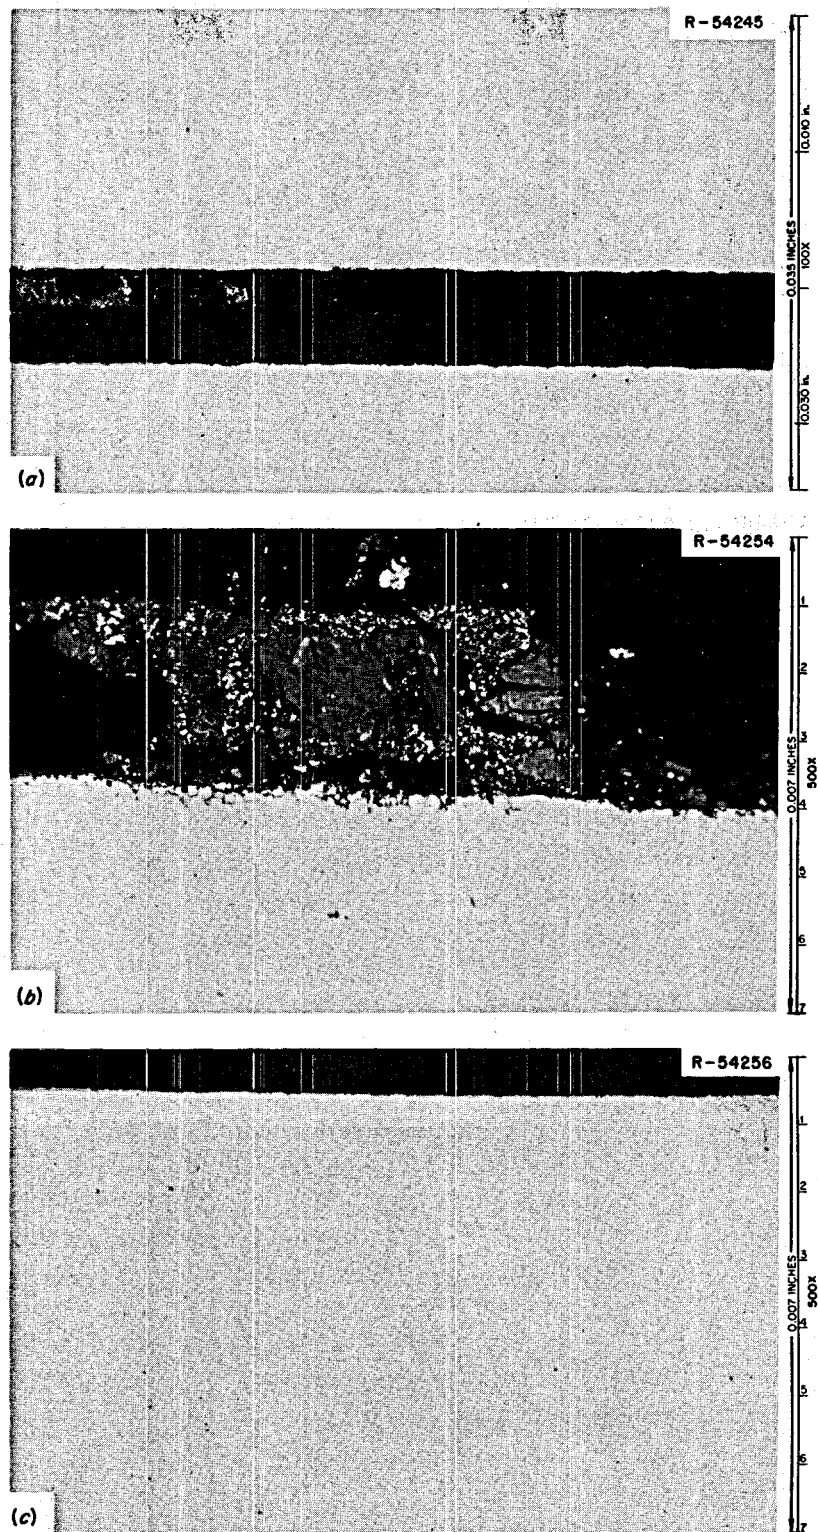
Photomicrographs involving the interface between the thimble and sleeve are shown in Fig. 15. Figure 15(a) shows the annular region with a separation of about 7 mils and some salt present. Few surface irregularities are visible at a magnification of 100x, indicating that they are considerably below 1 mil. Figure 15(b) is a 500x view of the thimble and shows some surface cracks to a depth of 0.3 mil. The outside of the sleeve is shown in Fig. 15(c); a few grain boundaries to a depth of about 1 mil are visible. Additional photomicrographs of the sleeve are shown in Fig. 16. The sleeve material does not appear to have received much work, since the carbide is very inhomogeneously distributed. Grain size is larger than usual away from the stringers. The inner and outer surfaces both have modified structures. A higher magnification view of the inner surface [Fig. 16(b)] shows that much of the modification is a high density of primary carbide. The outer surface [Fig. 16(c)] has a shallow layer of small grains, likely due to a working operation.

Fig. 15. As-polished surfaces of INOR-8 control rod thimble and sleeve. (a) Annulus between thimble and sleeve; thimble surface is in upper part of picture. (b) Outside surface of control rod thimble, showing presence of some salt and shallow surface cracking. (c) Outside surface of sleeve; surface exposed to flowing fuel salt.

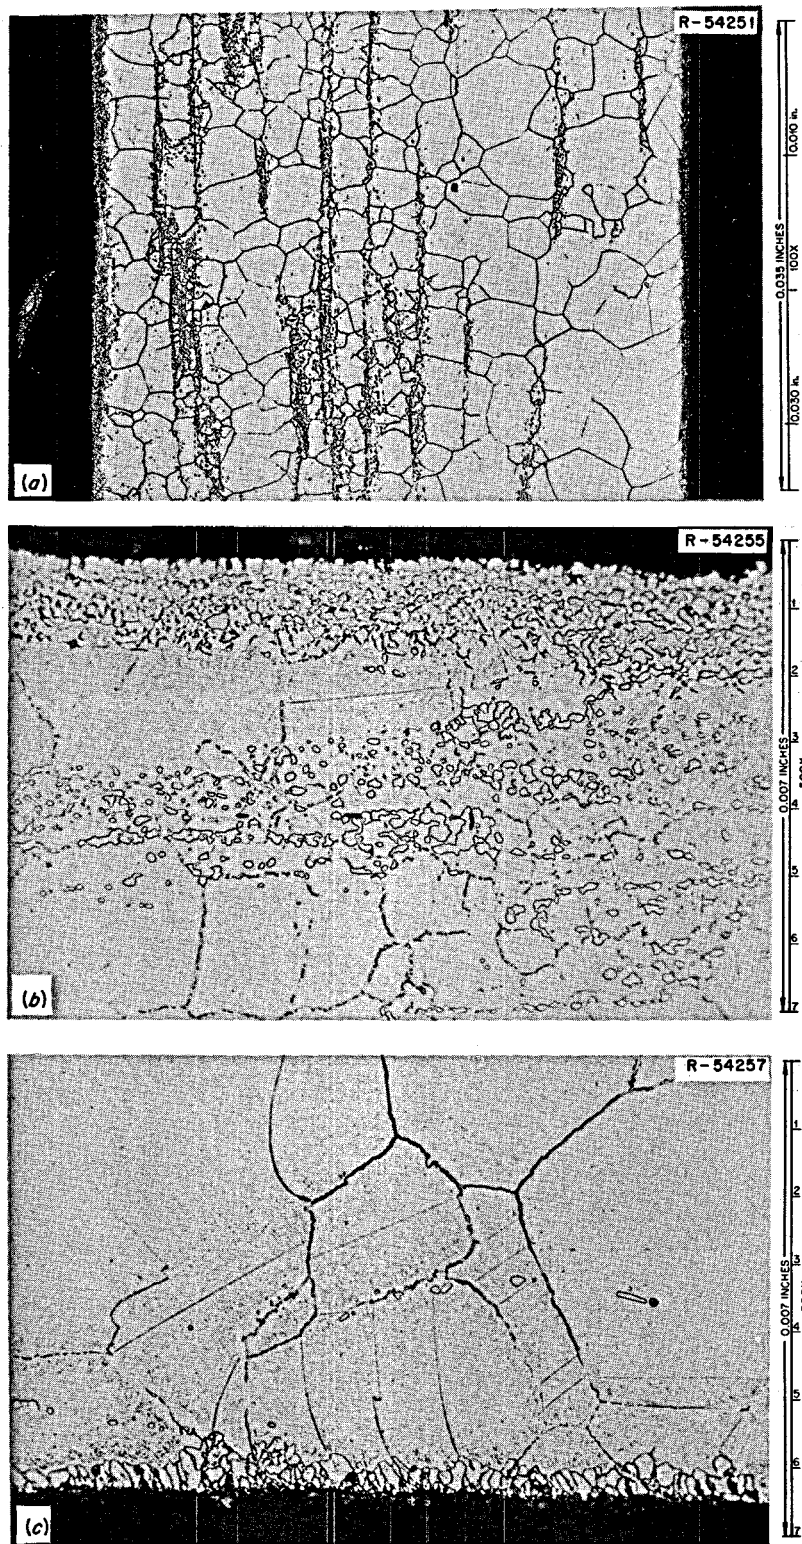
Fig. 16. INOR-8 control rod sleeve. Etched with aqua regia. (a) General microstructure; inner surface is on left and outer surface is on right. (b) Inner surface of sleeve. (c) Outer surface of sleeve. Reduced 30.5%.

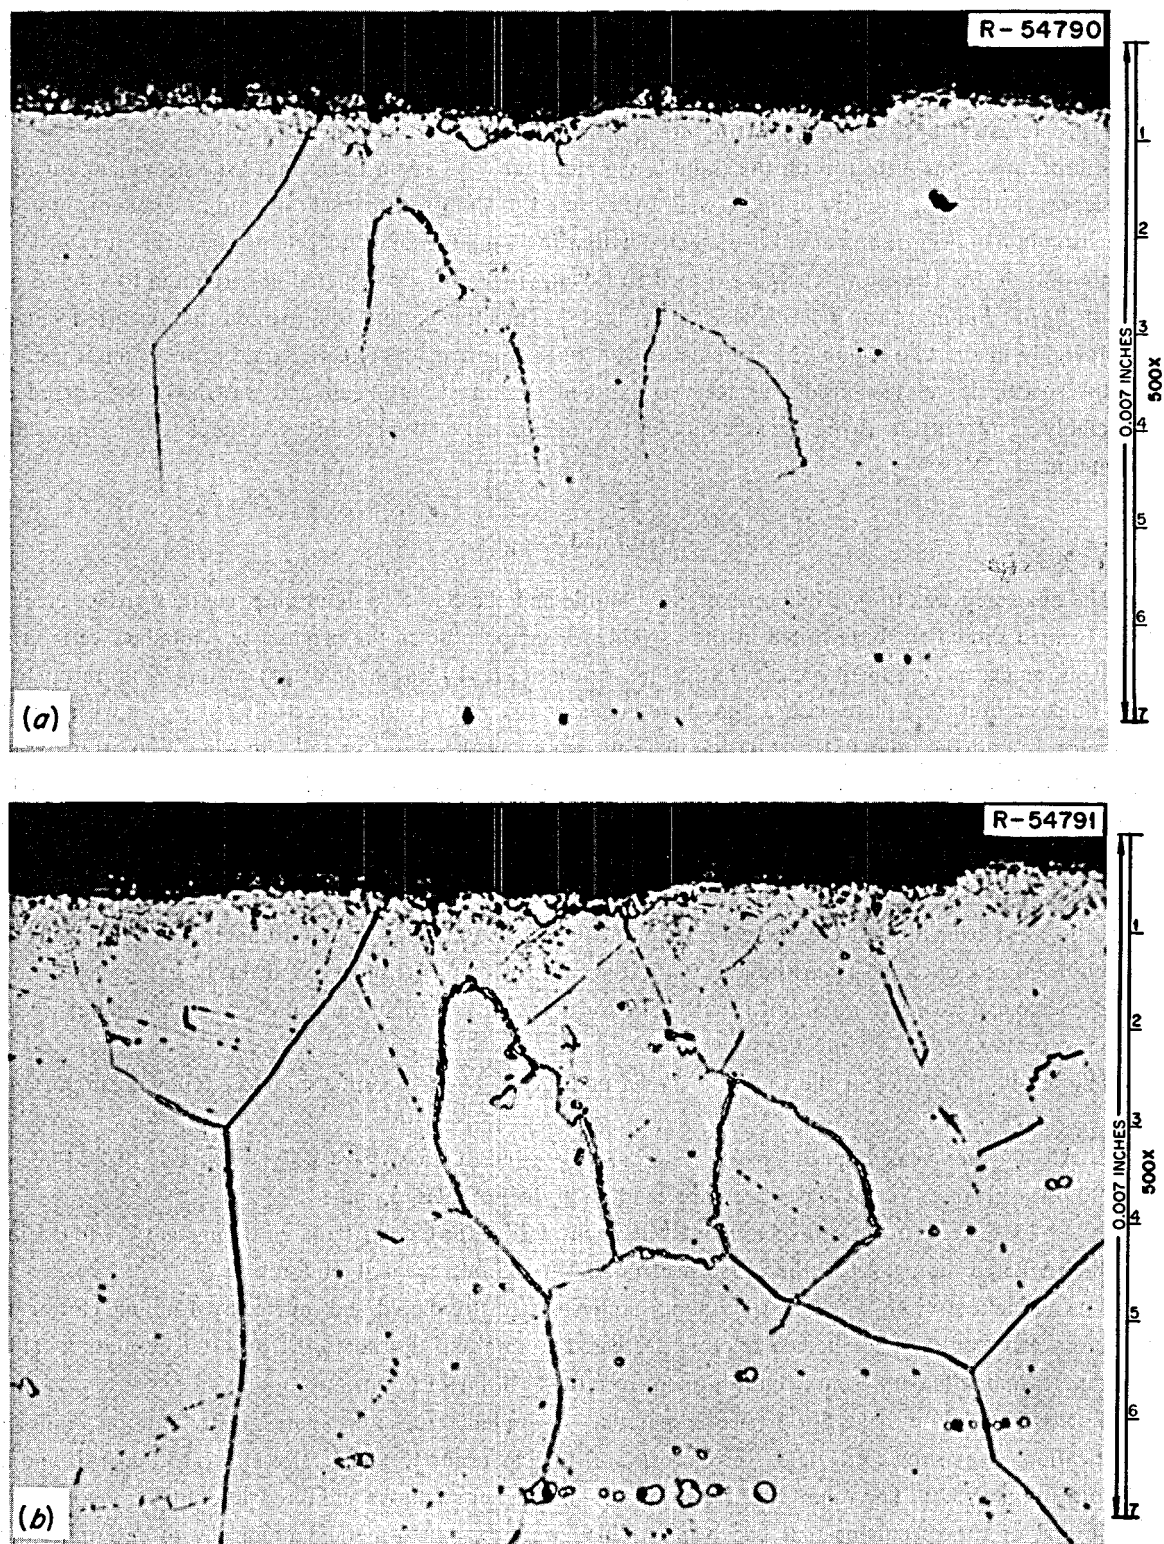
A second cut was made away from the sleeve, and typical photomicrographs are shown in Fig. 17. This part of the thimble was exposed to flowing salt. Some of the grain boundaries are visible in the as-polished condition to a depth of about 4 mils, and there is some surface modification [Fig. 17(a)]. Etching [Fig. 17(b)] delineates more of the grain structure and shows the shallow surface modification.

Fig. 17. INOR-8 control rod thimble where it was exposed directly to flowing salt. (a) As polished; (b) etched with aqua regia.

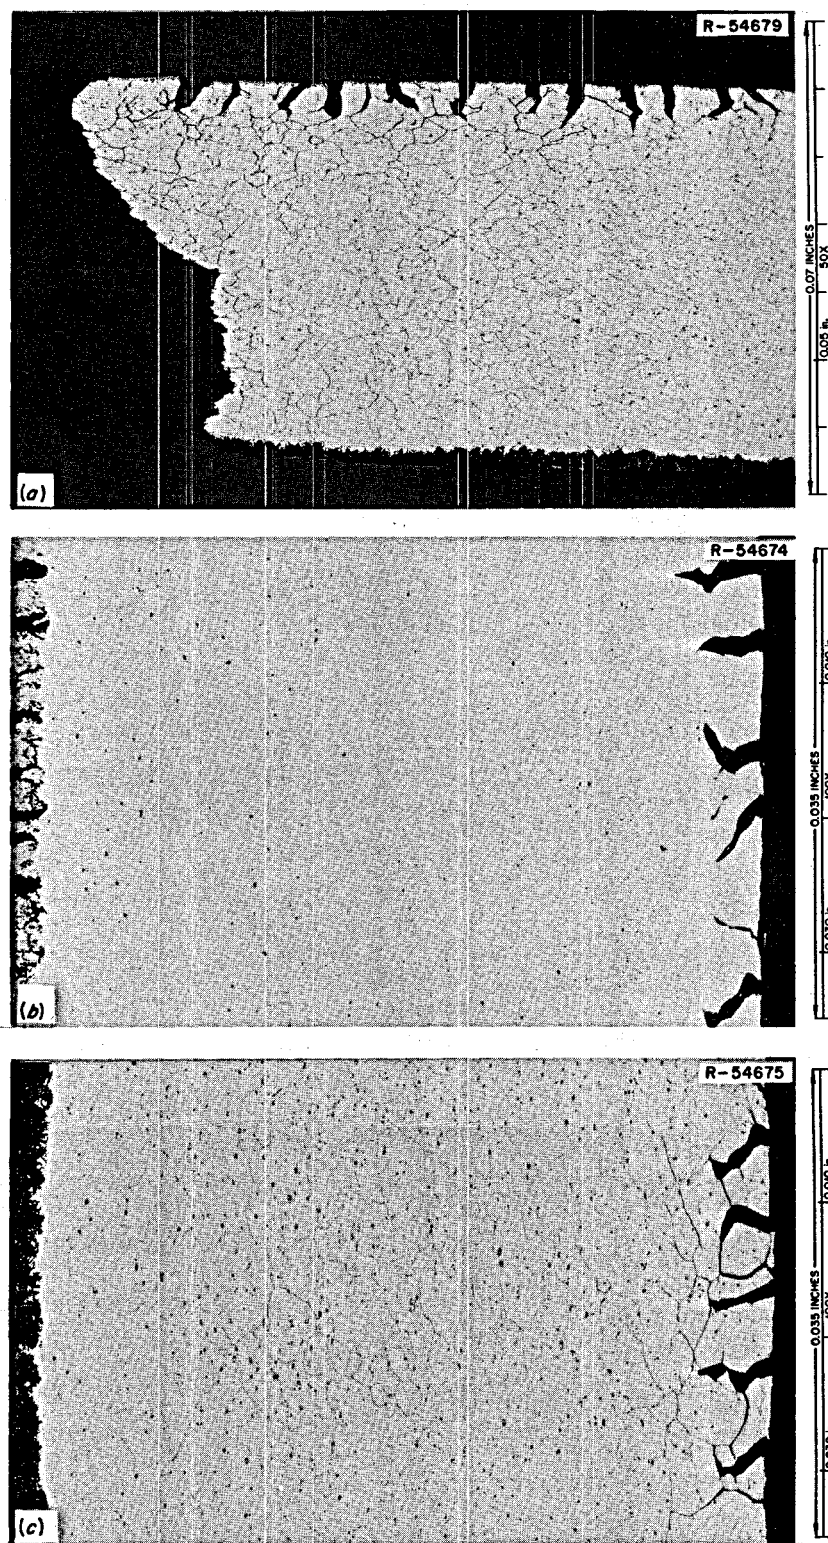
Several of the specimens that had been strained were examined metallographically to determine the extent of cracking during straining. Photomicrographs of the control rod thimble, which was exposed to flowing salt, are shown in Fig. 20. The inside surface was oxidized, and the oxide cracked as the specimen was strained. The oxide should be brittle, but it is important that these cracks did not penetrate the metal.

However, the side exposed to the salt exhibited profuse intergranular cracking. Almost every grain boundary cracked, and the cracks generally propagated to a depth of one grain, although there are several instances where the crack depth exceeded a depth of one grain. Several photomicrographs were combined and rephotographed to obtain Fig. 21. This sample had 192 cracks per inch, with average and maximum depths of 5.0 and 8.0 mils respectively. Many of the cracks shown in Figs. 20 and 21 have blunt tips, indicating that they did not propagate into the metal as the specimen was strained.

Fig. 20. INOR-8 control rod thimble specimen exposed to flowing salt and tested at 25°C. (a) Fracture – dark edge is oxide on inner surface of tube; cracks formed on outer surface; etched. (b) Cracks in outer surface of tubing as polished. (c) Cracks in outer surface of tubing; etched. Etchant: aqua regia. Reduced 30.5%.

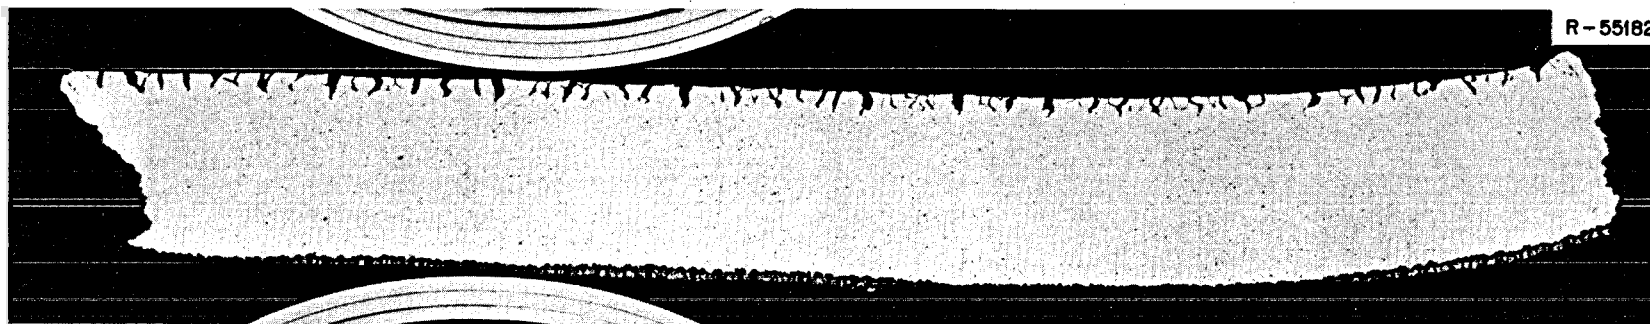
Fig. 21. Deformed section of INOR-8 control rod thimble. Fracture is on the left. The upper surface was in contact with flowing salt; the lower surface was exposed to the cell environment of N_2 plus 2 to 5% O_2 . The sample is about 0.06 in. thick.

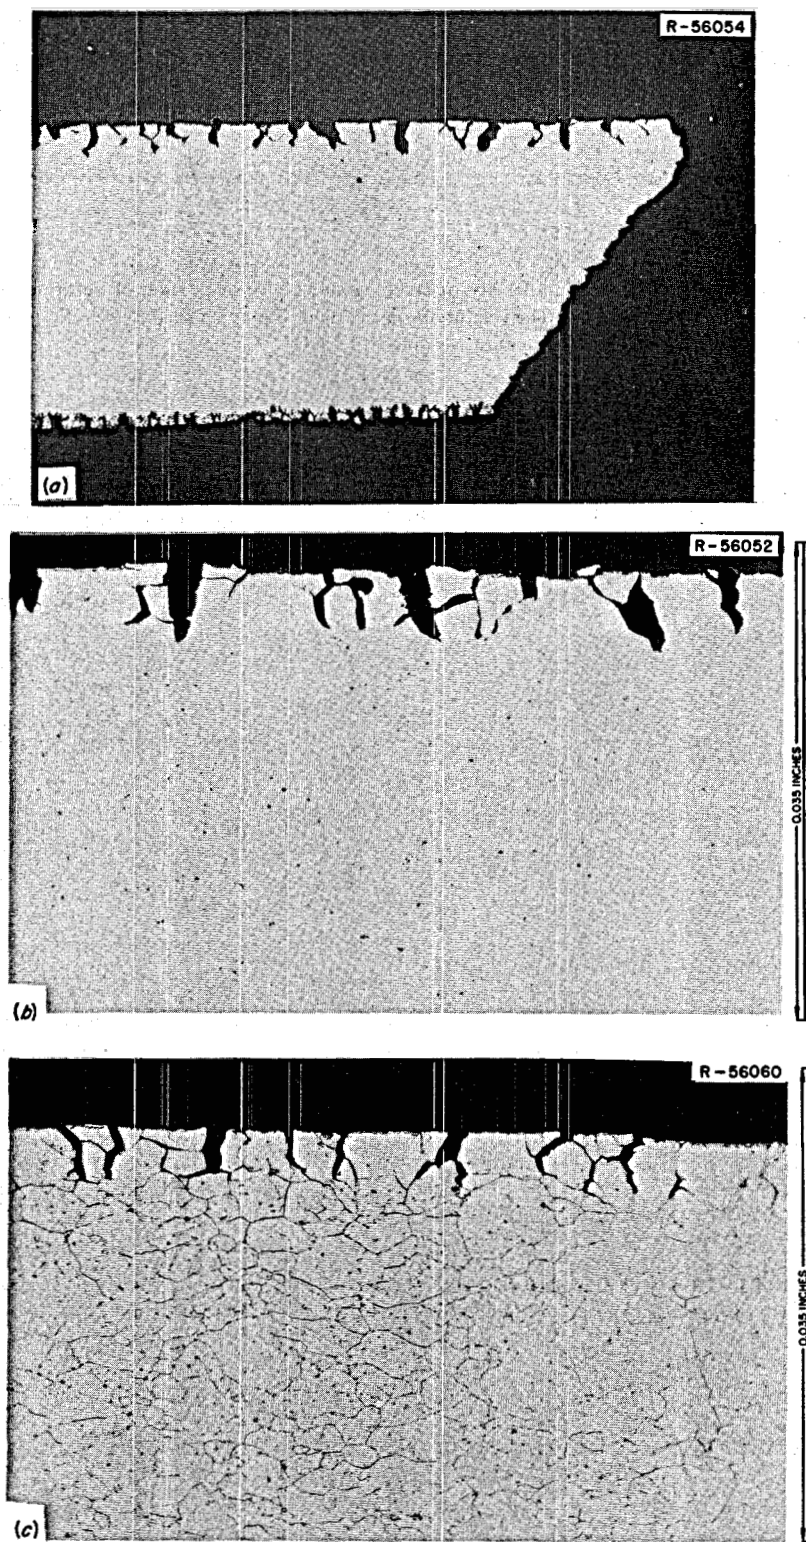
Fig. 22. INOR-8 control rod thimble exposed to fuel salt under a spacer sleeve and tested at 25°C. (a) As-polished view of fracture, 40X. (b) As-polished view of cracks. (c) Etched view of cracks. Etchant: aqua regia. Reduced 30.5%.

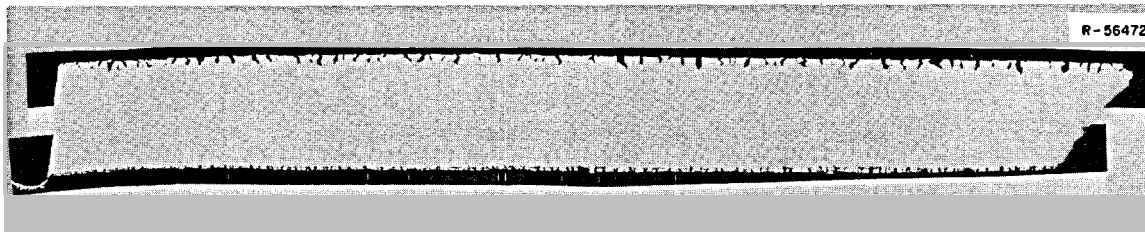
Fig. 23. Composite photograph showing density of cracking along edge of portion of deformed INOR-8 control rod thimble. 9.5X. The sample is 0.58 in. long. The fracture is on the right, the upper surface was exposed to fuel salt, and the lower surface was exposed to the cell environment of N_2 plus 2 to 5% O_2 .

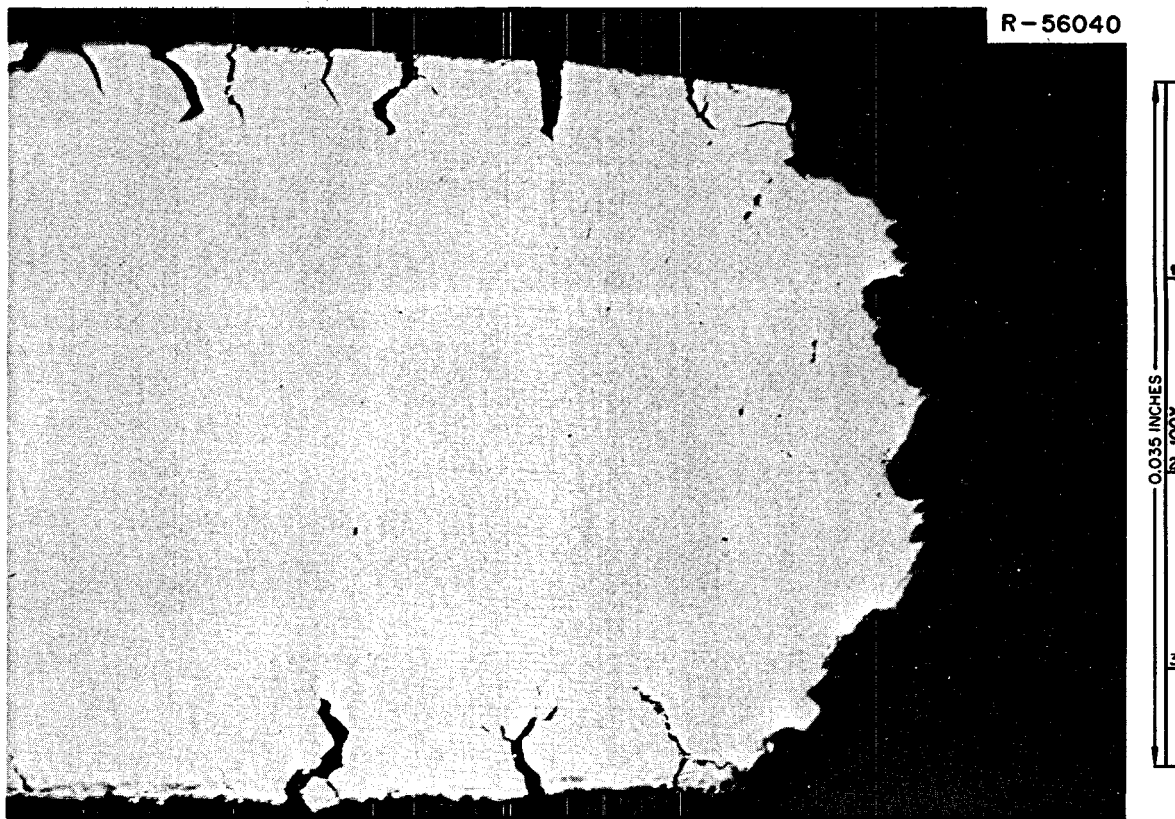
Fig. 24. Section of INOR-8 spacer sleeve tested at $25^\circ C$; as polished. The upper surface was exposed to almost static fuel salt, and the lower surface was exposed to rapidly flowing fuel salt.

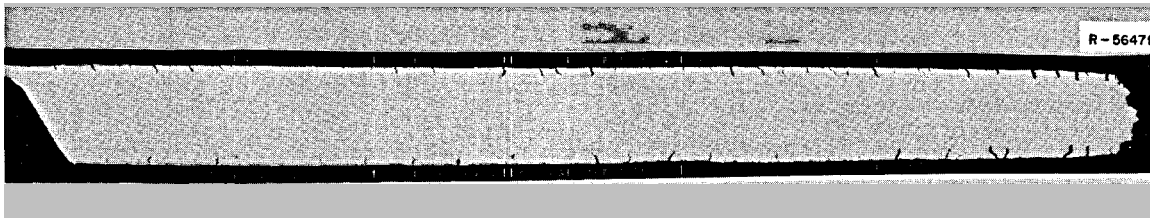
Fig. 25. Composite photograph comparing density of cracking on sides of INOR-8 spacer sleeve exposed to almost static salt (top) and to flowing salt (bottom). 11X. The sample is 0.52 in. long. Reduced 43%.

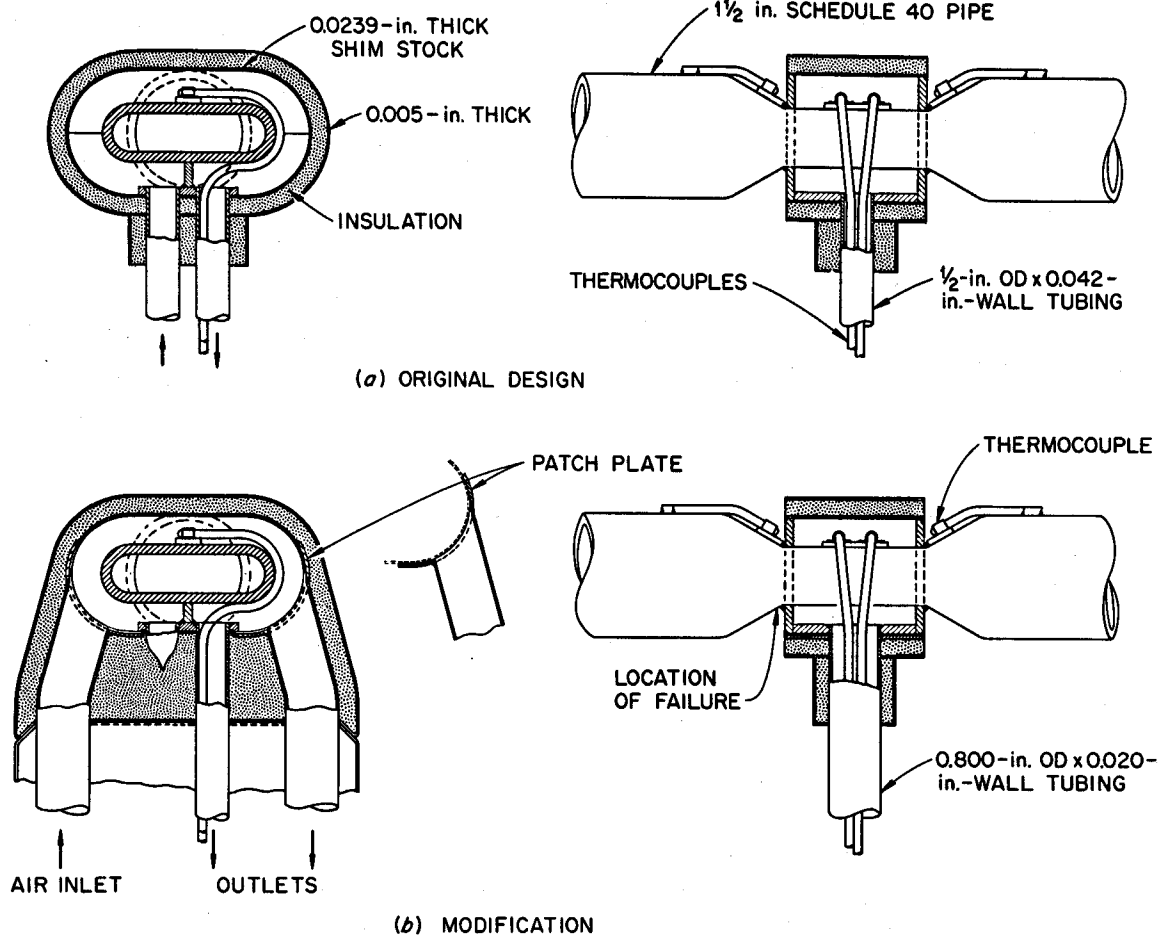
Fig. 28. Diagram showing possible cause of freeze-valve failure after modification.

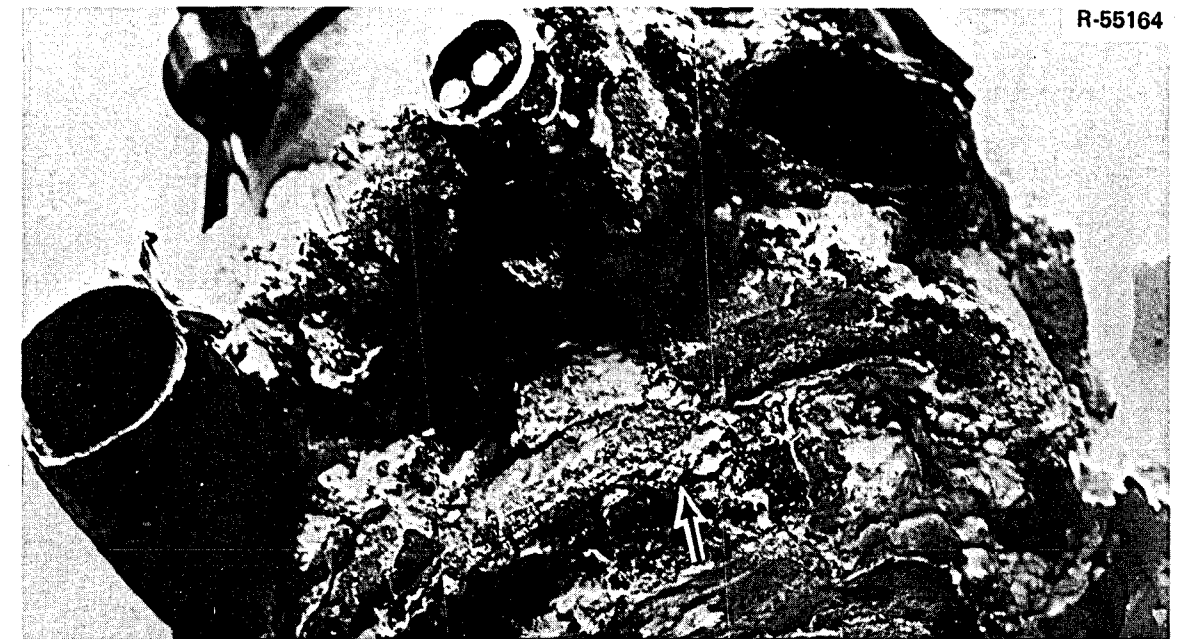
Fig. 31. Closeup of the bottom of freeze valve 105 showing INOR-8 gas inlet and outlet line of type 304 stainless steel that was corroded completely. The crusty substance is the salt. Note that there is no salt in the air annulus.

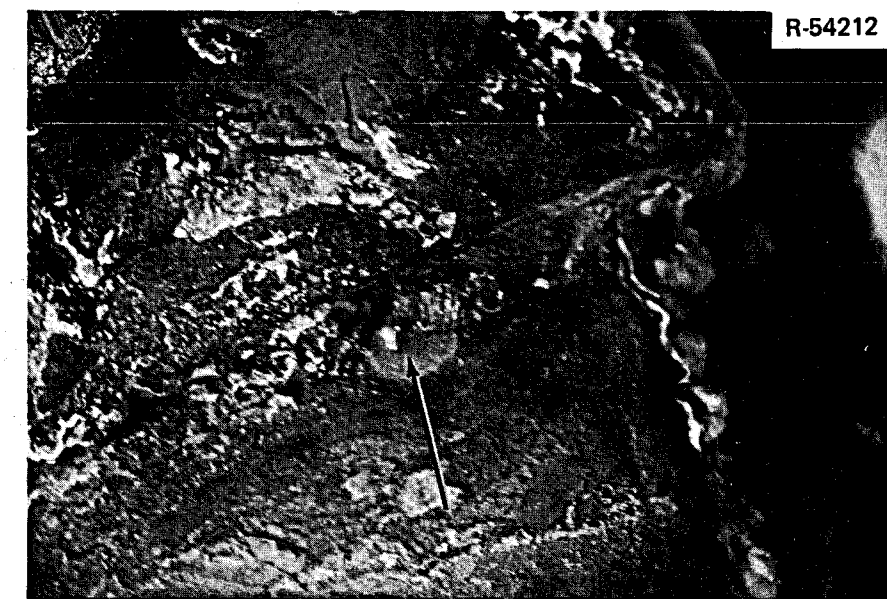
Fig. 32. Weld at one end of cooling shroud. The crack begins at the round salt stain and proceeds for about 1 in. along the pipe. The arrow points to the salt stain with the crack at 90° to the arrow.

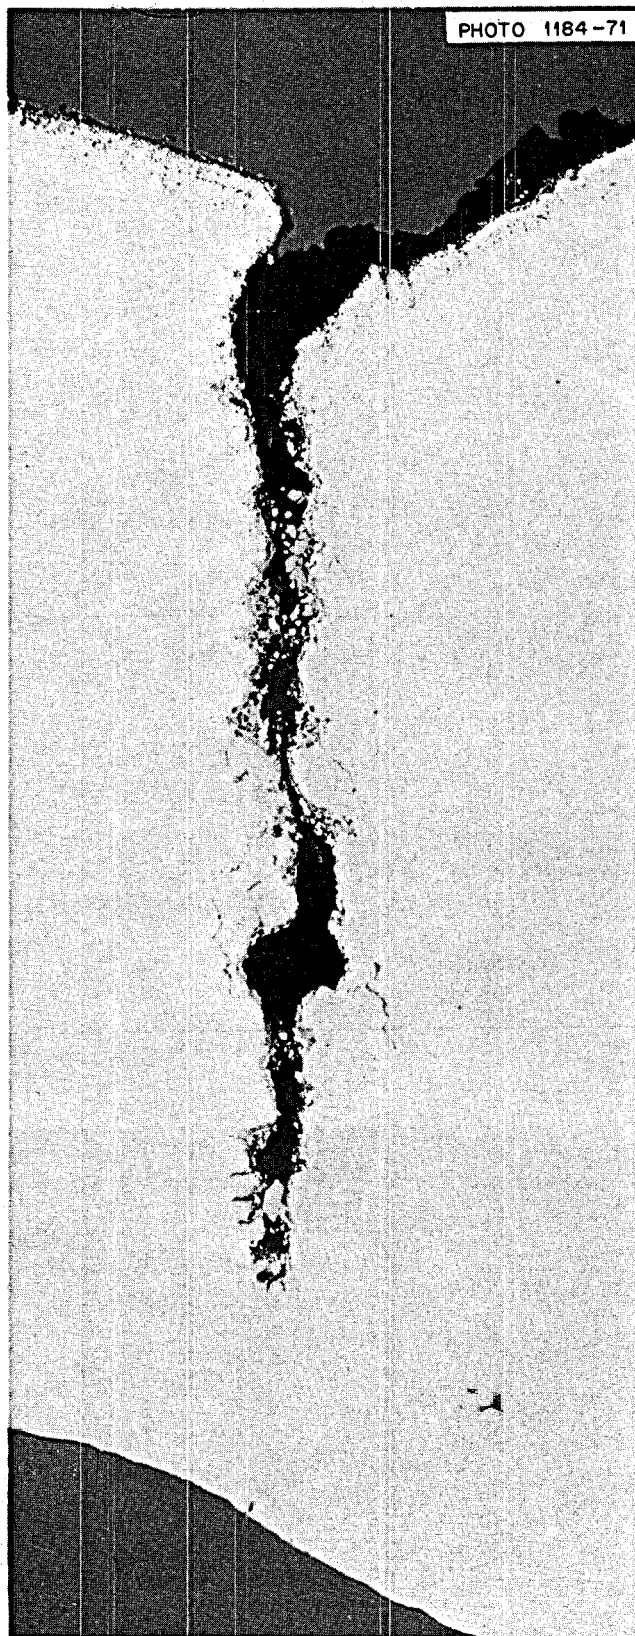
Fig. 33. INOR-8 tube wall of freeze valve 105 where the failure occurred. As polished, 50X. Bottom surface was exposed to fuel salt and the upper surface to air, with some salt after the leak occurred. Reduced 15%.

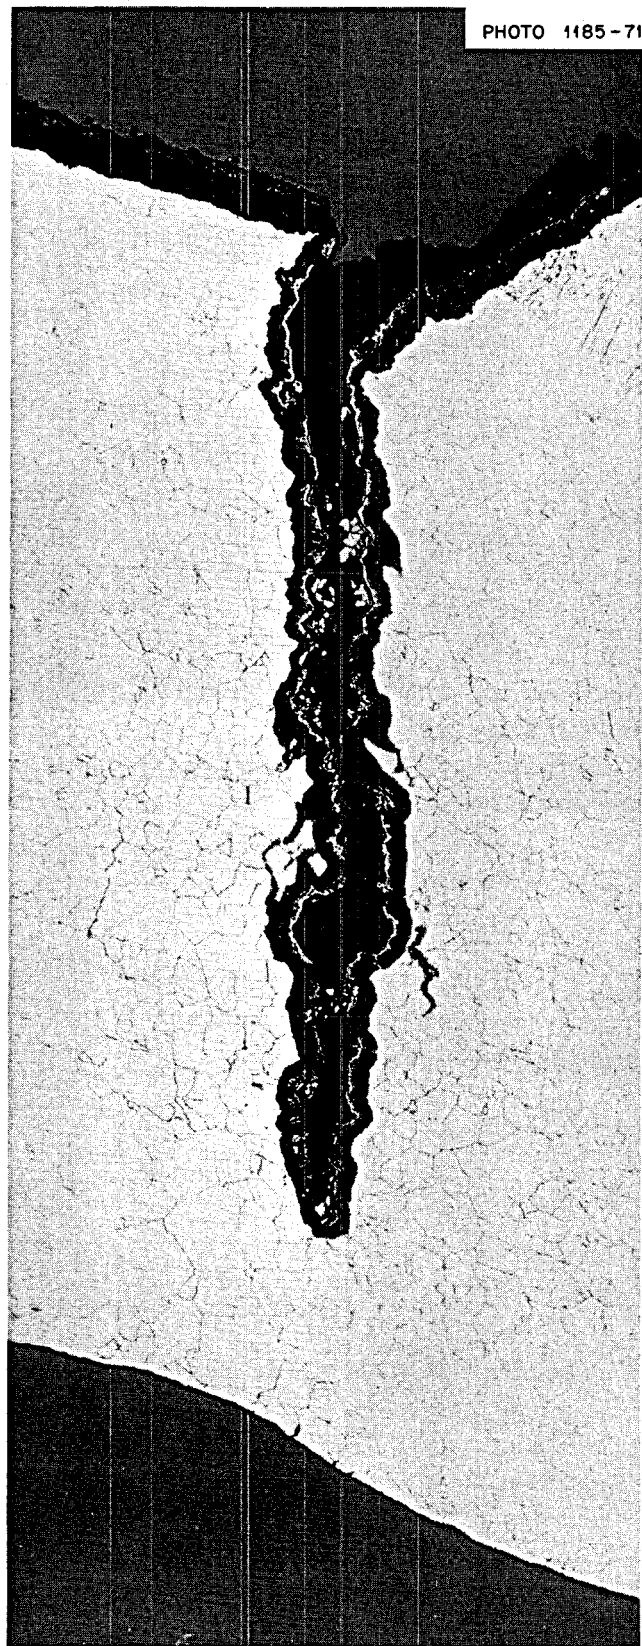
Fig. 34. INOR-8 tube wall of freeze valve 105 where the failure occurred. The weld supports the end of the cooling shroud; the failure occurred outside the cooling shroud. Etchant: aqua regia. 50X. Reduced 15%.

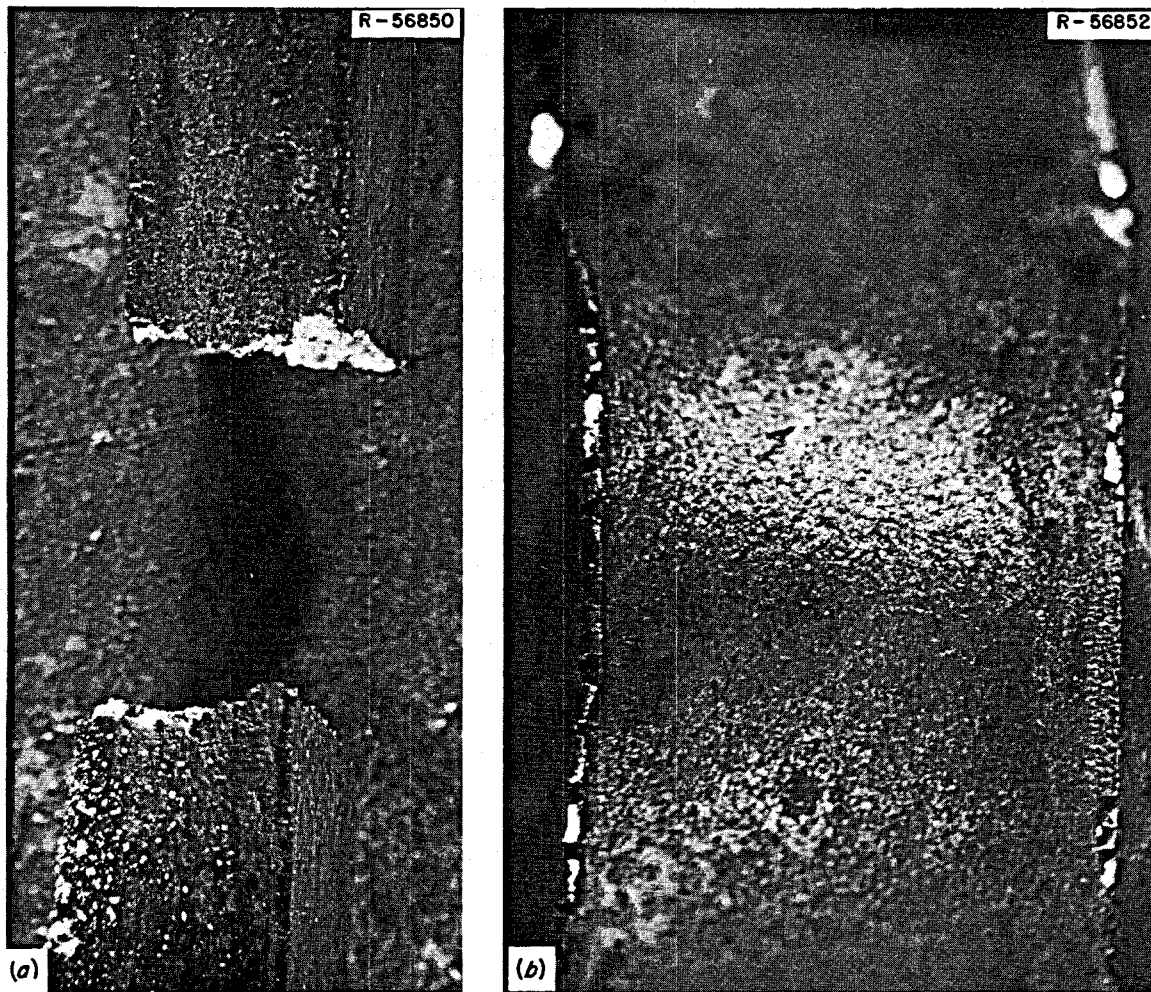
Fig. 35. INOR-8 surfaces exposed to salt in freeze valve 105 after deformation at 25°C. (a) Fracture of ring specimen pulled in tension. Note surface cracks near fracture. 4X. (b) Surface of bend specimen. Note some cracks on surface and edge cracks. 7X. Reduced 18.5%.

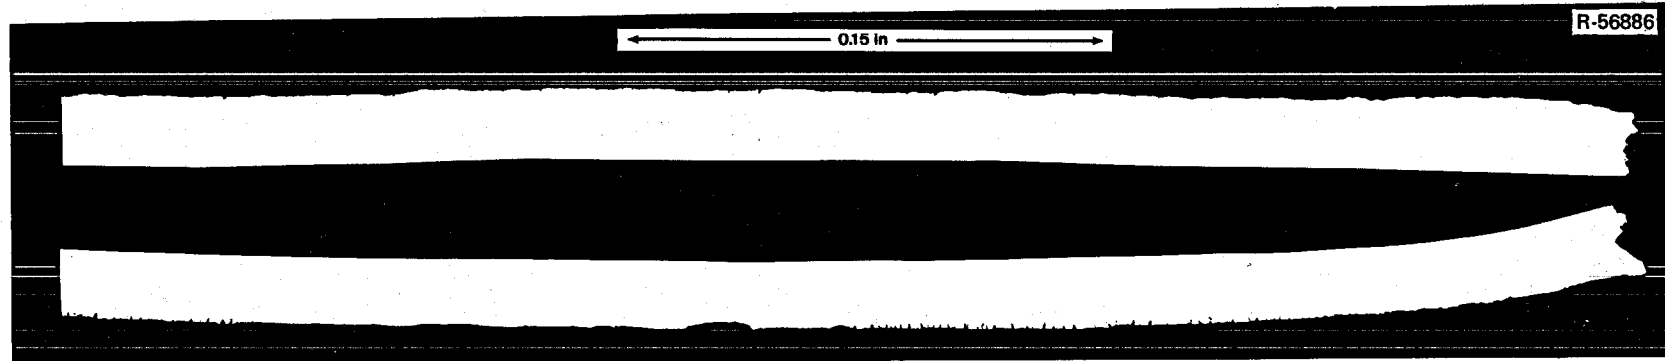
Fig. 36. Composite of photomicrographs of INOR-8 ring from freeze valve 105 that was pulled in tension. Upper surface was exposed to salt and the lower surface to the cell environment of N_2 plus 2 to 5% O_2 . Top portion is the tension side, and the lower part is the compression side.
