POSTIRRADIATION EXAMINATION OF MATERIALS FROM THE MSRE

H. E. McCoy
B. McNabb

METALS AND CERAMICS DIVISION

DECEMBER 1972

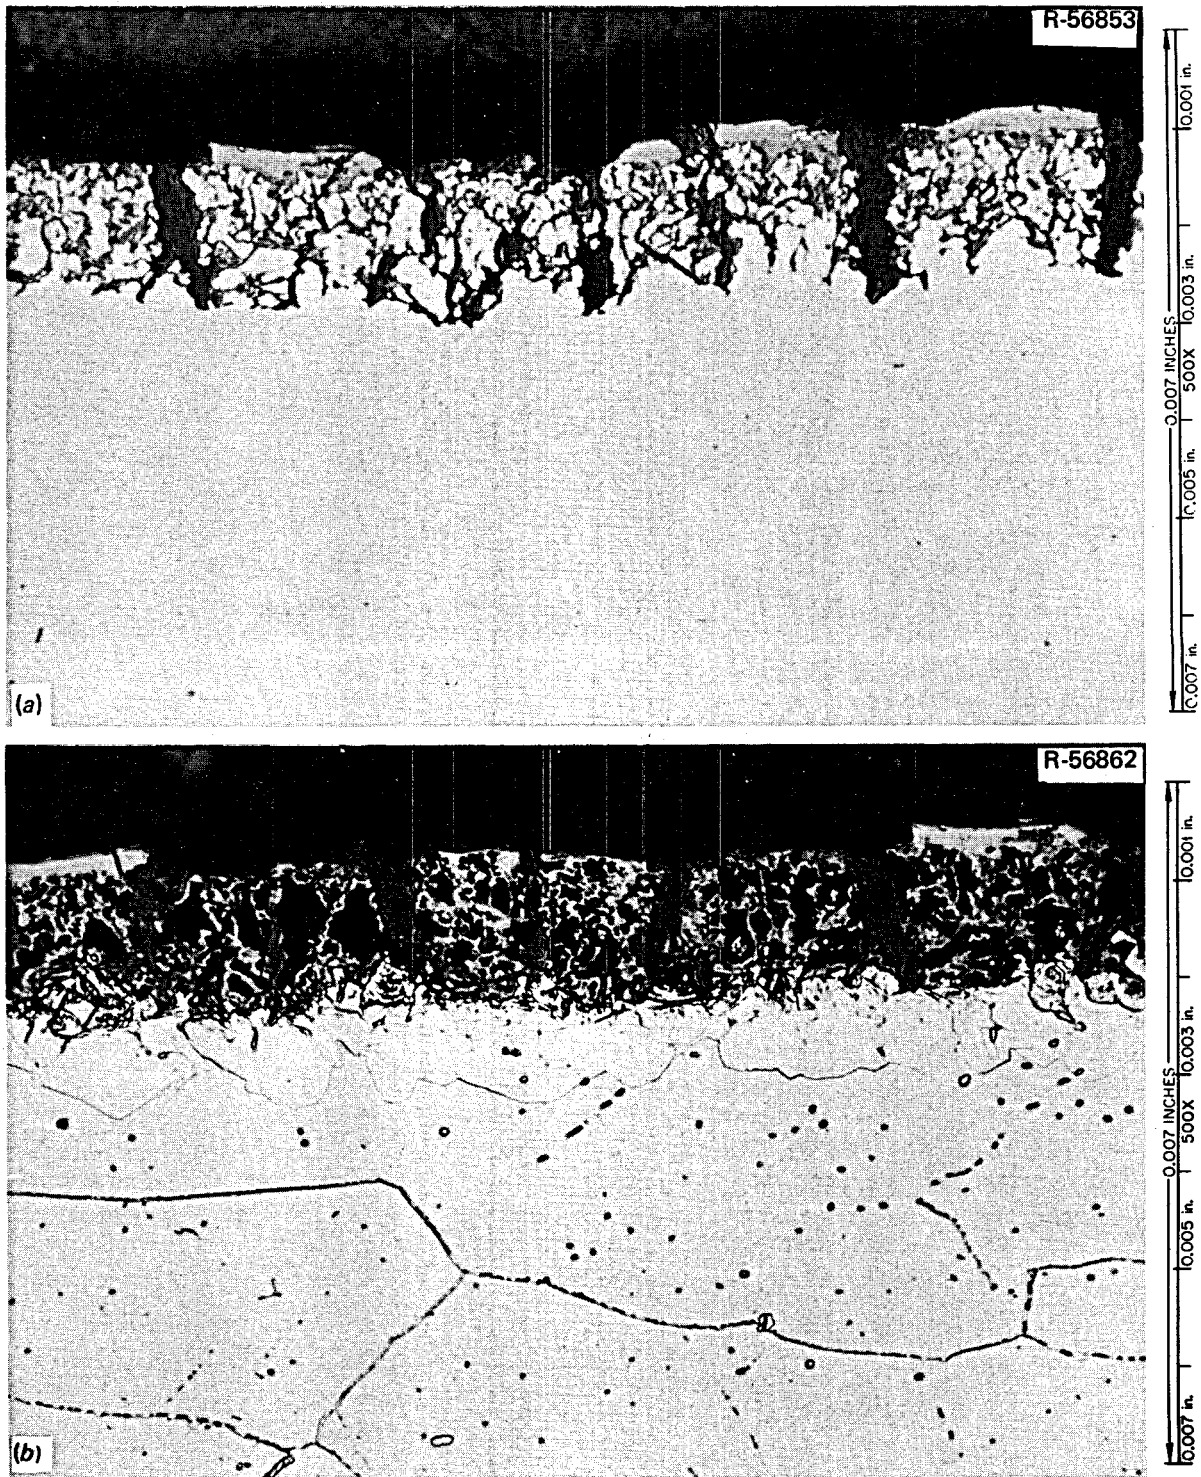
Fig. 37. INOR-8 tensile sample of freeze valve 105 showing the oxide that formed on the outside of the pipe. The cracks penetrated only the depth of the oxide. (a) As polished; (b) etched with lactic acid, HNO_3 , HCl .

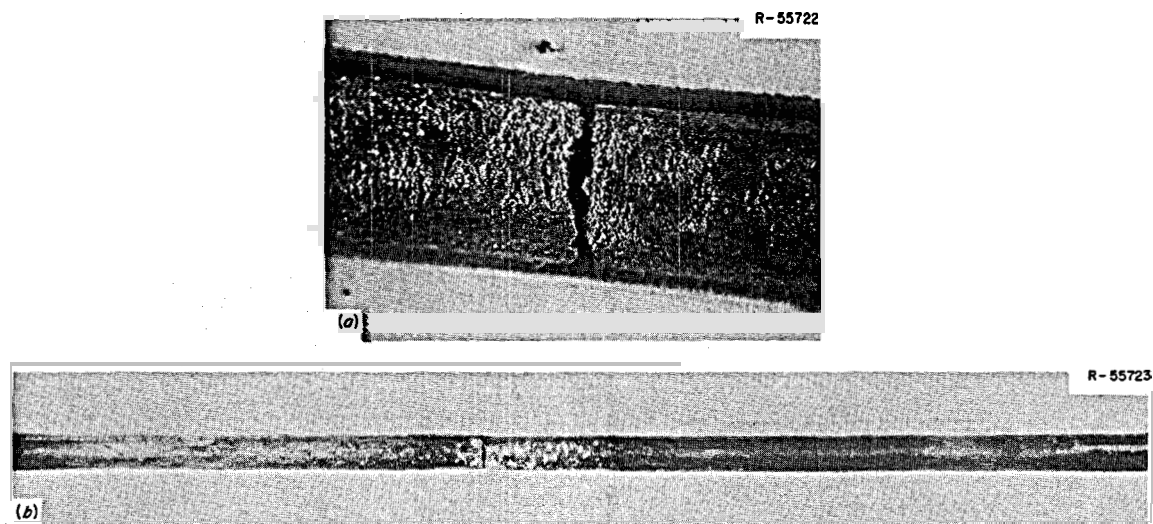
Fig. 47. Tensile-tested INOR-8 sampler cage rod from pump bowl. Rupture occurred near the average liquid-vapor interface. (a) Rupture area showing extensive surface cracking. (b) Composite of entire rod, with top at right. Rod diameter is $\frac{1}{4}$ in.

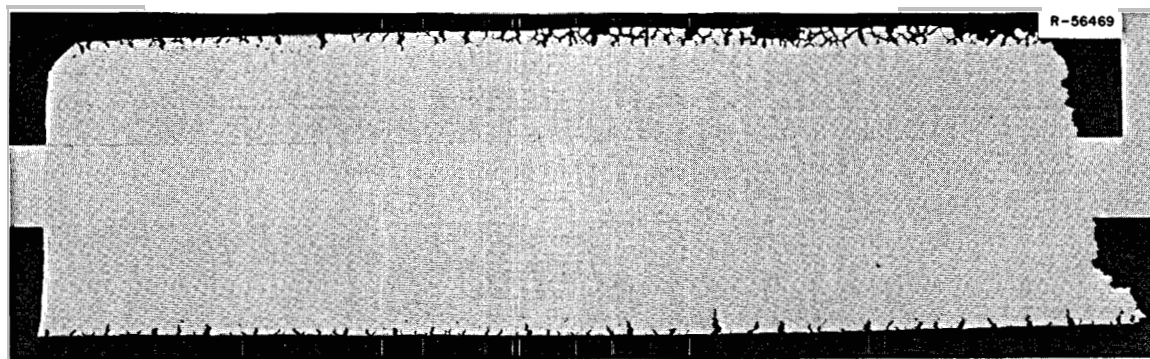
Fig. 48. Section of INOR-8 sample cage rod that was deformed at 25°C . $9.2\times$. The fracture (right) occurred at the salt-vapor interface. The rod is immersed further in the liquid from right to left. The length of the sample is 0.63 in.

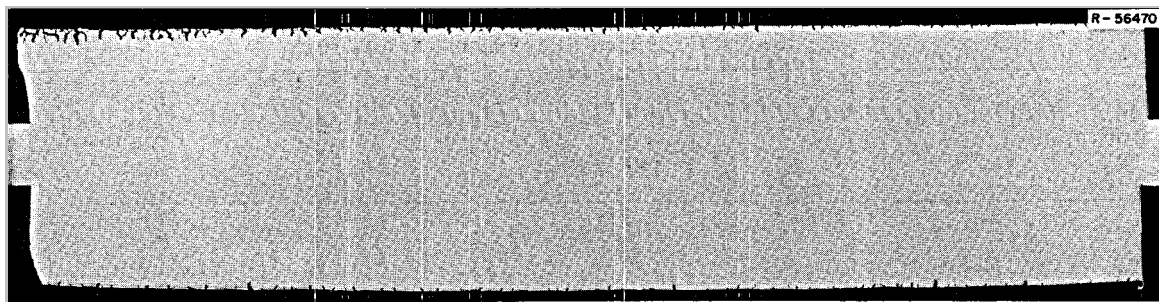
Fig. 50. Composite of photomicrographs of INOR-8 sampler cage rod strained at 25°C. 8.2X. Left end of sample was $\frac{3}{4}$ in. from fracture. The rod progressed further into the vapor region from left to right. Sample length is 0.72 in.

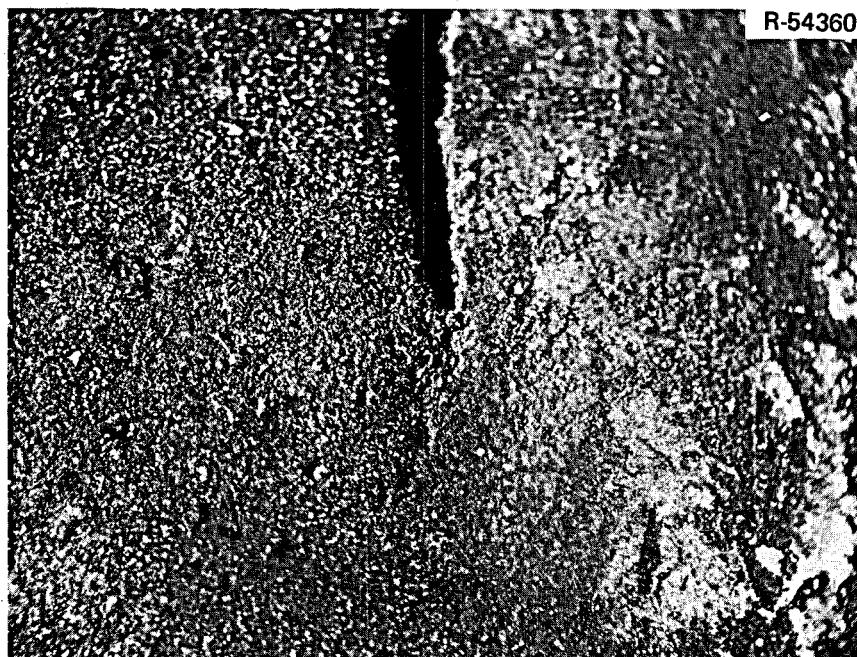
Fig. 63. Crack formed in copper sampler retrieved from pump bowl. Outer surface was coated with deposited material.

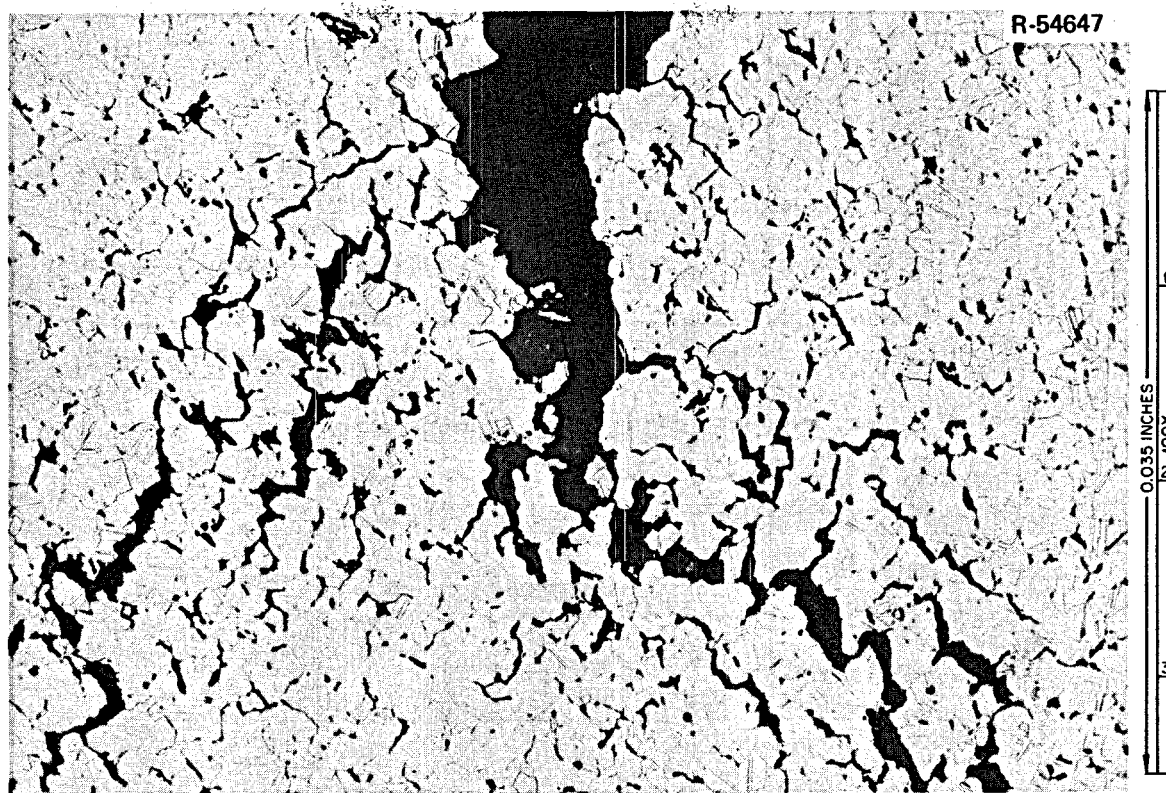
Fig. 64. Section of copper capsule showing extensive intergranular cracking.

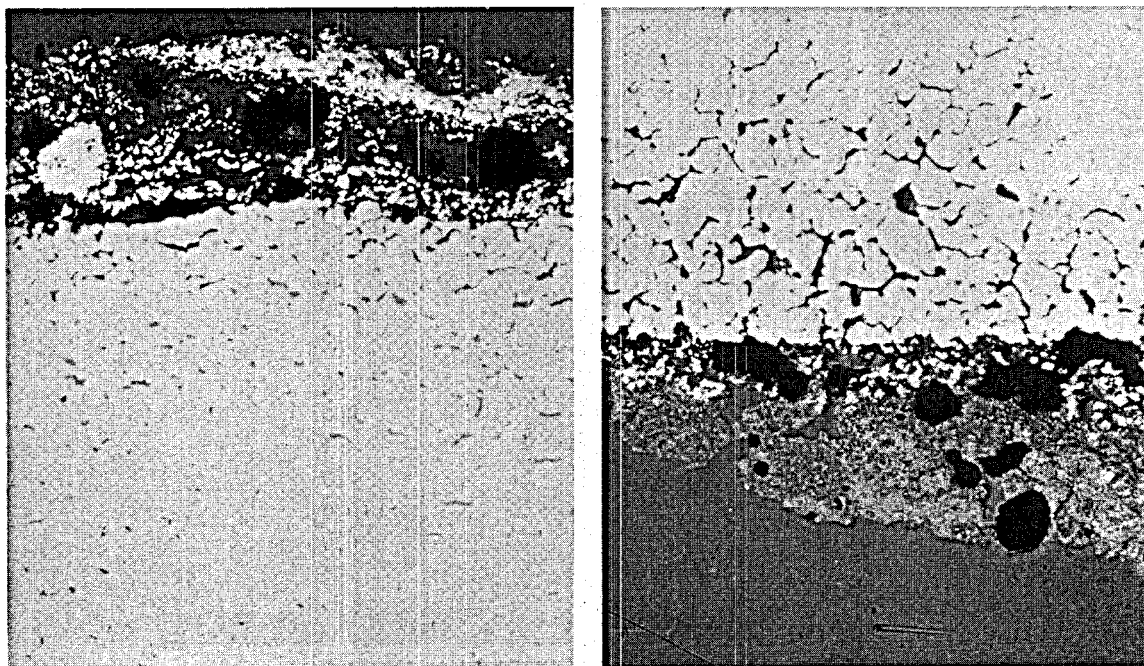
Fig. 65. Photomicrographs of copper MSRE fuel sampler showing layers on outside surface (left) and inner surface (right).

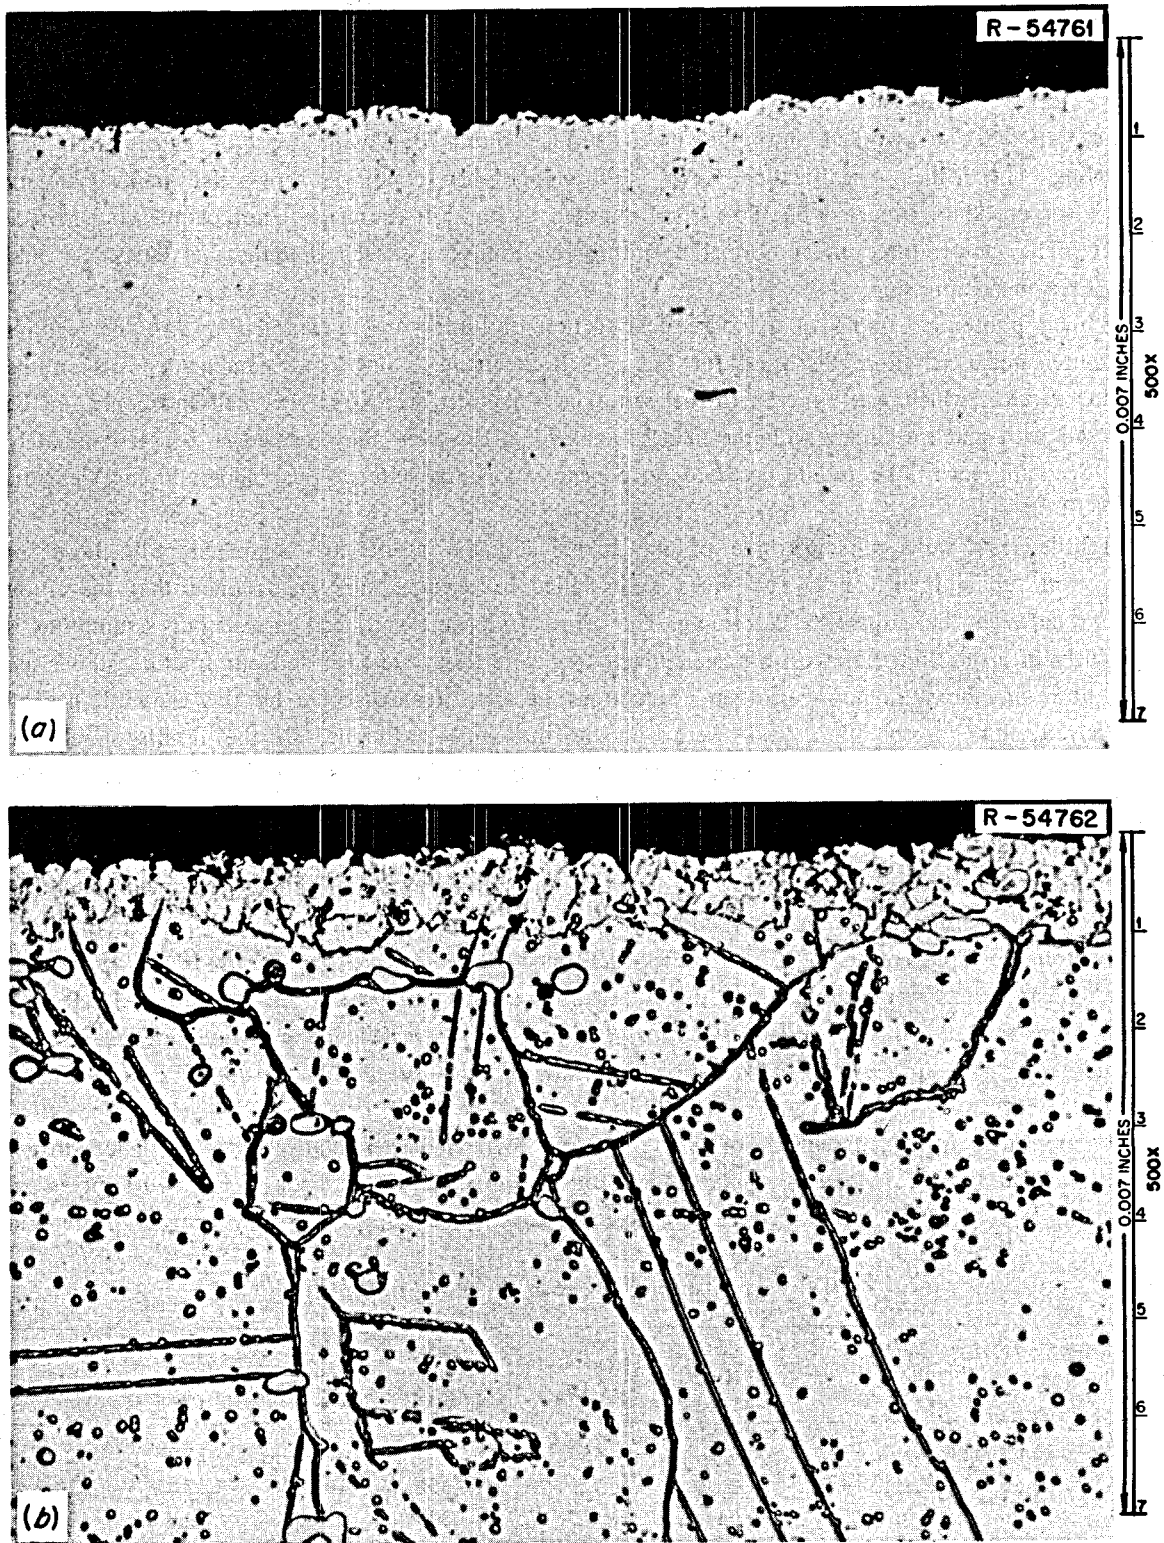
Fig. 71. Inside surface of INOR-8 primary heat exchanger shell. The surface was exposed to fuel salt, and the modified structure to a depth of about 1 mil is apparent. (a) As polished; (b) etched with aqua regia.

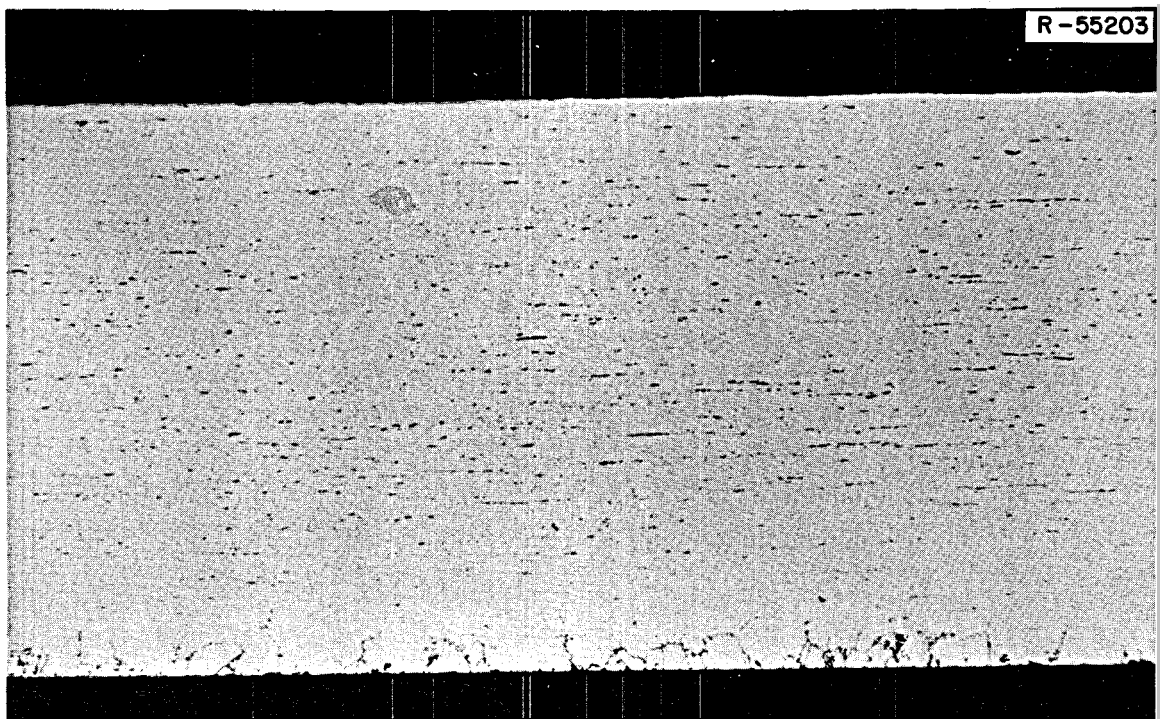
Fig. 76. INOR-8 heat exchanger tubing in the unstressed condition. The side with the small cracks was exposed to fuel salt, and the other was exposed to coolant salt.

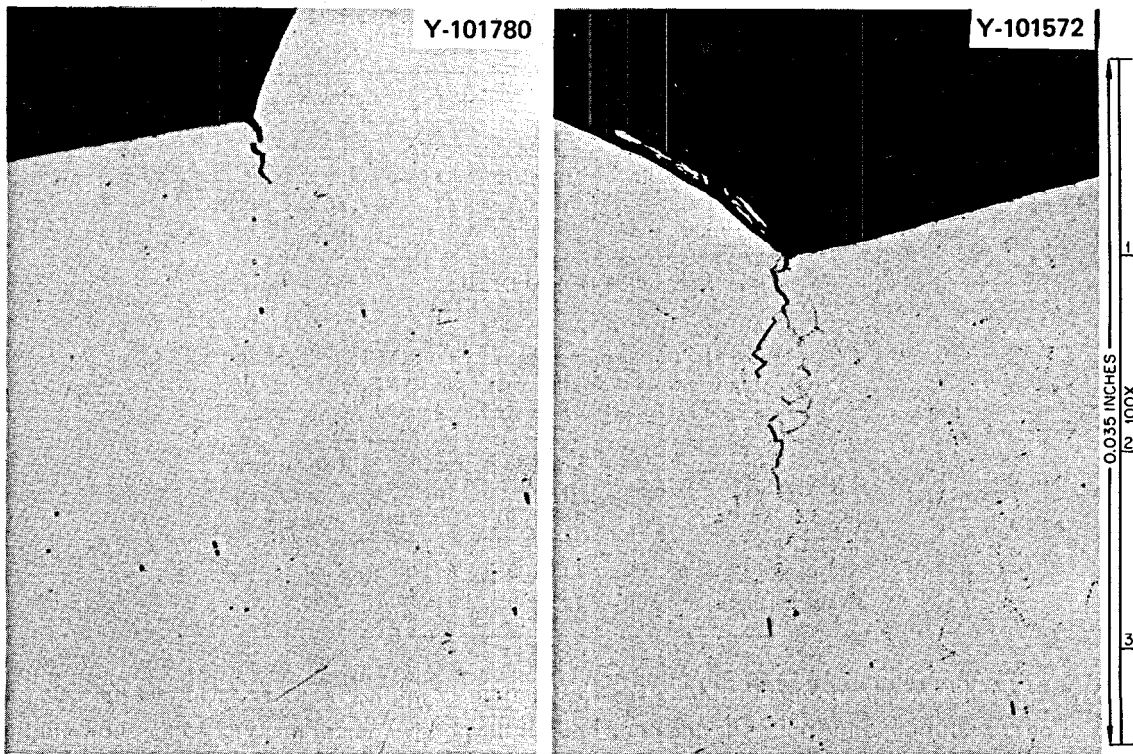
Fig. 86. Cracks in the root pass of the inlet weld. The cracks occurred at the fusion line and likely resulted from the poor fit-up of the parts. As polished.

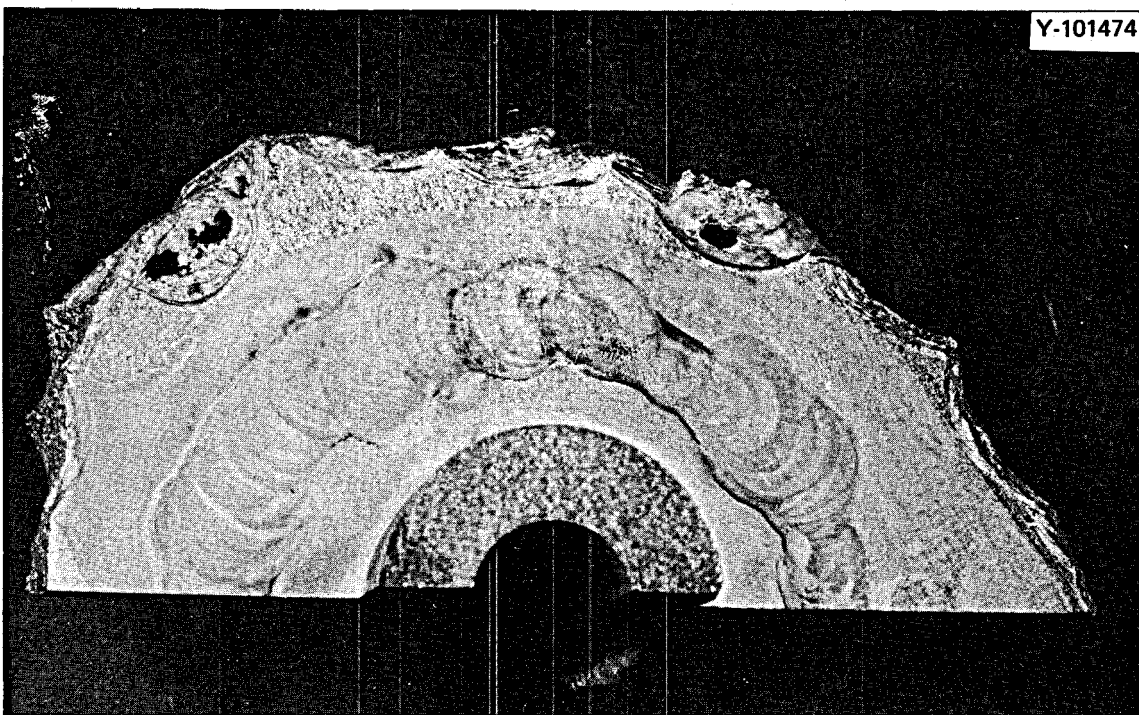
Fig. 87. Underside (salt side) of half of the INOR-8 thermocouple well from the inlet line to the MSRE radiator. The part was acid etched and coated with dye penetrant. Note the indication of a crack around most of the weld and an incomplete root pass region.
