CORROSION ASSOCIATED WITH FLUORINATION  
IN THE OAK RIDGE NATIONAL LABORATORY  
FLUORIDE VOLATILITY PROCESS

A. P. Litman  
A. E. Goldman

METALLURGY DIVISION

JUN - 5 1961

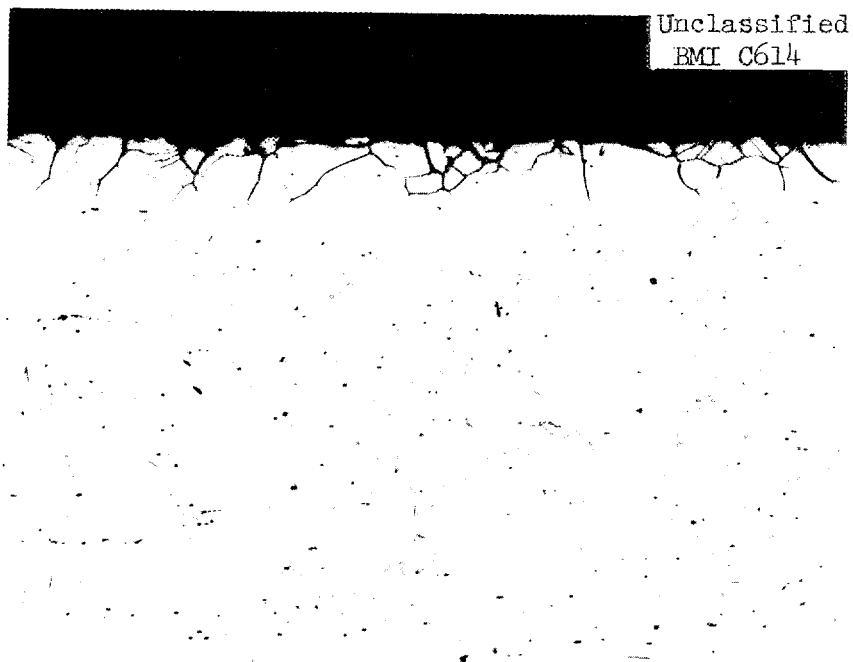
Typical photomicrographs of sections from the Mark II fluorinator can be seen in Figs. 19 through 23. Intergranular attack was prevalent in all

Fig. 19. Microstructure of Sample from Interior Surface of Mark II VPP Fluorinator 3 in. Below Slip-on Flange (Vapor Phase, Area A)  
Etchant: Nitric-acetic acid. 100X.

sections in all regions but penetration was deepest in the samples from the interface and salt regions. Maximum grain-boundary attack was found to be 33 mils in the salt-phase sample A-3b which was in the vicinity of the shell to head girth weld.

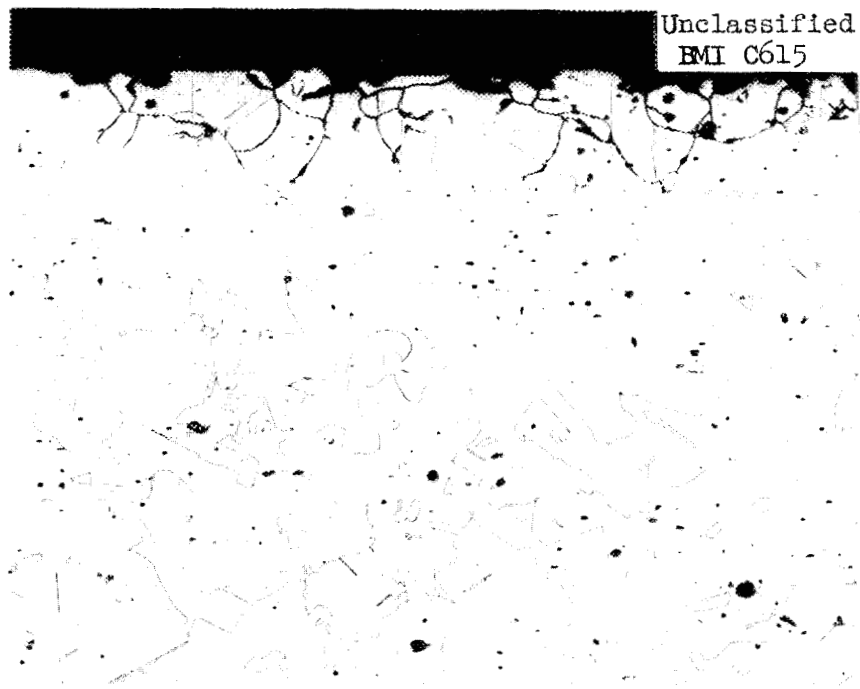
Fig. 20. Microstructure of Sample from Interior Surface of Mark II VPP Fluorinator 19 in. Below Slip-on Flange (Vapor Phase, Area A). Etchant: Nitric-acetic acid. 100X.

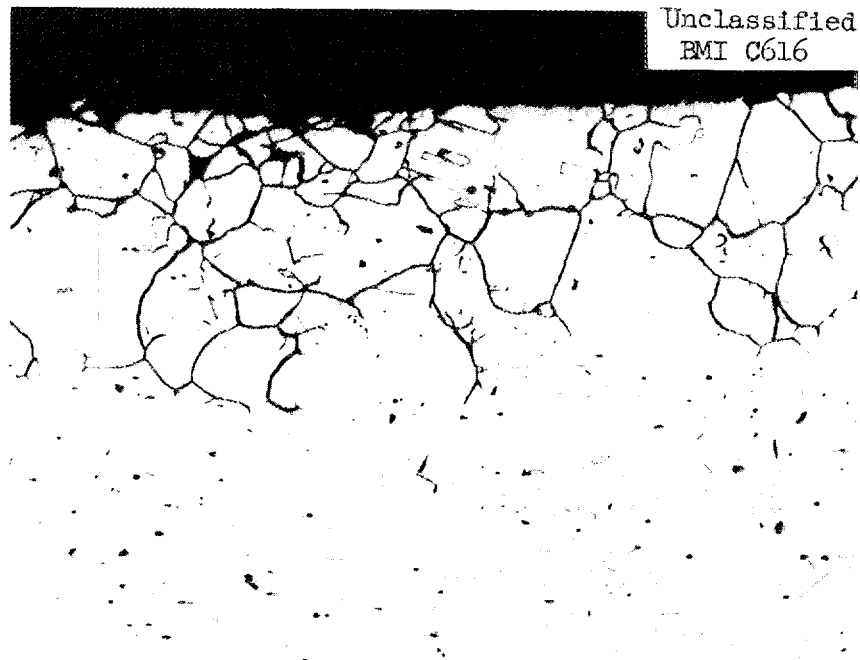
Fig. 21. Microstructure of Sample from Interior Surface of Mark II VPP Fluorinator  $\frac{3}{4}$  in. Below Slip-on Flange (Vapor-Salt Interface, Area A). Etchant: Nitric-acetic acid. 100X.

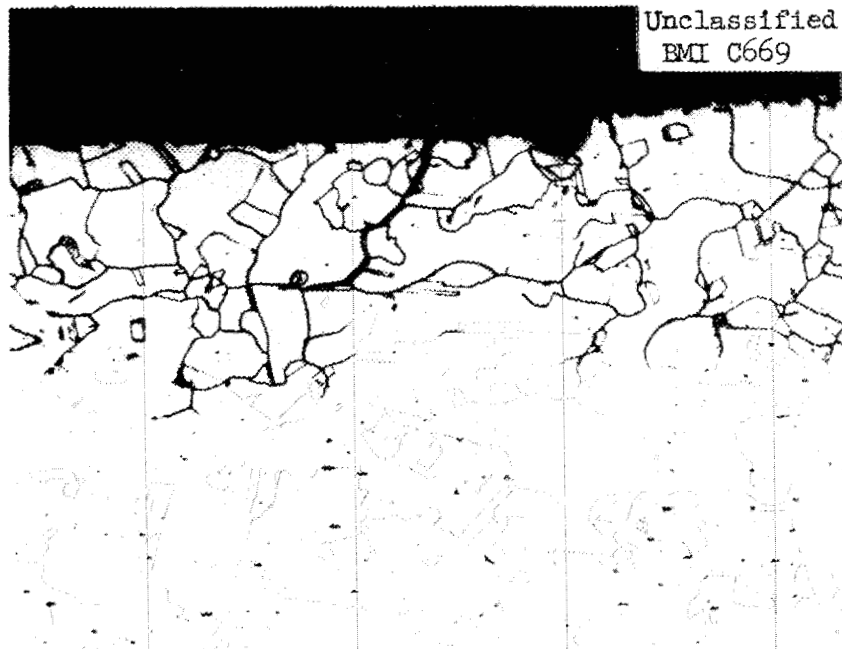
Fig. 22. Microstructure of Sample from Interior Surface of Mark II VPP Fluorinator 42 in. Below Slip-on Flange (Salt Phase, Area C). Etchant: Nitric-acetic acid. 100X.

In the salt region of Area C, a few small intergranular cracks were found on the interior of the vessel wall. A typical crack is shown in the unetched condition in Fig. 26 and in the etched condition in Fig. 22. Very pronounced darkening of the grain boundaries to approximately the same depth as the crack was evident after etching.

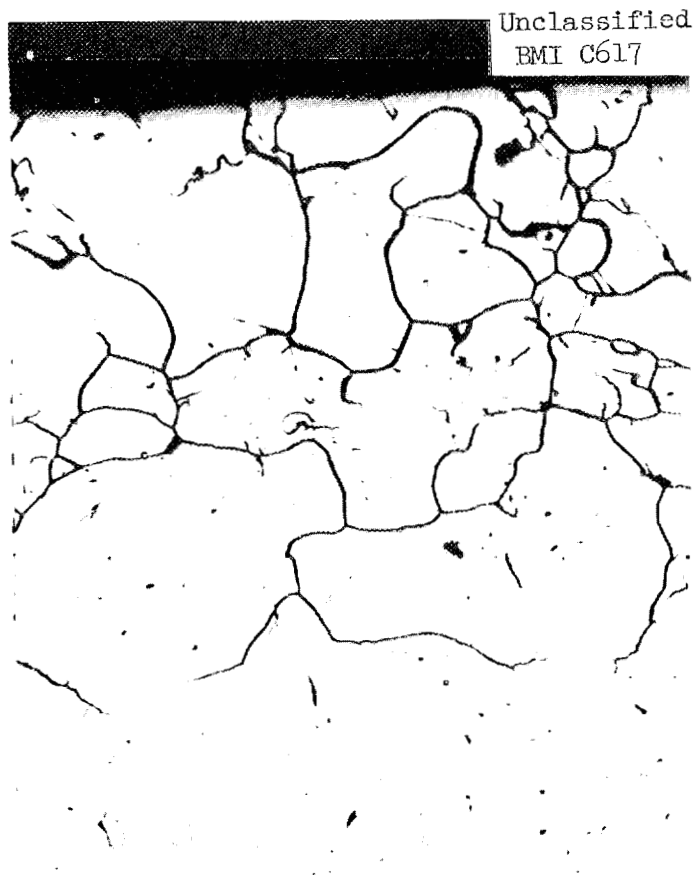
Fig. 23. Microstructure of Sample from Interior Surface of Mark II VPP Fluorinator Approx 47 in. Below Slip-on Flange (Salt Phase, Area A) Vicinity of Girth Shell to Bottom Head Weld. Etchant: Nitric-acetic acid. 100 X.

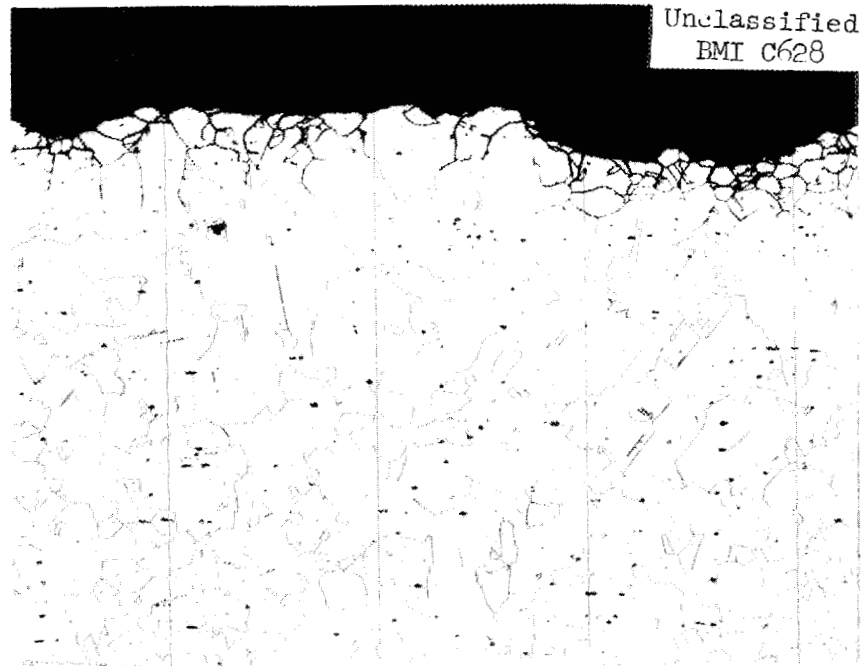
A pitting attack was found on the interior wall near Area C in the vapor region, about 3 in. down from the bottom of the slip-on flange. Figure 24 shows the appearance of the surface at 3X, and Fig. 25 shows a metallographic section through this pitted area. The latter indicates a level of intergranular penetration similar to that found in other upper-vapor regions. The depth of intergranular attack did not appear to vary from top to bottom of the pits.

Fig. 25. Microstructure of Sample from Interior Surface of Mark II VPP Fluorinator 3 in. Below Slip-on Flange (Vapor Phase, Area C) in Region of Pitting-Type Attack. Etchant: Nitric-acetic acid. 100X.

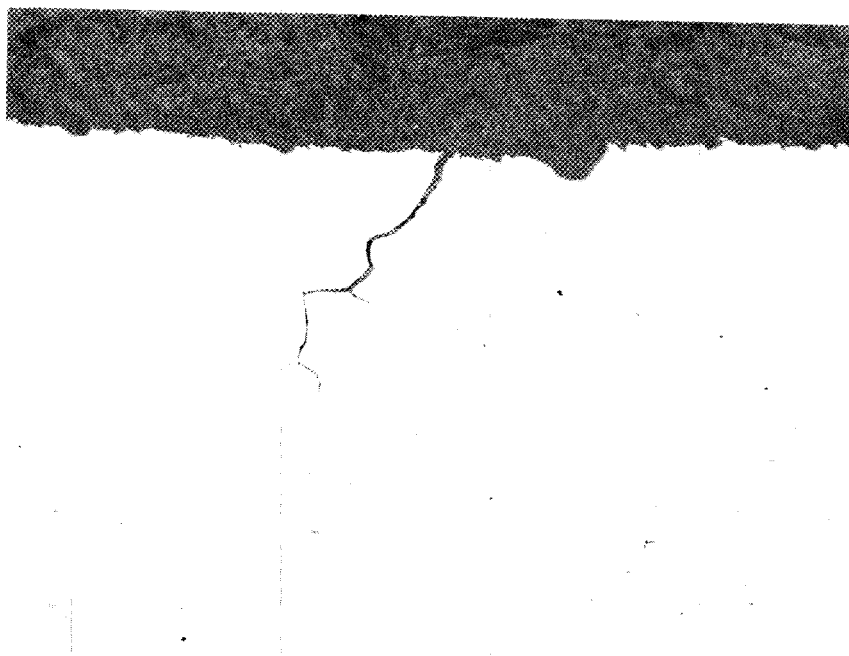
Fig. 26. Photomicrograph of Sample from Interior Surface of Mark II VPP Fluorinator 42 in. Below Slip-on Flange (Salt Phase, Area C) Showing Crack Easily Visible Before Sectioning. As-polished. 100X.

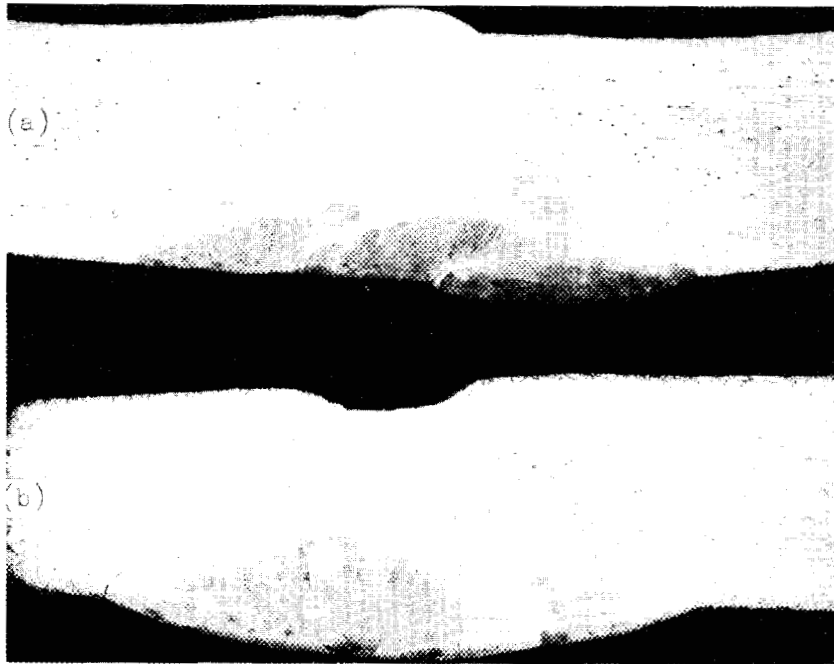
Cross sections from the fluorinator shell longitudinal weld are shown in Fig. 27 (Samples B-T and A-3b) which depicts sections in the vapor and salt phases, respectively. The weld joint from the salt region shows what appears to be an increased attack at the weld root. This confirms the visual examinations of the Mark II fluorinator. Examination of the weld from the salt section at high magnification revealed pronounced grain-boundary darkening after etching to a maximum depth of 10 mils. Similar, deeper grain-boundary darkening occurred in the base metal adjacent to the weld metal, extending to a maximum depth of 33 mils.

Fig. 27. Photomacrographs of Longitudinal Weld Sections Through Wall of Mark II VPP Fluorinator (a) From Vapor Phase 3 in. Below Slip-on Flange, (b) From Salt Phase 47 in. Below Slip-on Flange. Etchant: Nitric-acetic acid. 5X.

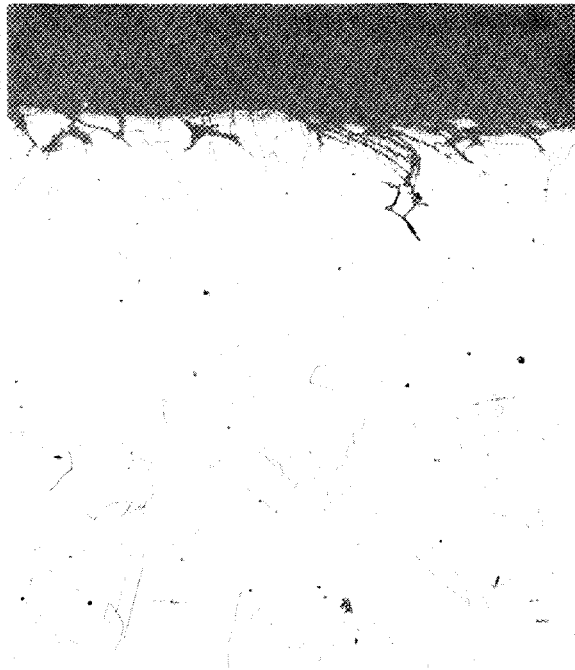
The exterior of the vessel displayed a corrosive attack which appeared to be intergranular in nature. Penetration varied from 1-6 mils, the maximum occurring at or below the vapor-salt interface (Fig. 28, Sample A-3b). However, there was one exception to this pattern. A grain-boundary penetration of approx 12 mils in depth was found on the exterior surface opposite the pitted region in the vapor near Area C.

Fig. 28. Microstructure of Sample from Exterior Surface of Mark II VPP Fluorinator Approx 47 in. Below Slip-on Flange (Salt Phase, Area A) Showing Result of Air Oxidation. Etchant: Nitric-acetic acid. 100X.

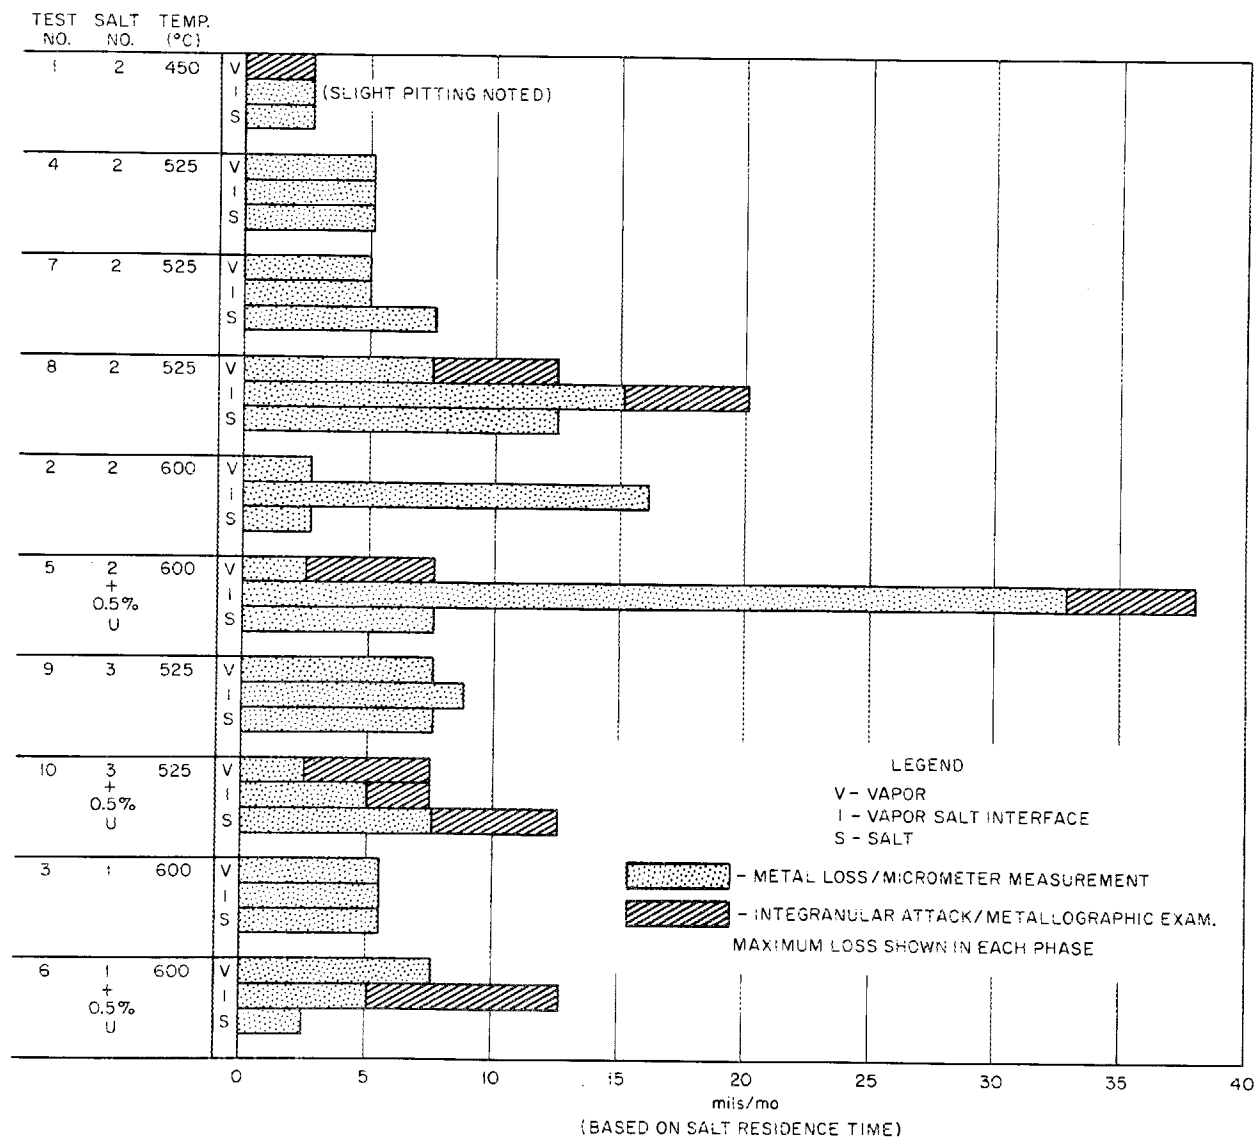
Fig. 36. Summary of Corrosion on A Nickel Miniature Fluorinators Using Different Process Flowsheets.

Lowering the temperature of the reactor containing the same LiF-bearing salt, LiF-NaF-ZrF<sub>4</sub> (26-37-37 mole %), to 525°C produced erratic corrosion results. Two of the vessels, Nos. 4 and 7, showed uniform, comparatively small metal losses in all regions while vessel No. 8 showed an increased attack, especially at the vapor-salt interface. Intergranular attack was also exhibited by vessel No. 8. As shown in Table XIII, vessel No. 8 was in a downstream position from vessels Nos. 4 and 7, and the deviation in behavior may, therefore, have been the result of carry-over and collection of certain constituents conducive to greater corrosive attack.

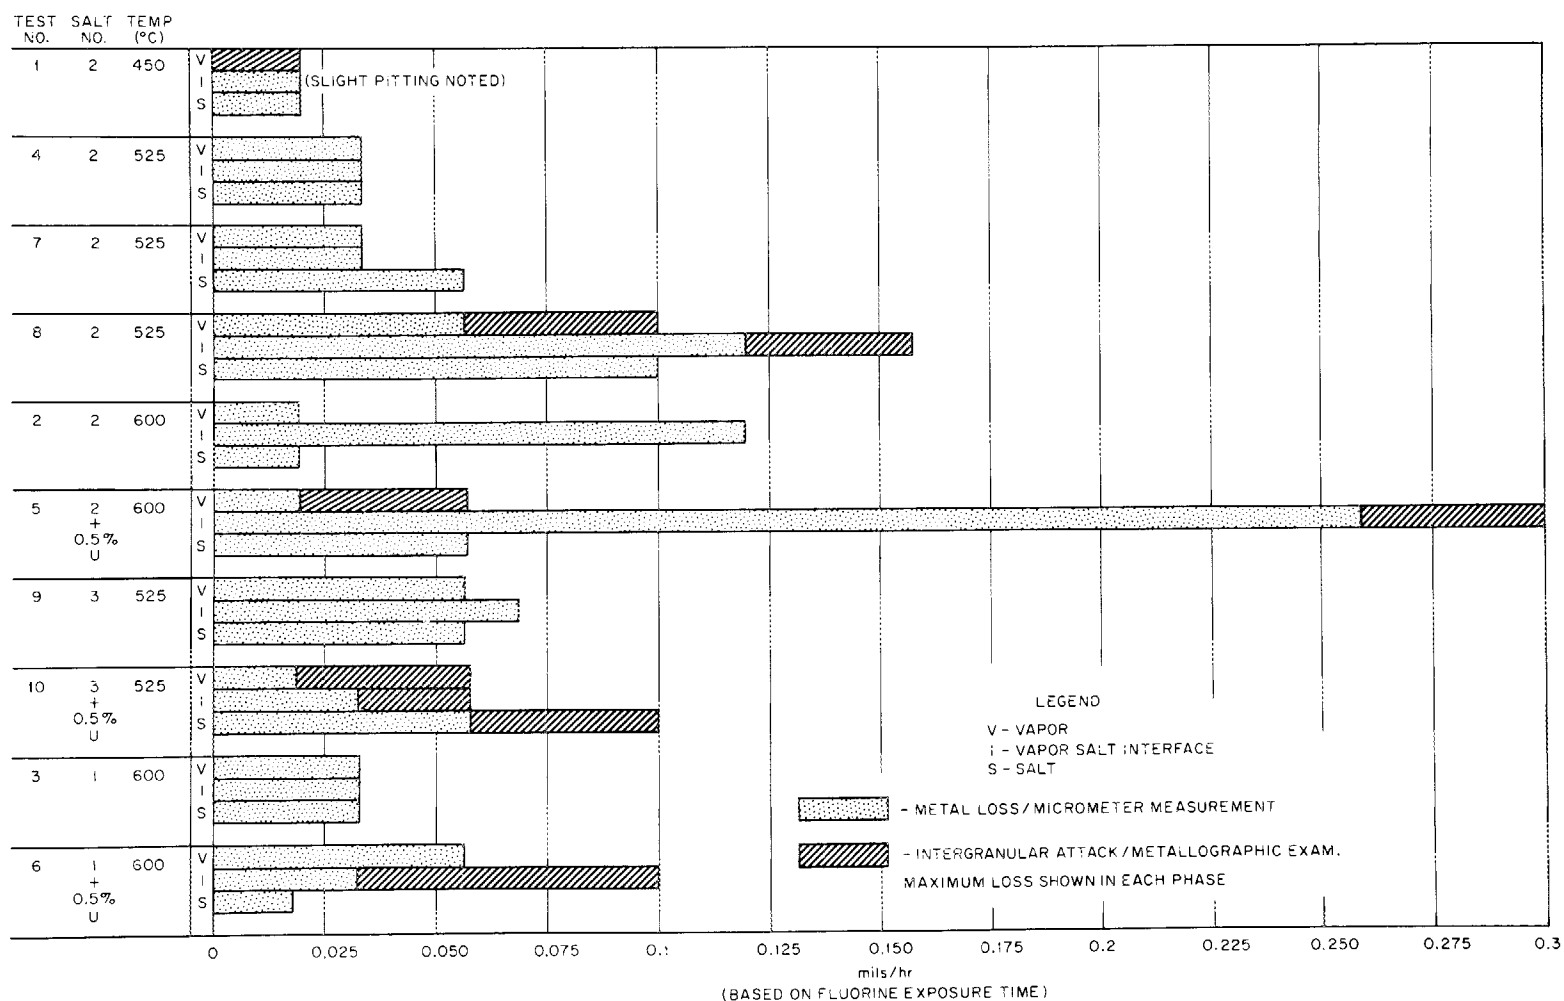
Fig. 37. Summary of Corrosion on A Nickel Miniature Fluorinators Using Different Process Flowsheets.

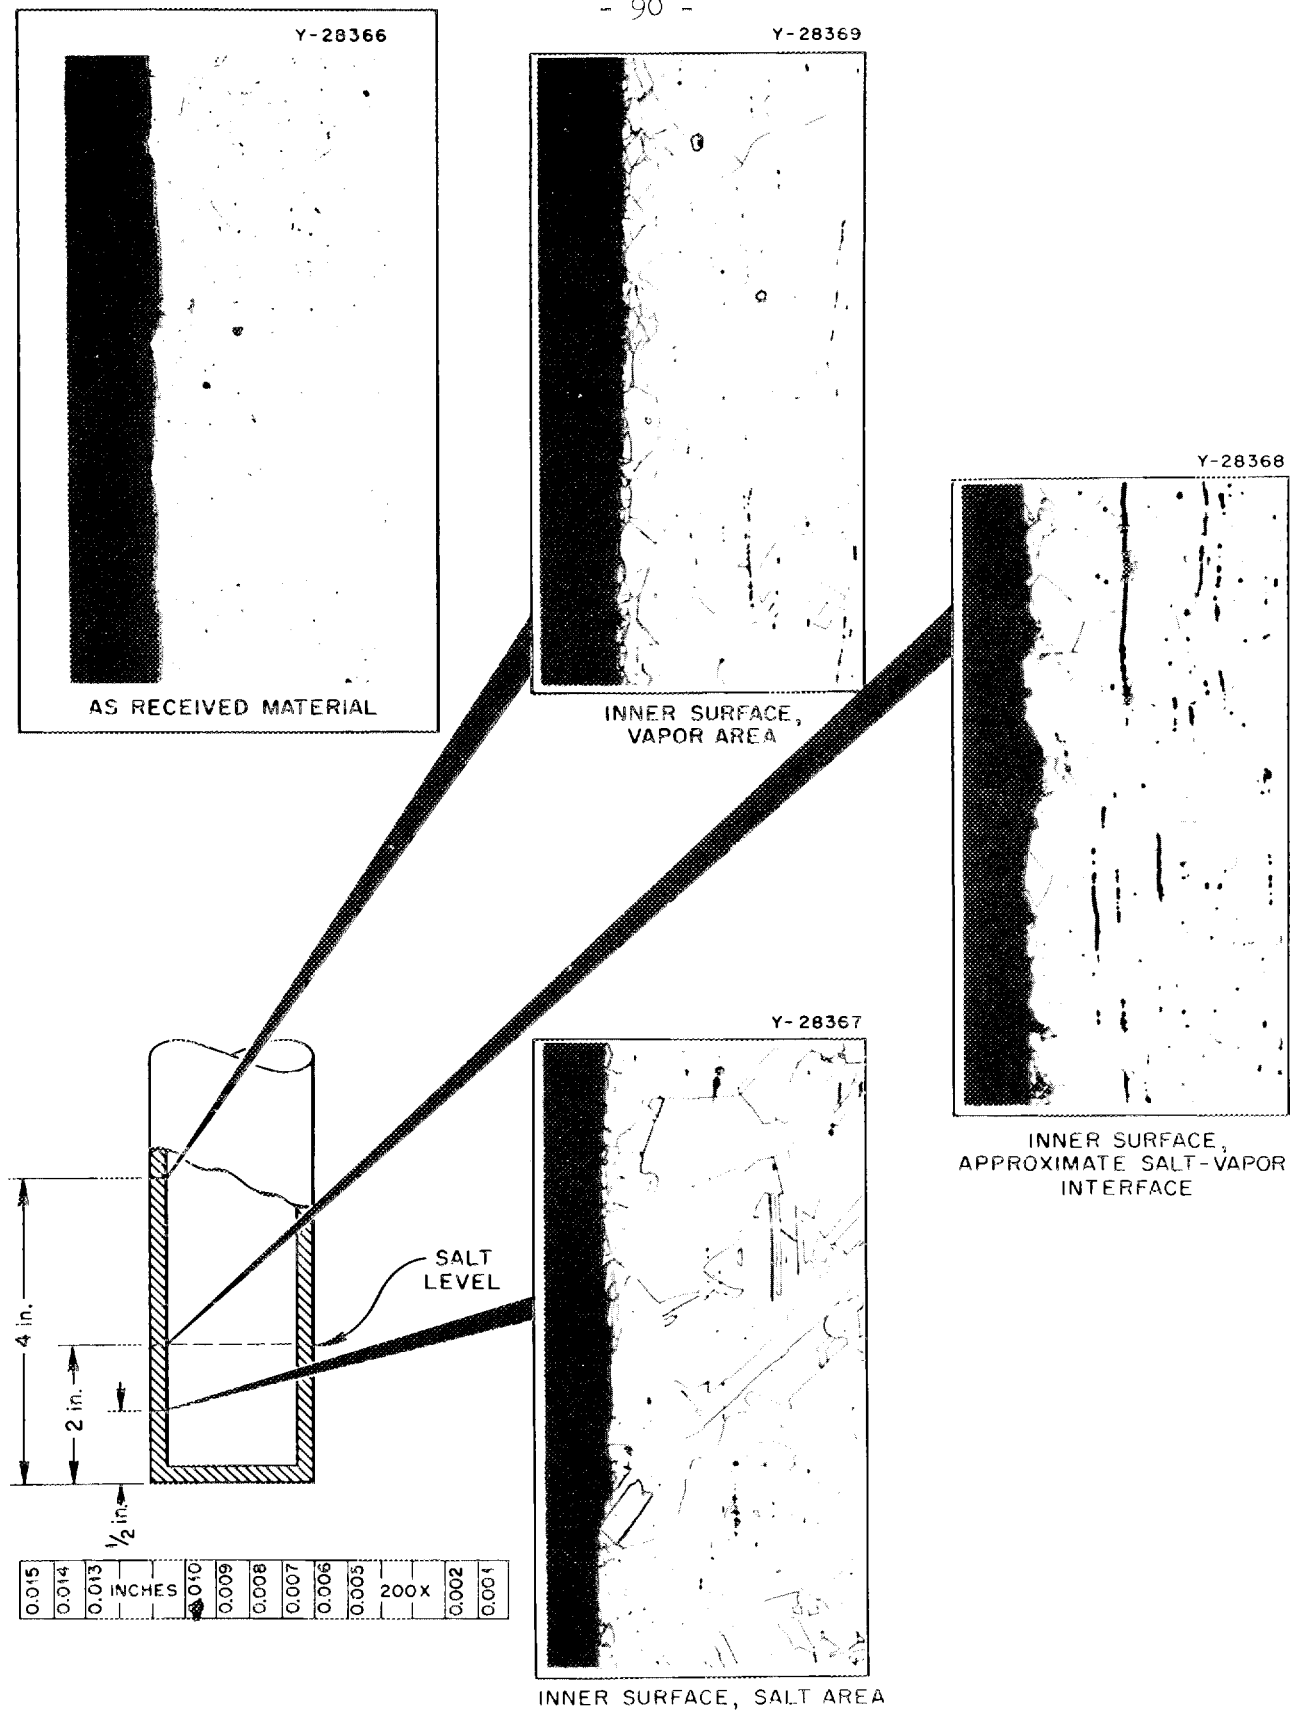
Fig. 38. Typical Microstructures of Samples from A Nickel Miniature Test Fluorinator No. 1. Etchant: Acetic-nitric-hydrochloric acid. 200X.

Lowering the process temperature to 450°C and utilizing the same lithium-bearing salt (No. 2) reduced corrosive attack to the lowest levels found in this test series. These results were provided by vessel No. 1 where the approximate losses were 0.02 mil/hr, based on fluorine sparge time. This is especially significant since lithium-sodium-zirconium fluoride salt mixtures can be used in the volatility process at lower operating temperatures than the NaF-ZrF<sub>4</sub> composite system because of the lower liquidus line of the lithium-bearing system.

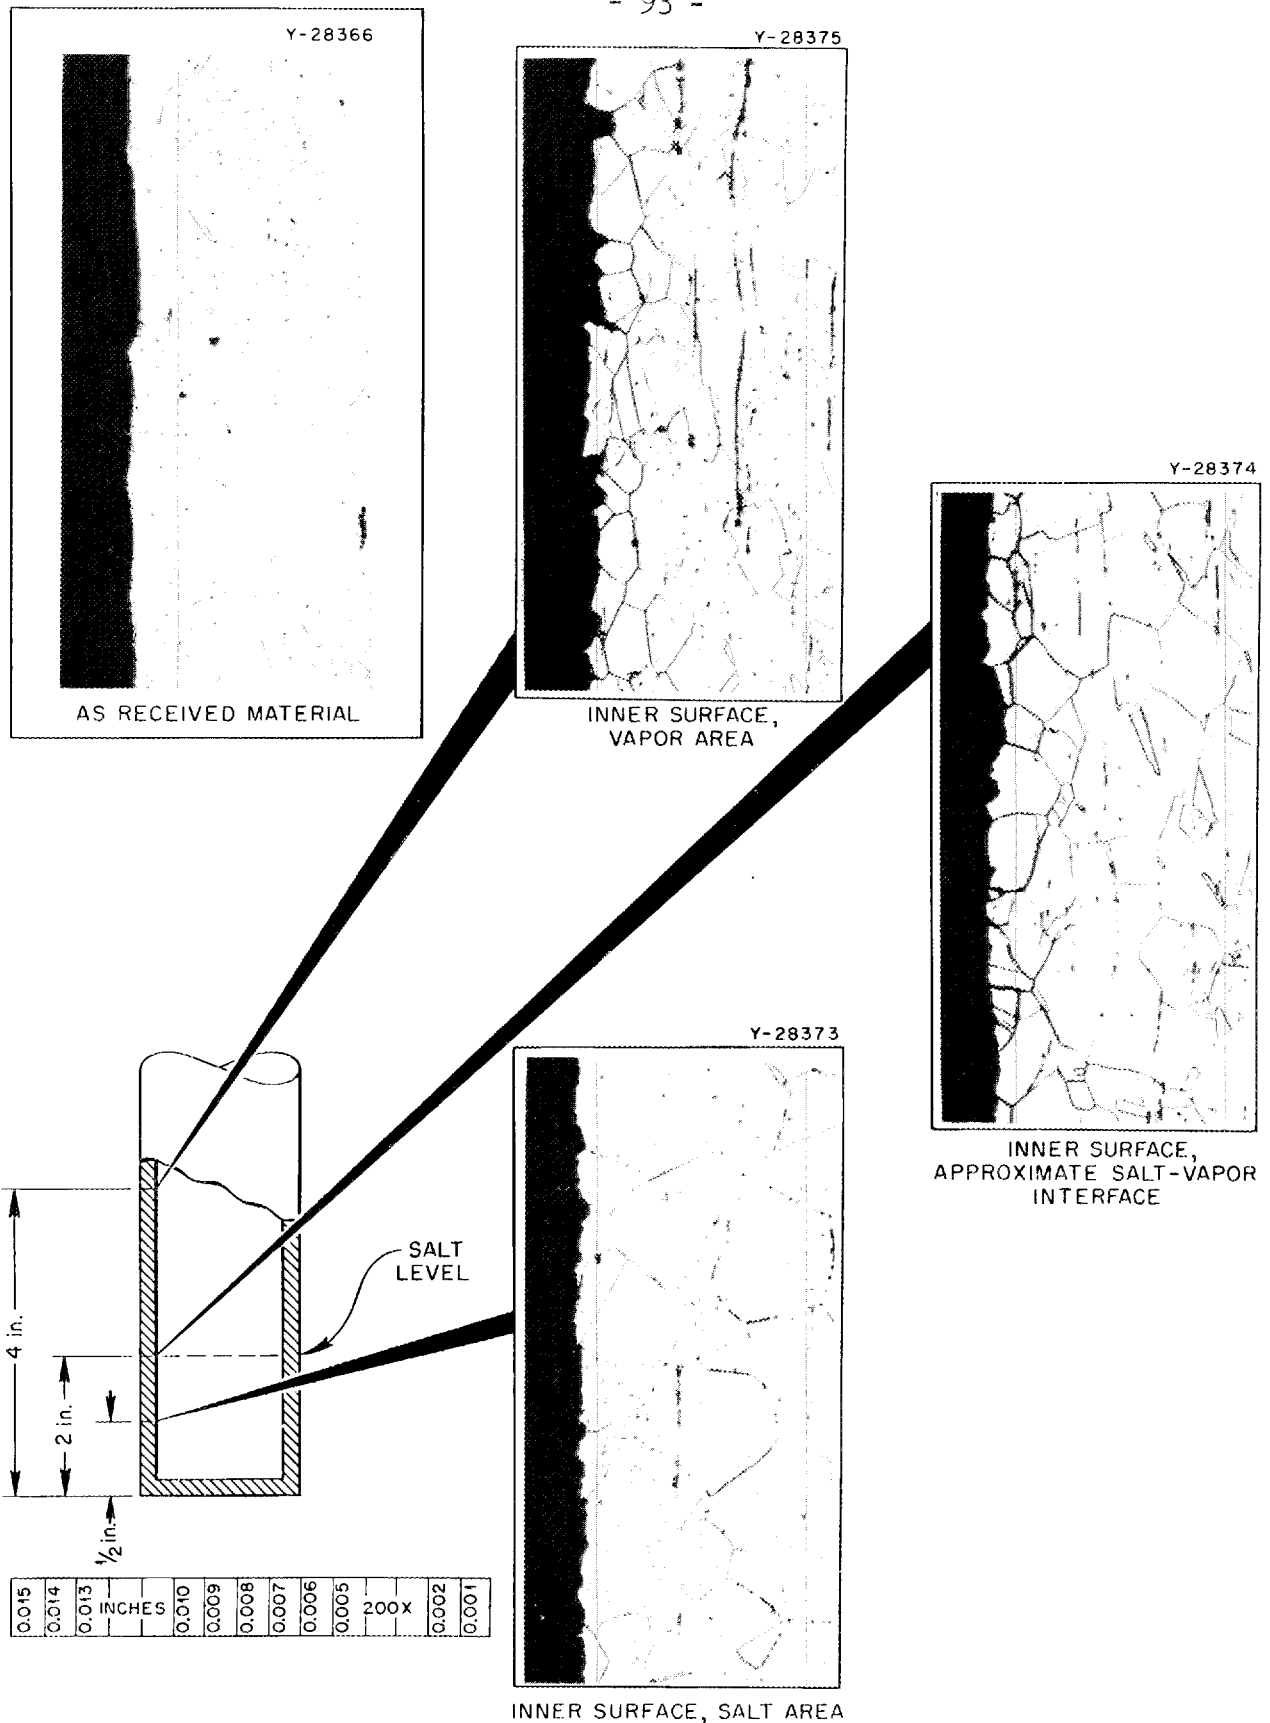
Fig. 41. Typical Microstructures of Samples from A Nickel Miniature Test Fluorinator No. 8. Etchant: Acetic-nitric-hydrochloric acid. 200X.

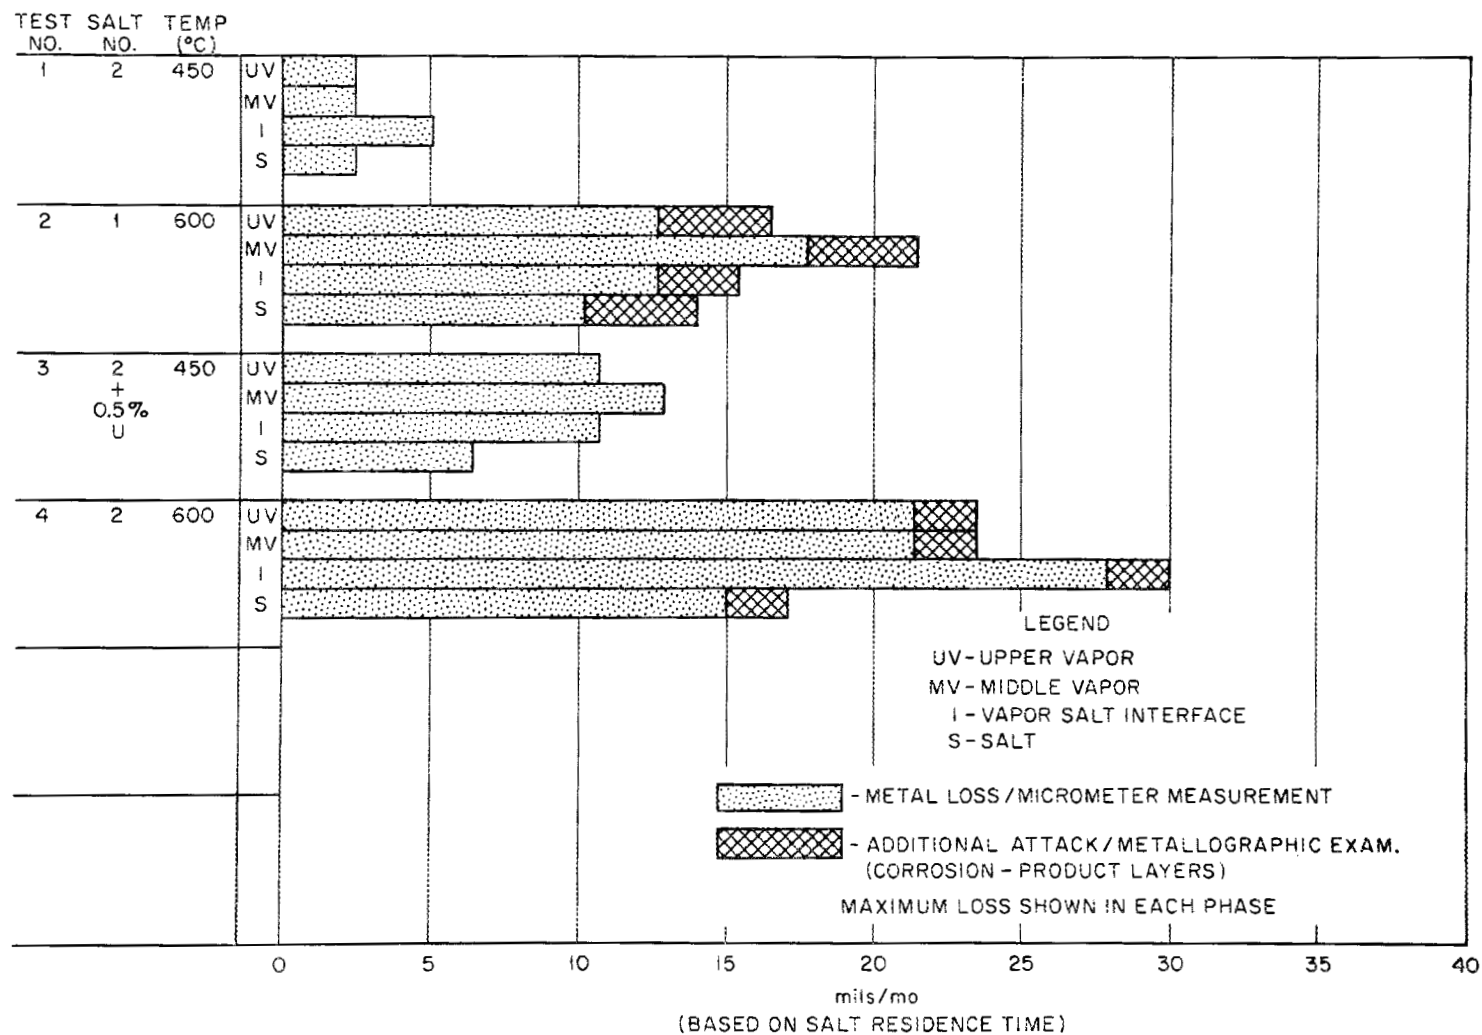
The INOR-8 test fluorinators showed a variety of corrosion manifestations depending on the test conditions. Considering the two vessels which operated at 600°C, vessel No. 2, which contained equimolar NaF-ZrF<sub>4</sub>, showed less attack than vessel No. 4, which contained LiF-NaF-ZrF<sub>4</sub> (26-37-37 mole %).

Fig. 43. Summary of Corrosion on INOR-8 Miniature Fluorinators Using Different Process Flowsheets.

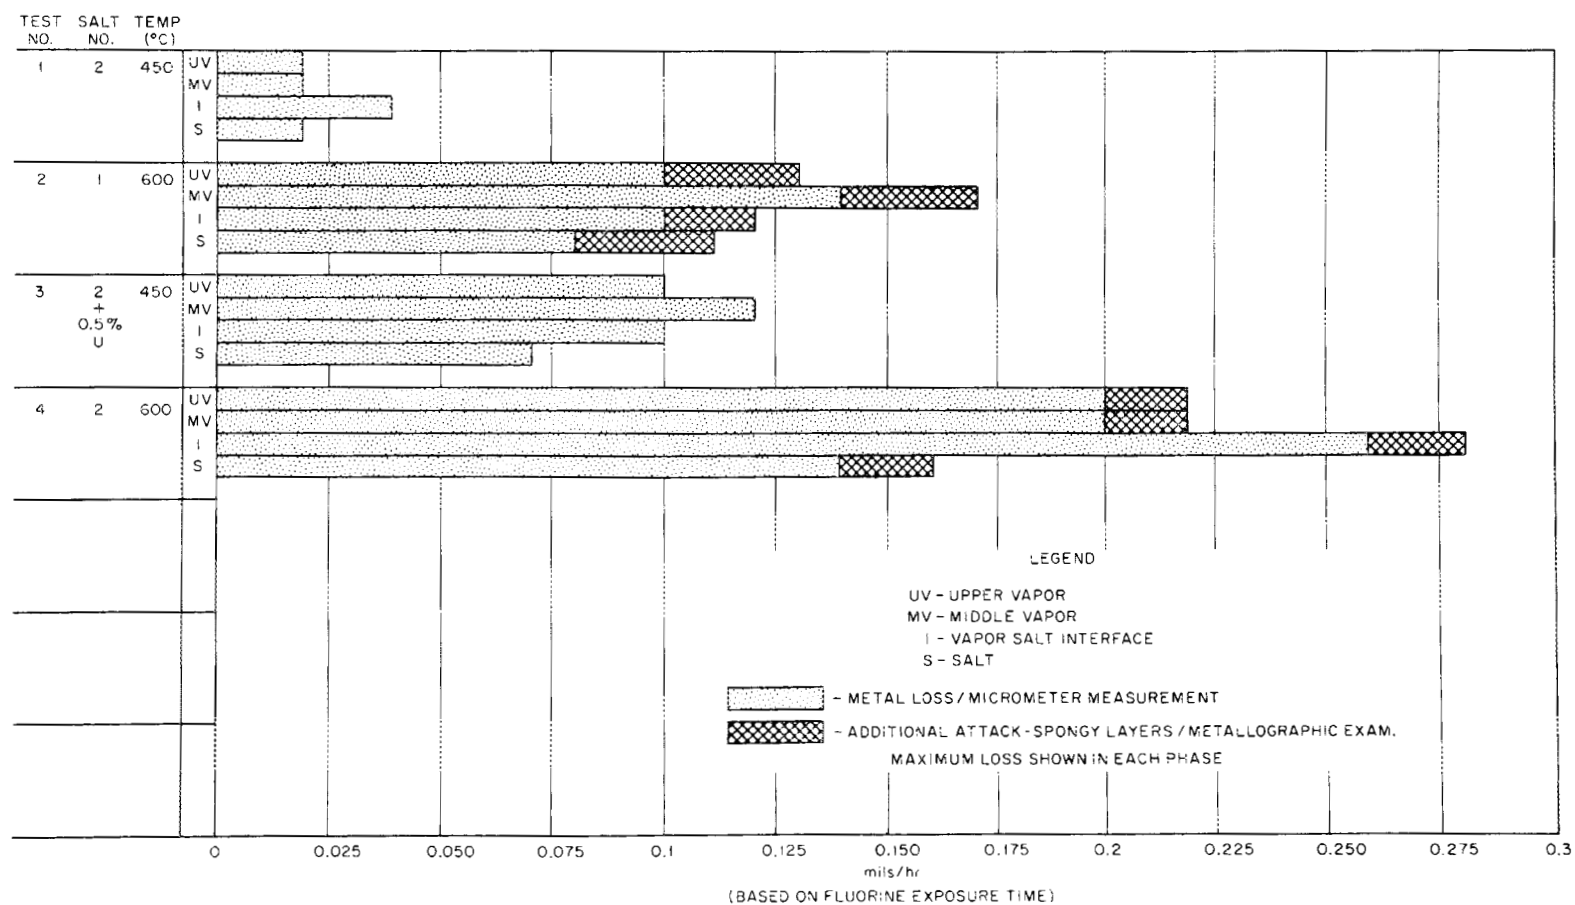
Fig. 44. Summary of Corrosion on INOR-8 Miniature Fluorinators Using Different Process Flowsheets.

Reducing the operating temperature to 450°C and using the same lithium-bearing salt significantly reduced attack as indicated for vessel No. 1 (Figs. 43 and 44). The maximum attack found in this vessel was also at the vapor-salt interface at a rate of 5 mils/month. The addition of uranium to the lithium-bearing salt described plus operation at 450°C more than doubled the corrosive attack when compared to the nonuranium-containing salt. This occurred in vessel No. 3.

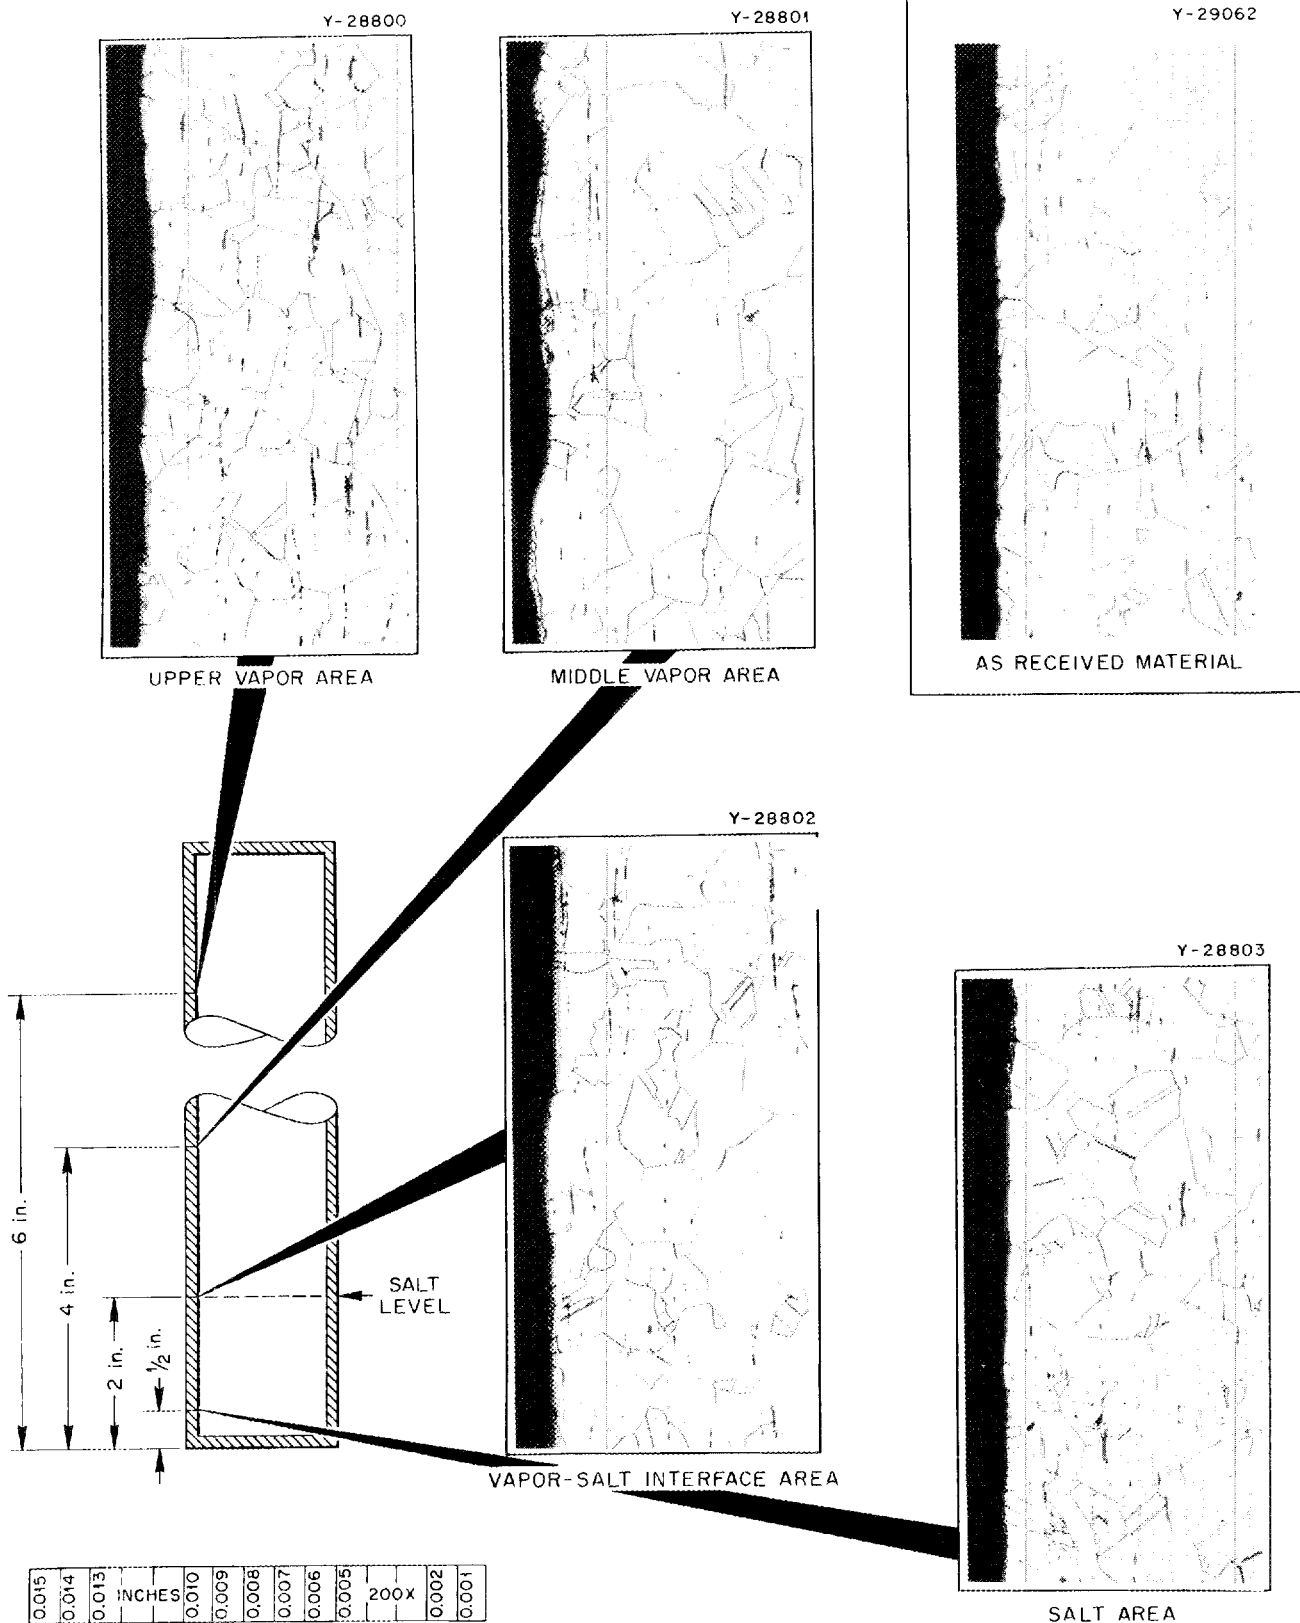
Fig. 45. Typical Microstructures of Samples from INOR-8 Miniature Test Fluorinator No. 1. Etchant: Modified aqua regia. 200X.

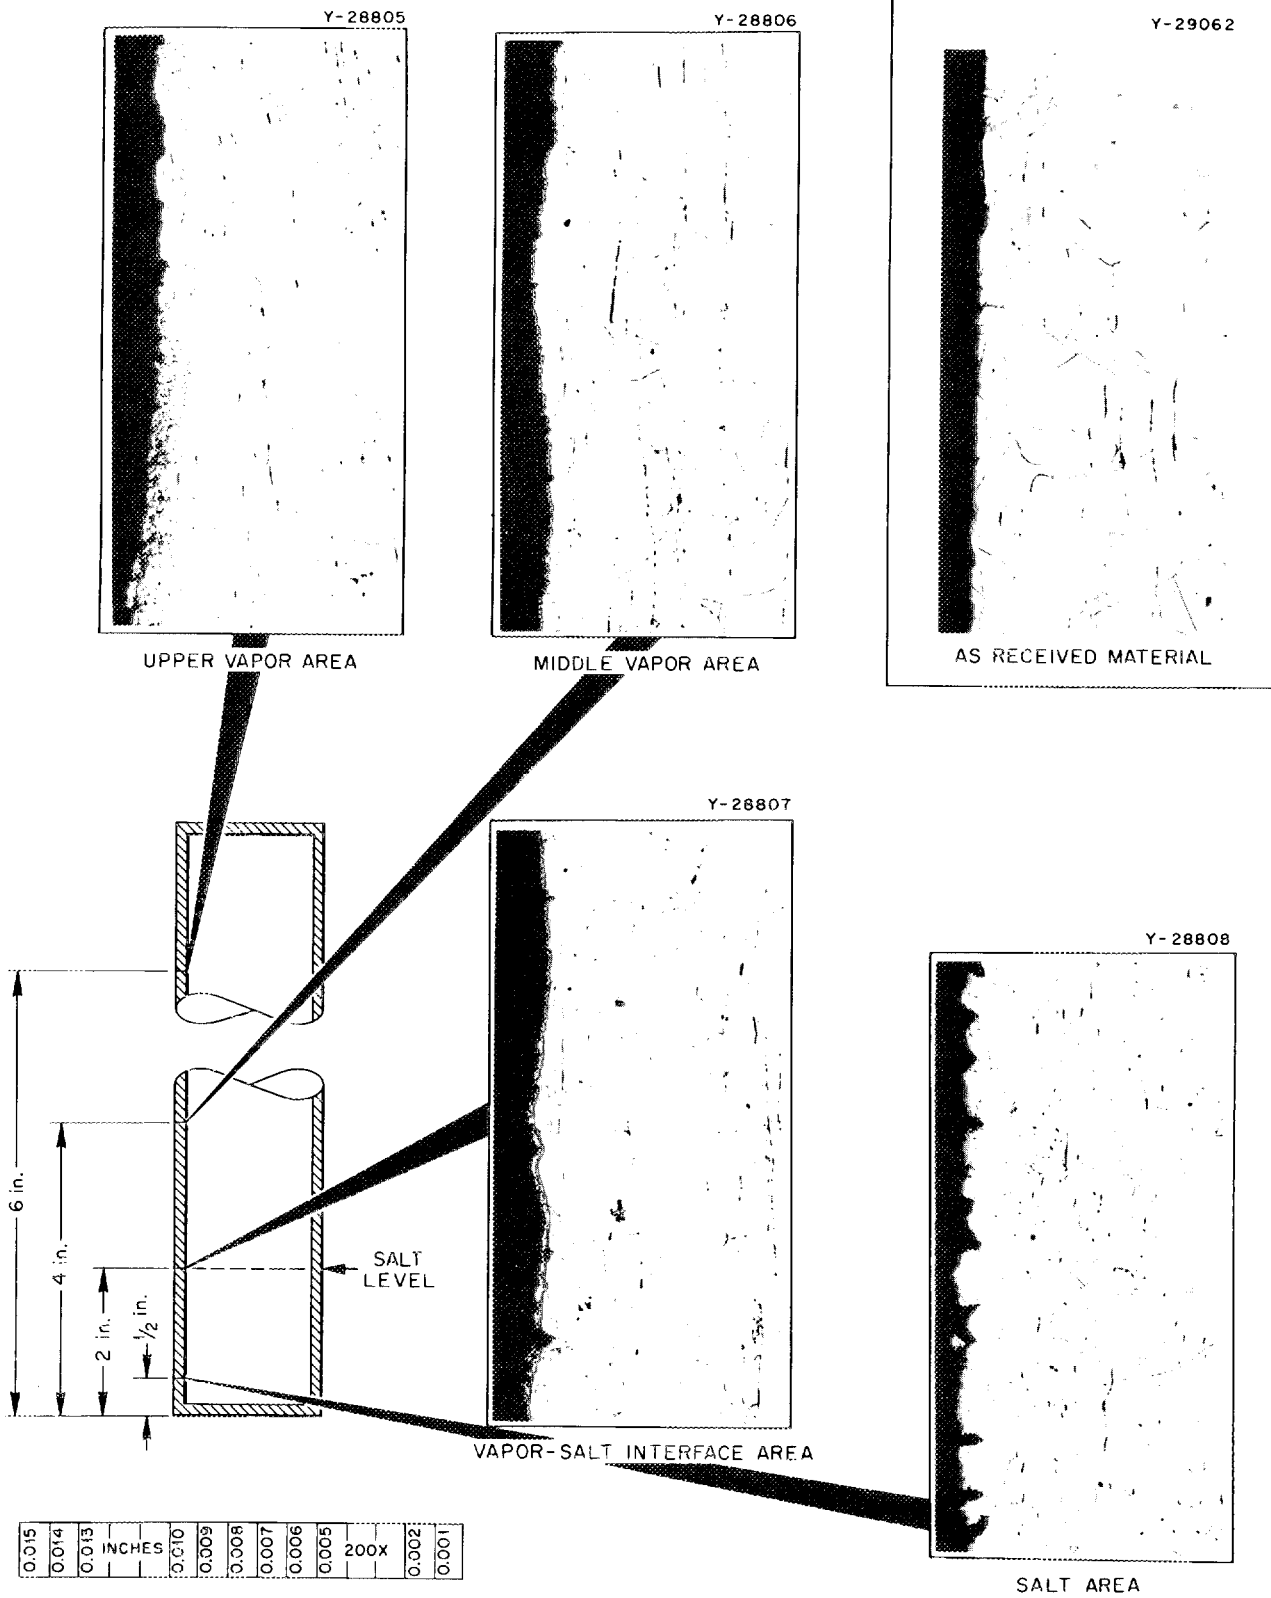
Fig. 46. Typical Microstructures of Samples from INOR-8 Miniature Test Fluorinator No. 2. Etchant: Modified aqua regia. 200X.

Examination of the metallographic specimens in the as-polished state, Fig. 49, disclosed spongy layers on the surfaces of the vapor region specimens from vessels Nos. 2 and 4. These two vessels operated at the highest temperatures of the test series. Upon etching with a modified aqua regia solution, 5:1, HCl:HNO<sub>3</sub>, the spongy regions were for the most part destroyed. Figures 46 and 49 display the microstructures for specimens from the two vessels and show that in only one region, the upper vapor area of vessel No. 2 (Fig. 46) did significant amounts of the spongy region remain.
