CORROSION ASSOCIATED WITH FLUORINATION  
IN THE OAK RIDGE NATIONAL LABORATORY  
FLUORIDE VOLATILITY PROCESS

A. P. Litman  
A. E. Goldman

METALLURGY DIVISION

JUN - 5 1961

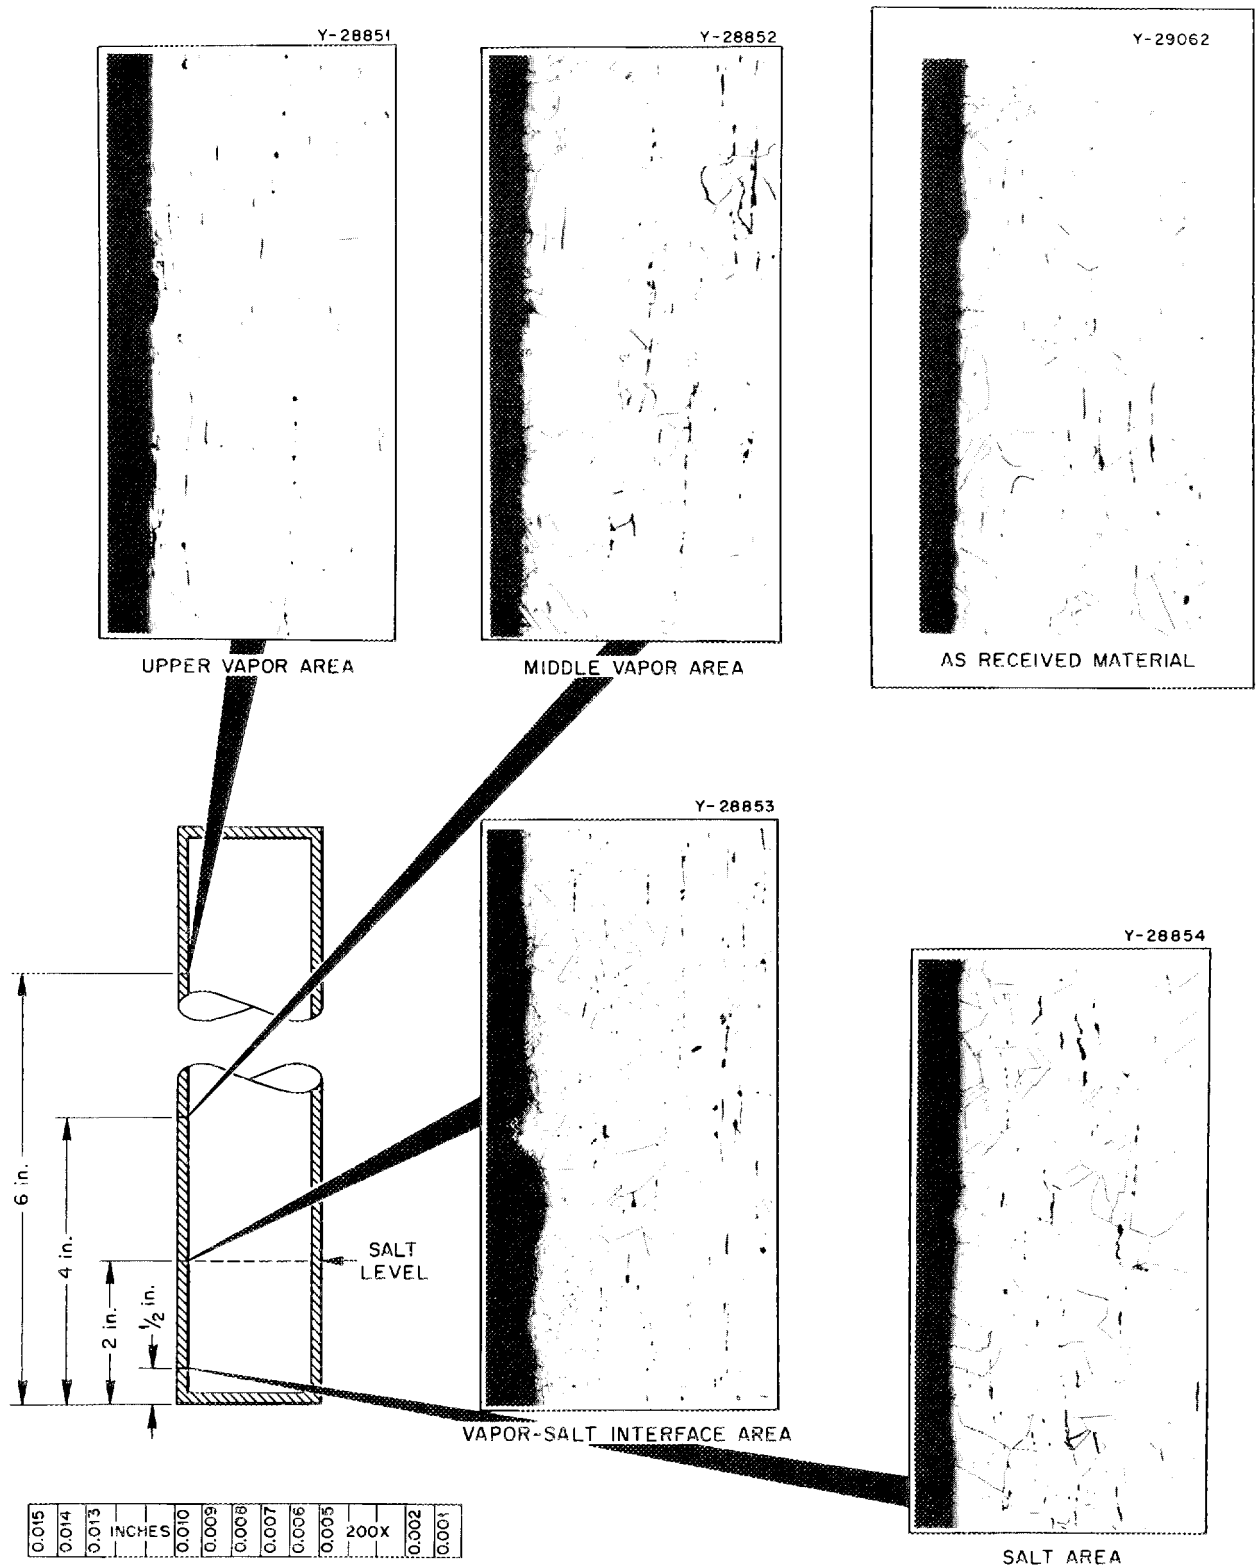
Fig. 47. Typical Microstructures of Samples from INOR-8 Miniature Test Fluorinator No. 3. Etchant: Modified aqua regia. 200X.

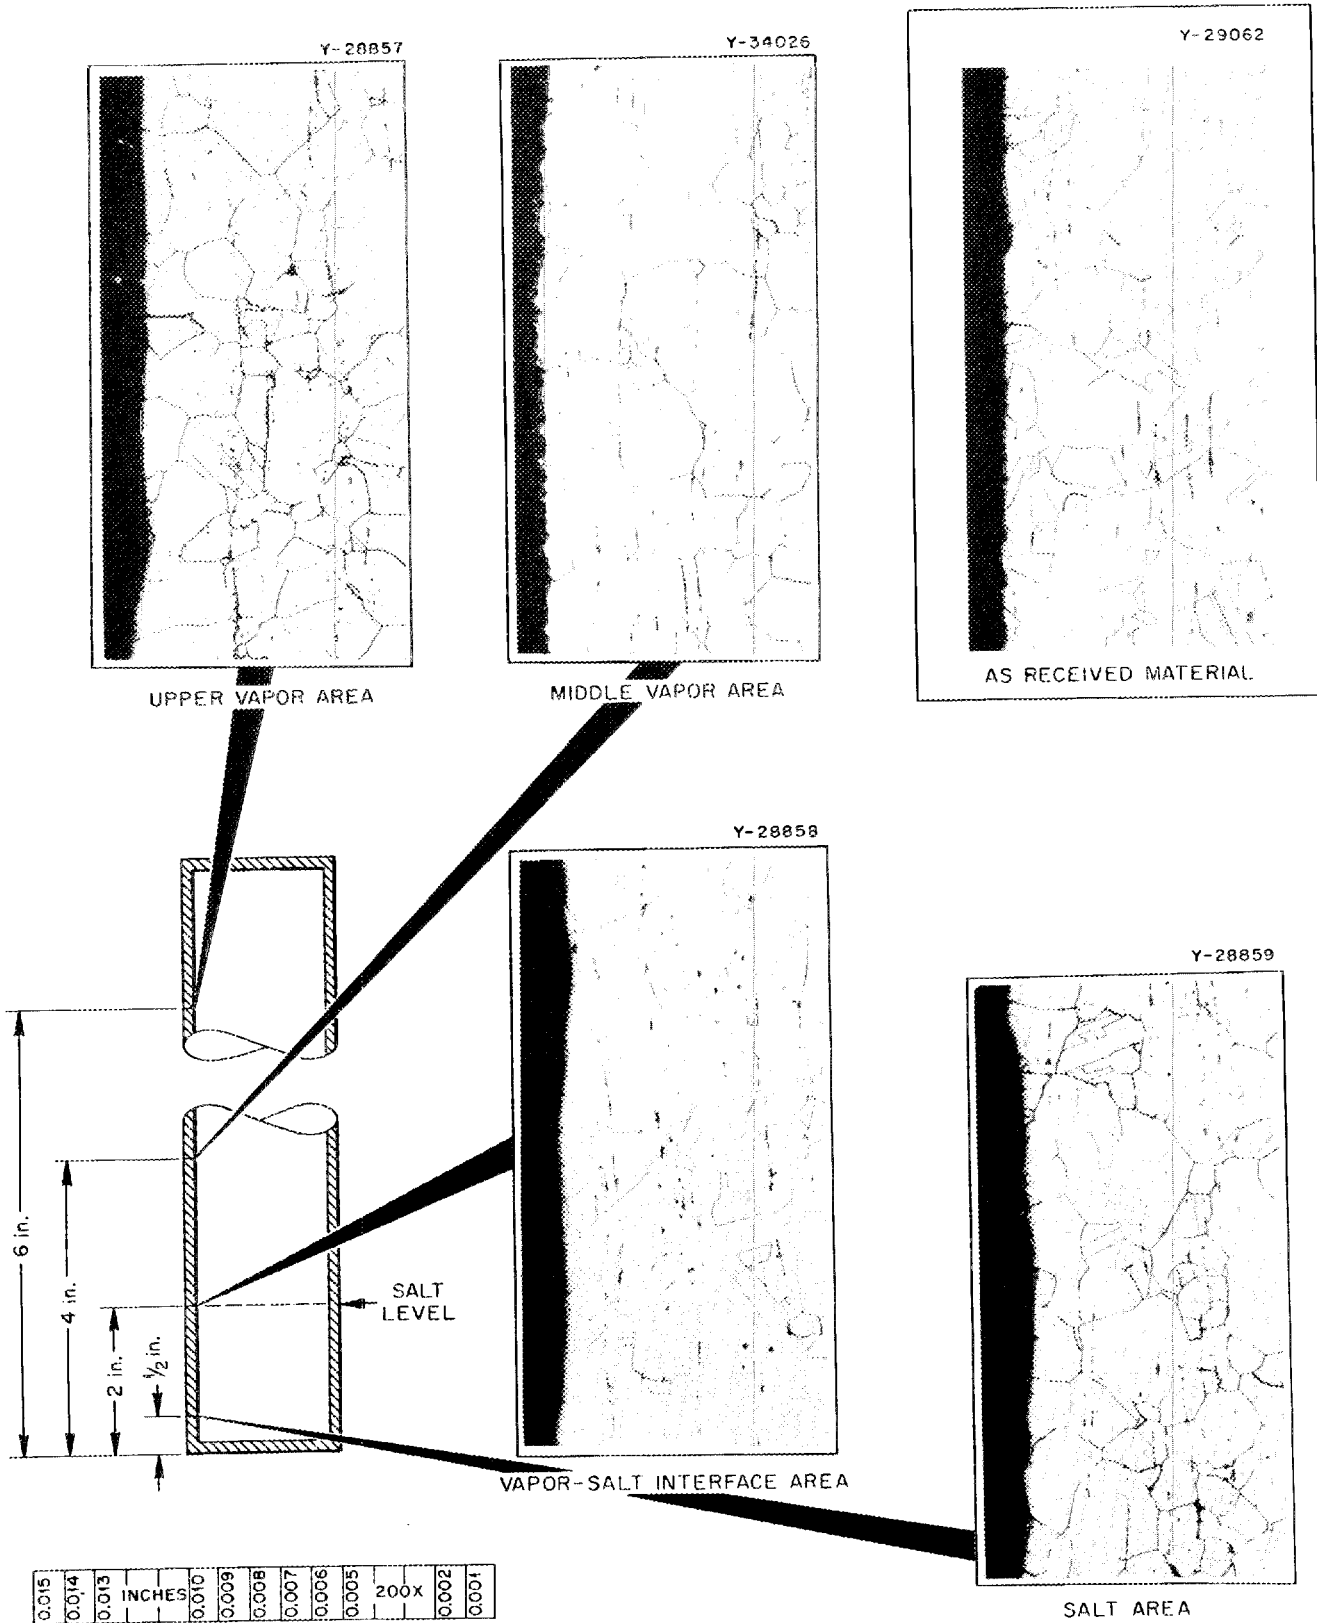
Fig. 48. Typical Microstructures of Samples from INOR-8 Miniature Test Fluorinator No. 4. Etchant: Modified aqua regia. 200X.

Maximum attack in the latter vessel occurred at the vapor-salt interface at a rate of 30 mils/month, based on residence time in the molten salts. This was the maximum attack rate for the entire INOR-8 series.

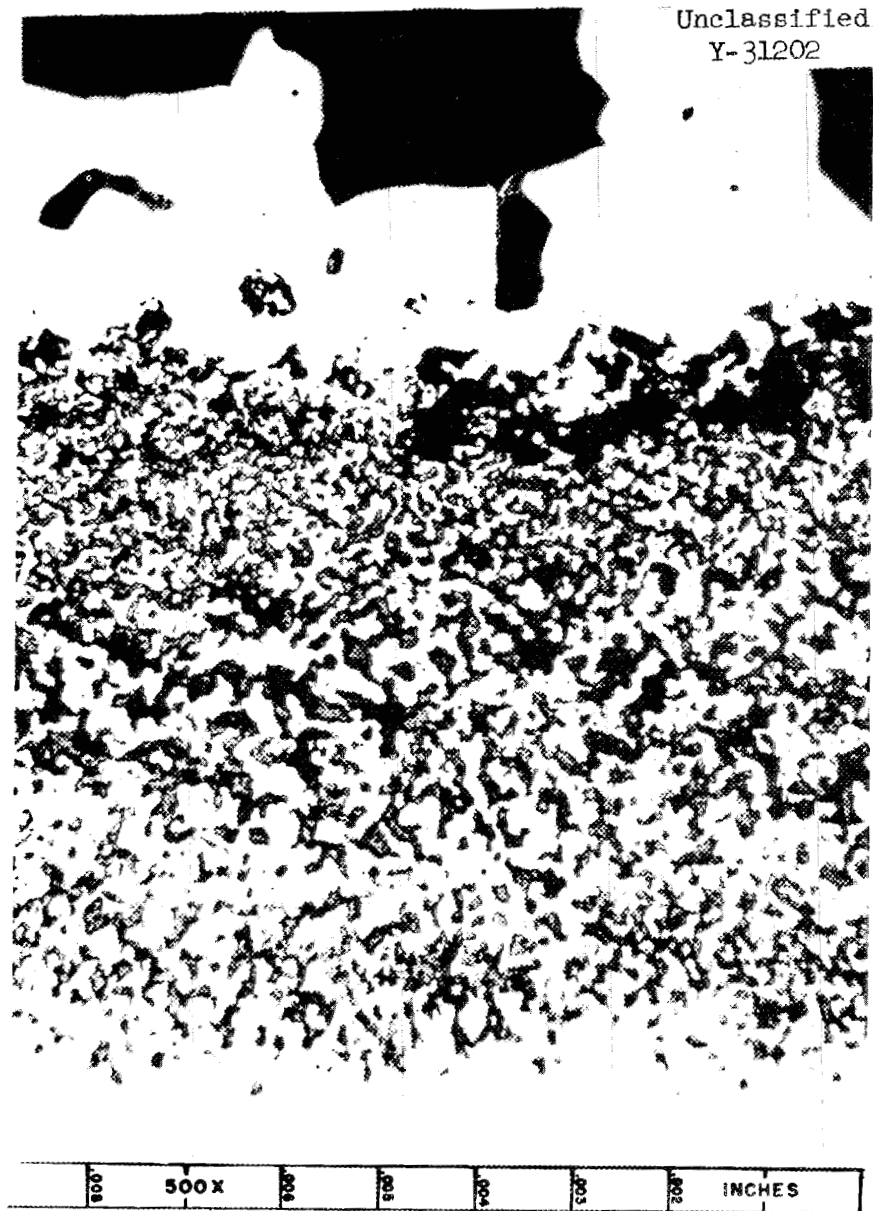
Careful repolishing on the upper vapor area sample from vessel No. 2 and examination of the surface disclosed a corrosion product which resolved itself into two distinct layers, as shown in Fig. 50. Just above the INOR-8 base metal was a spongy region which was composed of voids and solid metal intermixed. Many of the voids appeared to be partially filled with nonmetallic-appearing compounds. Above the spongy region, on the outermost surface of the specimen, was an irregular layer that had the angular appearance of metal crystals.

Fig. 50. Surface Layers on Sample from Vapor Region of INOR-8 Miniature Test Fluorinator No. 2. As-polished. 500X.

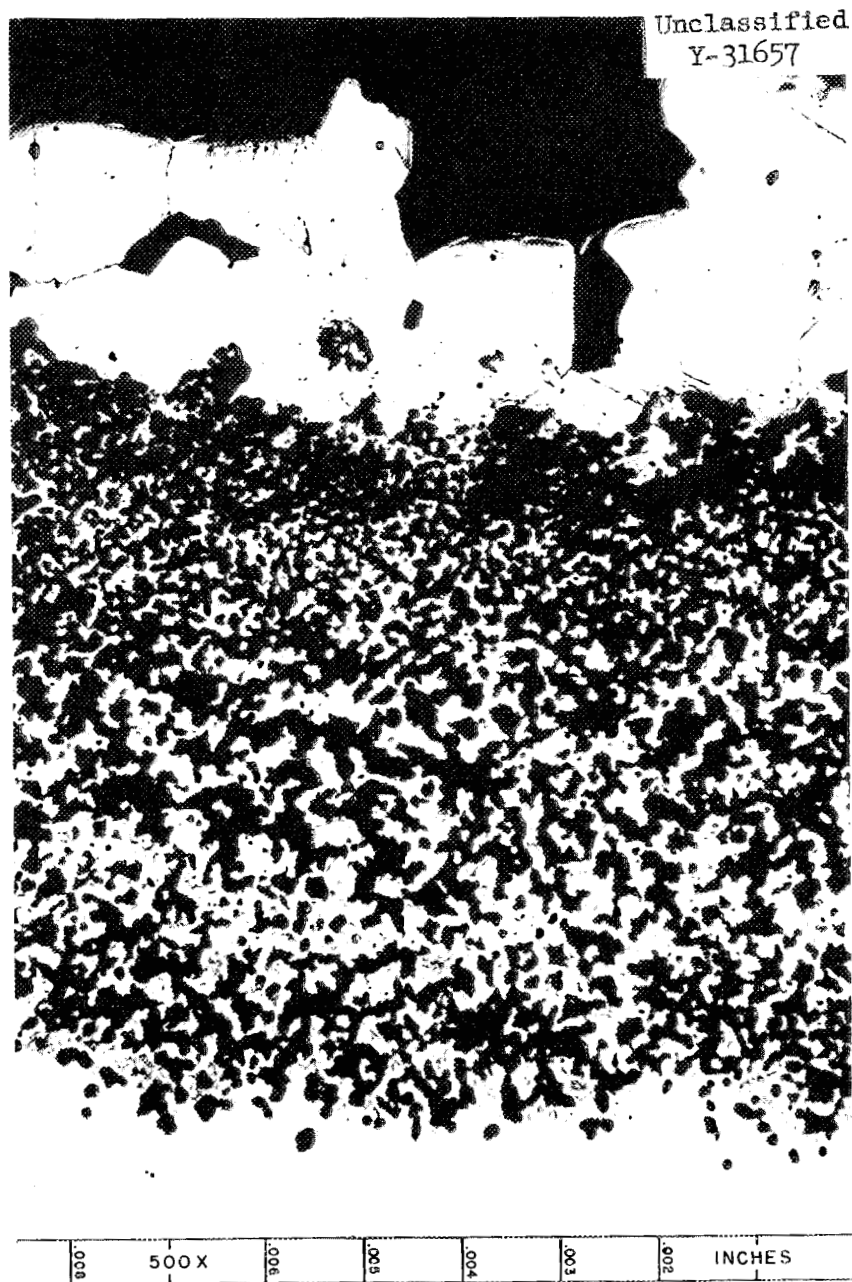
Upon etching the specimen with a mixture of 10% KCN and 10% (NH<sub>4</sub>)<sub>2</sub>S<sub>2</sub>O<sub>8</sub>, 1:1 ratio in water, the outermost layer of the surface showed different characteristics than the INOR-8 base metal. The comparatively mild etchant delineated grain boundaries in the outer layer but left the base metal unaffected, as displayed in Fig. 51.

Fig. 51. Surface Layers on Sample from Vapor Region of INOR-8 Miniature Test Fluorinator No. 2. Etchant: Potassium cyanide-ammonium persulfate. 500X.

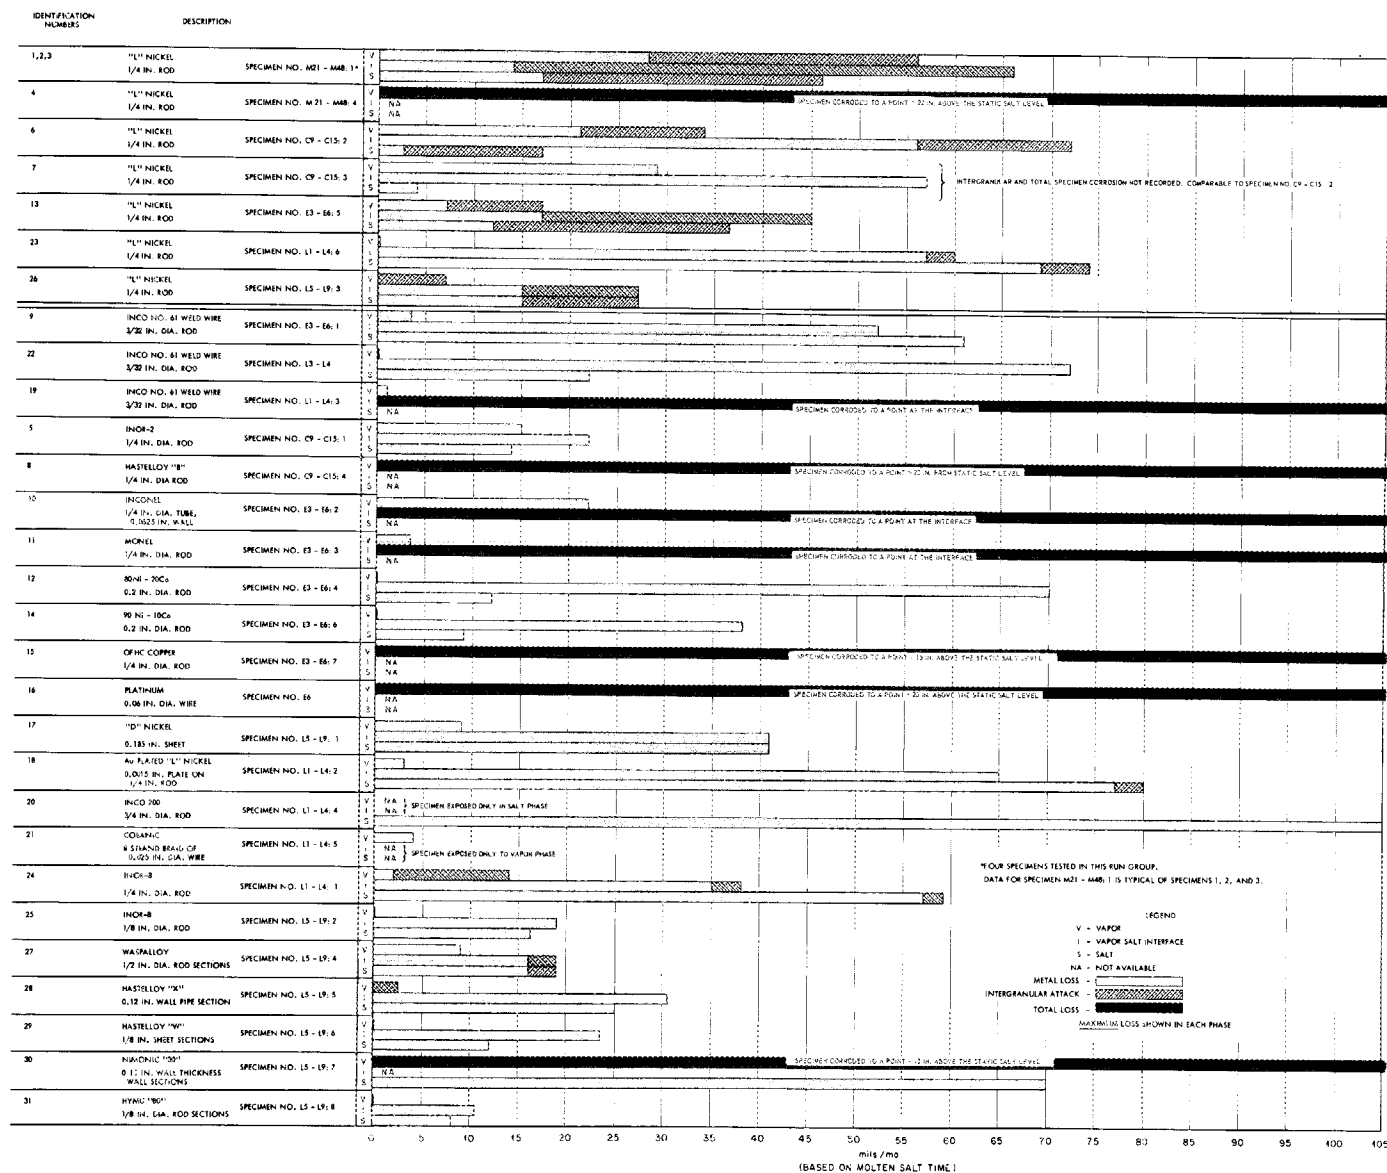
Fig. 55. Summary of Corrosion on Specimens Exposed in VPP Fluorinator.

Several specimens registered lower rates of maximum corrosive attack than the L nickel control rods. These specimens included Hymu 80, INOR-2, INOR-8, Hastelloy W, Hastelloy X, Waspalloy, and the 90 wt % Ni-10 wt % Co alloys. In particular, Hymu 80 was superior to all test specimens in all runs, although the specimen registered a maximum bulk loss rate of 11 mils/month, based on molten-salt residence time, at the vapor-salt interface. Total loss of corrosion specimens, indicating corrosion rates of > 105 mils/month based on molten-salt time, was found for one L nickel specimen, one INCO-61 weld wire specimen, and for the Hastelloy B, Nimonic 80, Inconel, Monel, copper, and platinum specimens.

The behavior of the gold-plated L nickel corrosion specimens indicated that no protection was provided by the plating. Comparison with L nickel specimen number L-1-L-4:6 in Fig. 55 shows comparable losses.

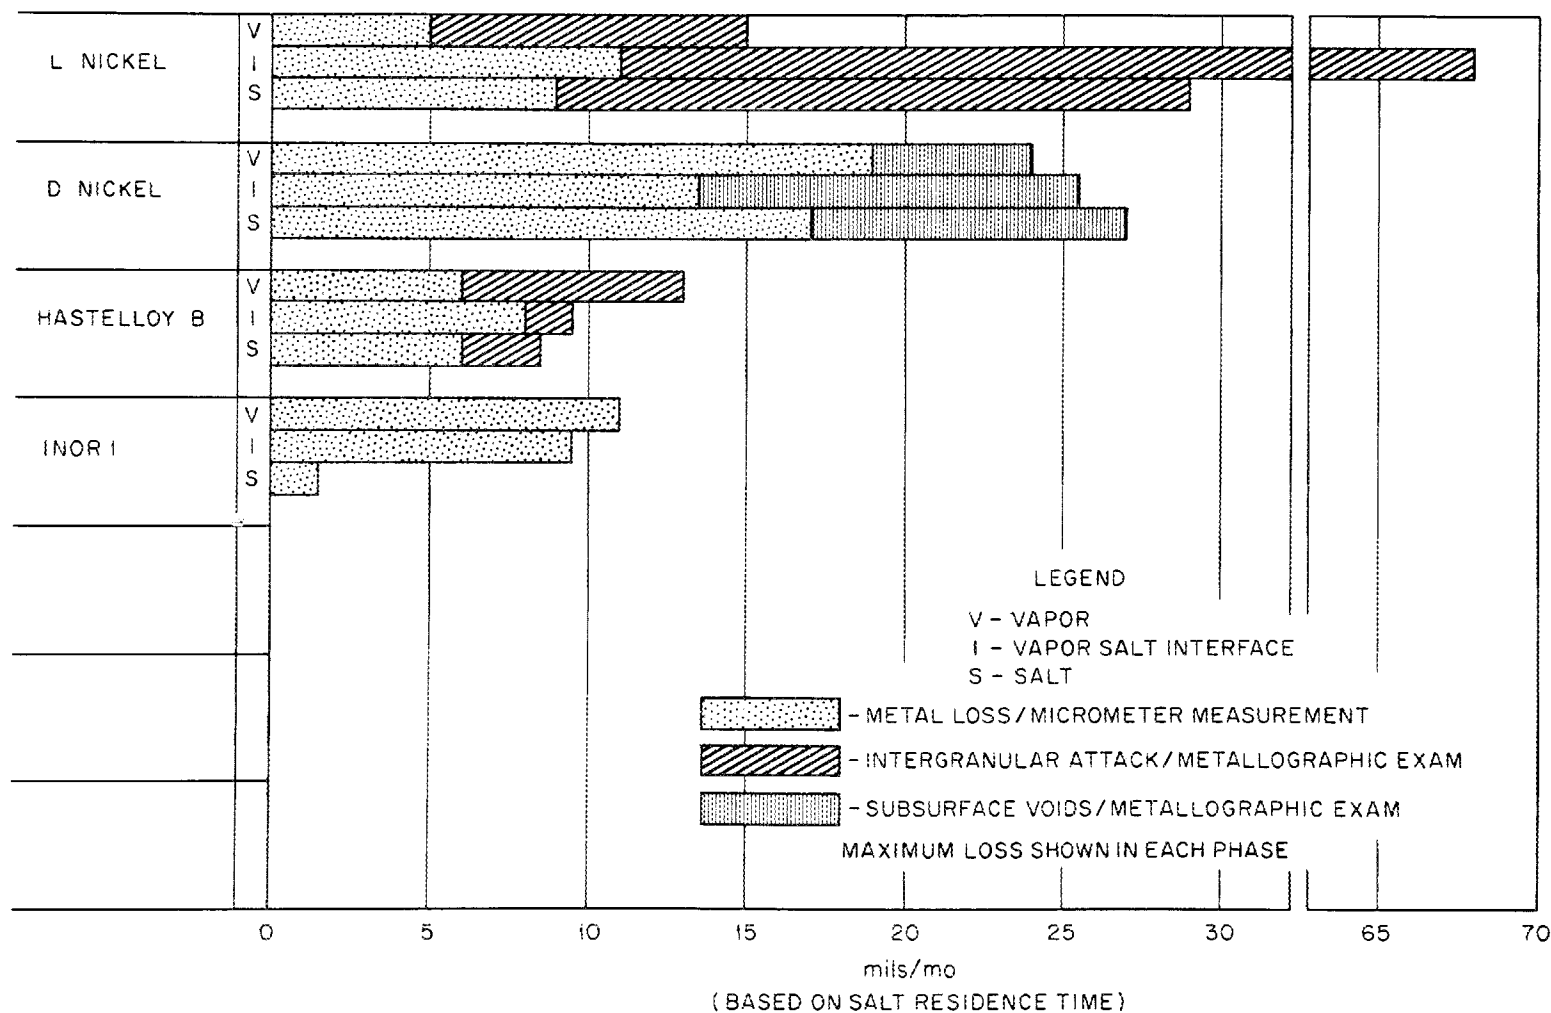
Fig. 57. Summary of Corrosion on Coupons Exposed to a Fluorination Environment by the Argonne National Laboratory.

Comparison of the Argonne National Laboratory corrosion results with those obtained at ORNL is difficult because of differences in test procedures which include fluorine flow rates, specimen location and geometry, and salt compositions. However, Argonne's results on L nickel fit the corrosion limits determined for the ORNL scouting corrosion reference specimens in the salt and at the salt-vapor interfaces. Vapor-phase specimens are not readily comparable, since Argonne specimens were only 3 to 4 in. above the salt surface.

The Argonne National Laboratory Hastelloy B and the D nickel specimens generally had less attack than scouting specimens at ORNL. The differences may be attributed to more severe operating conditions in the ORNL pilot plant fluorinator. Since no INOR-1 specimen had been tested at ORNL, no comparisons could be derived.

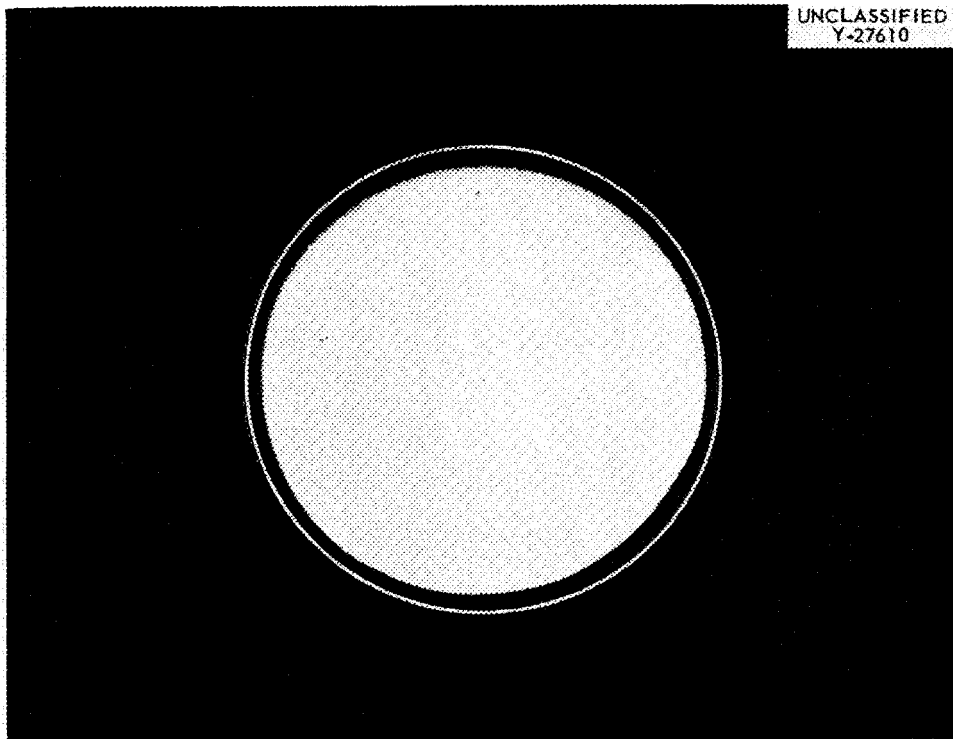
Fig. 59A. Cross Section of Interface Region Sample from L Nickel Corrosion Specimen (Runs L-5-L-9:3). Interior circumference of white circle indicates original size. As-polished. 10X.

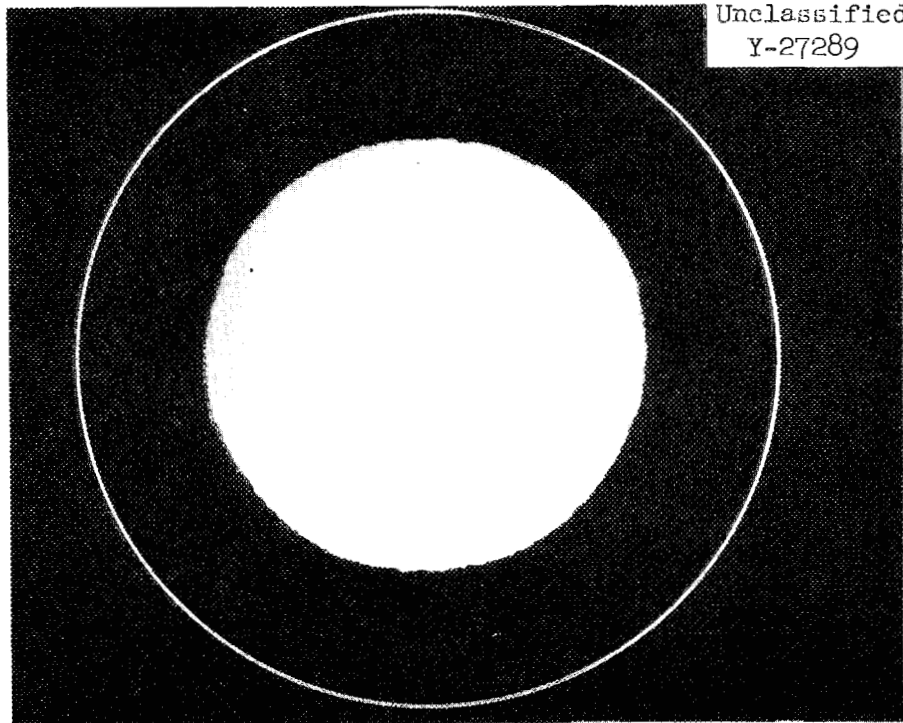
Fig. 60A. Cross Section of Salt Region Sample from Gold Plated L Nickel Corrosion Specimen (Runs L-1-L-4:2). Interior circumference of white circle indicates original size. As-polished. 15X.

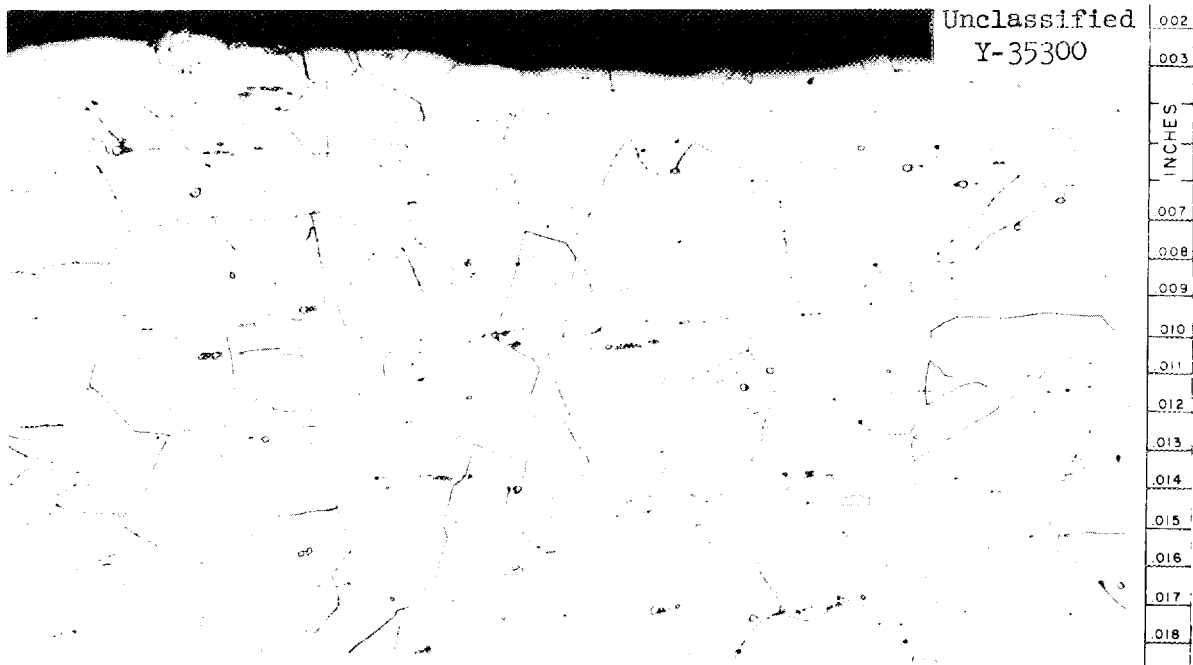
A high-temperature, oxidization-resistant, nickel-chromium-iron alloy, Inconel, has been mentioned as being useful in contact with fused fluoride salts. During the single test in the fluorination environment, the specimen completely failed at the vapor-salt interface, and also exhibited a rather high vapor-phase attack.

Fig. 64. Section of Vapor Region Sample from Inconel Corrosion Specimen (Runs E-3-E-6:2) Showing Typical Surface and Microstructure. Etchant: Modified aqua regia. 200X.

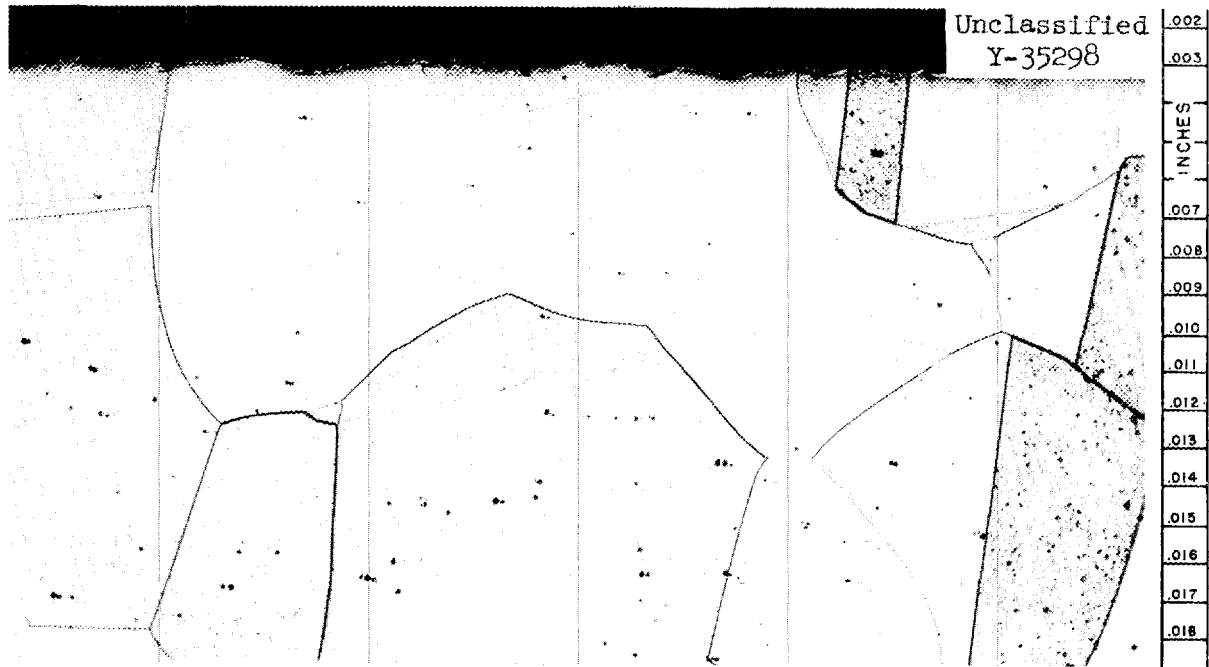
The nickel-rich copper specimen, Monel, provided poor resistance to the fluorination environment during a single test run. The specimen failed completely at the vapor-salt interface.

Fig. 65. Section of Vapor Region Sample from Monel Corrosion Specimen (Runs E-3-E-6:3) Showing Typical Surface and Microstructure.  
Etchant:  $\text{HC}_2\text{H}_3\text{O}_2:\text{HNO}_3:\text{HCl}$ . 200X.

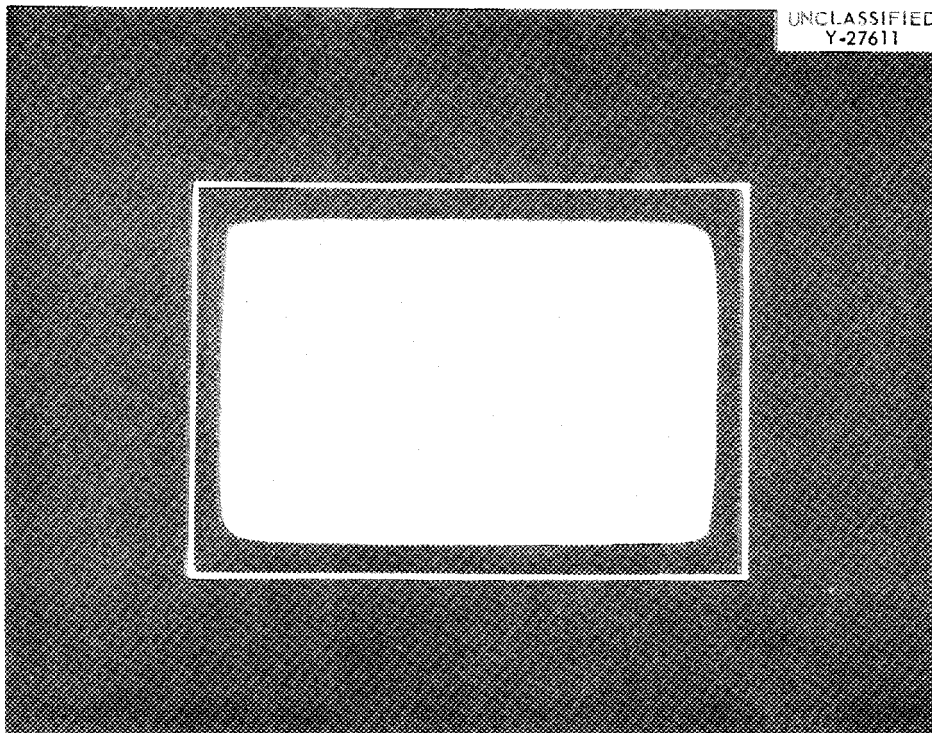
The D nickel, containing about 5% Mn, and developed for improved resistance to sulfur attack in oxidizing atmospheres at elevated temperatures, presented somewhat higher loss rates than the L nickel specimen simultaneously exposed. The D nickel specimen presented a different geometry to the corrodents, sheet vs rod, but that difference is not believed to have been significant in producing the higher rates of attack.

Fig. 70A. Cross Section of Interface Region Sample from D Nickel Corrosion Specimen (Runs L-5-L-9:1). Interior of white lines indicates original size. As-polished. 10X.

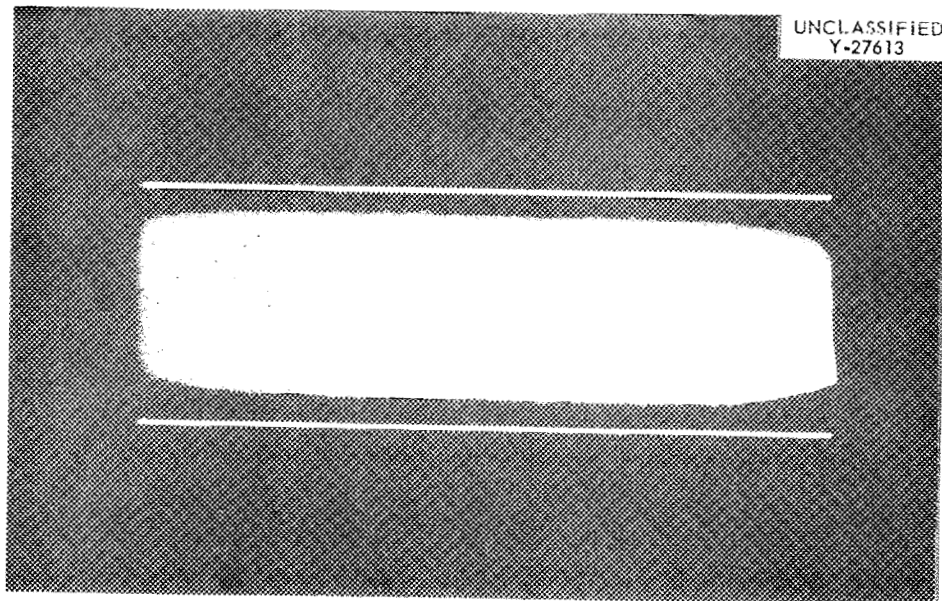
Fig. 76A. Cross Section of Interface Region Sample from Hastelloy W Corrosion Specimen (Runs L-5-L-9:6). Interior of white lines indicates original thickness. As-polished. 10X.

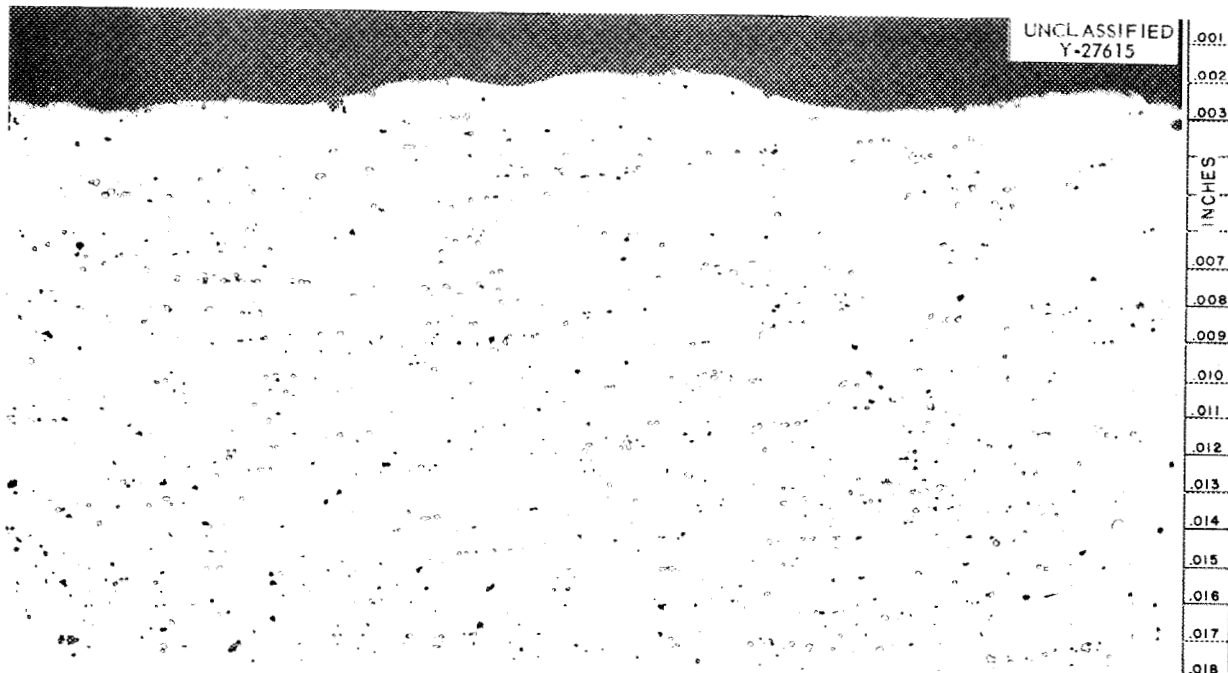
Fig. 76B. Portion of Fig. 76A. Typical Surface and Microstructure. Etchant: Chromium regia. 200X.

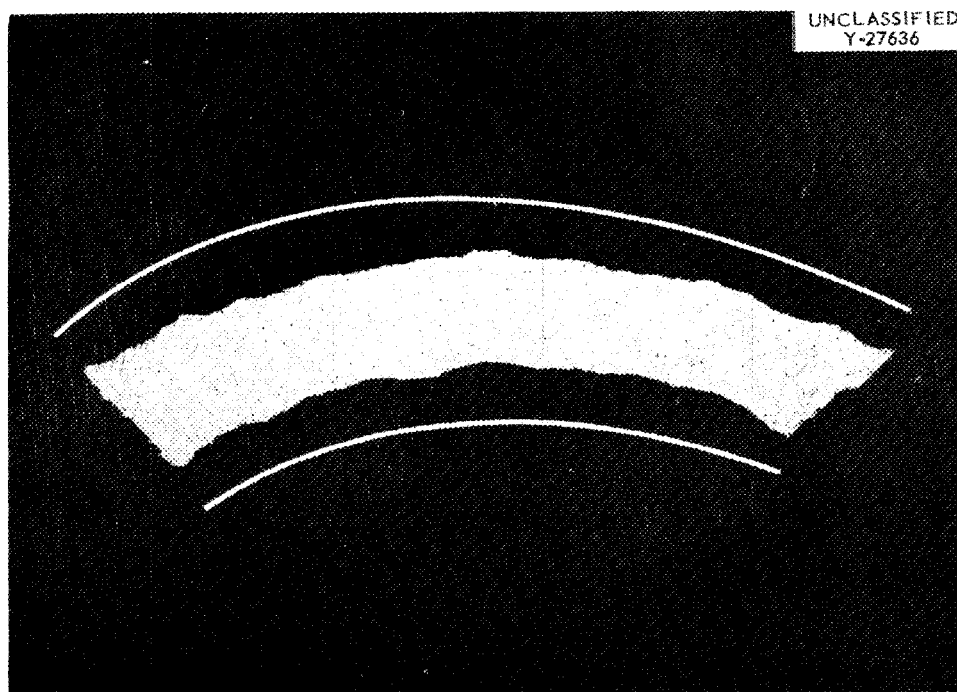
Fig. 77A. Cross Section of Salt Region Sample from Nimonic 80 Corrosion Specimen (Runs L-5-L-9:7). Interior of white lines indicates original thickness. As-polished. 10X.

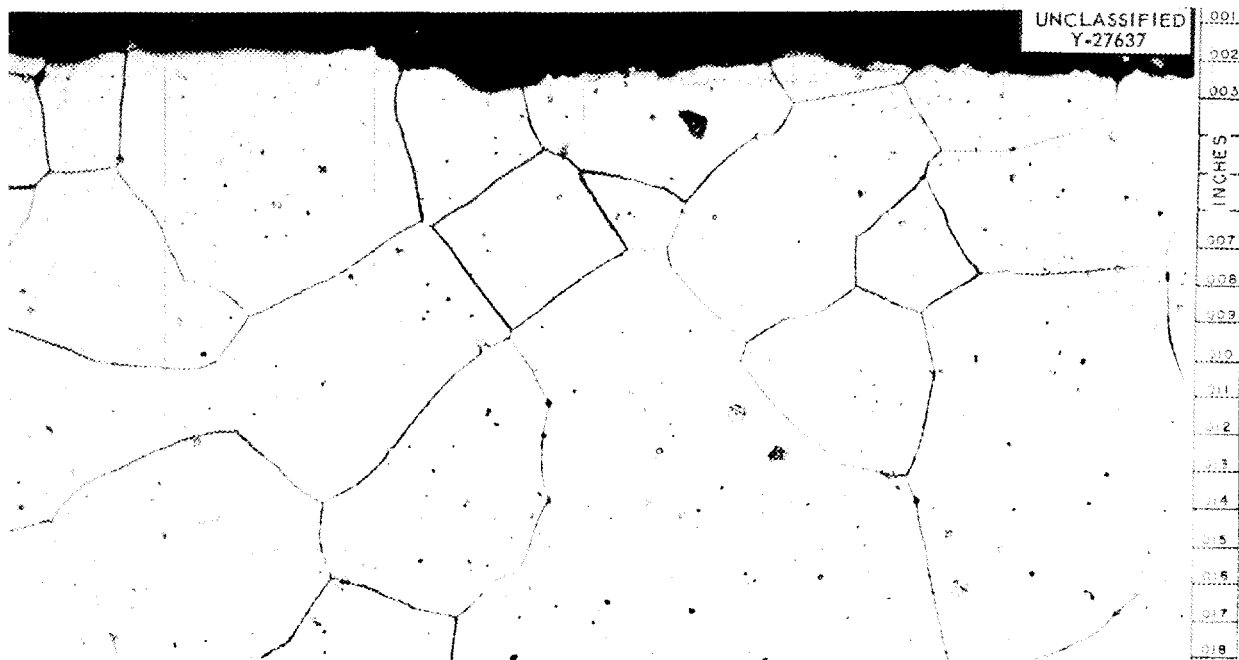
Fig. 77B. Portion of Fig. 77A. Typical Surface and Microstructure. Etchant: Aqua regia. 200X.

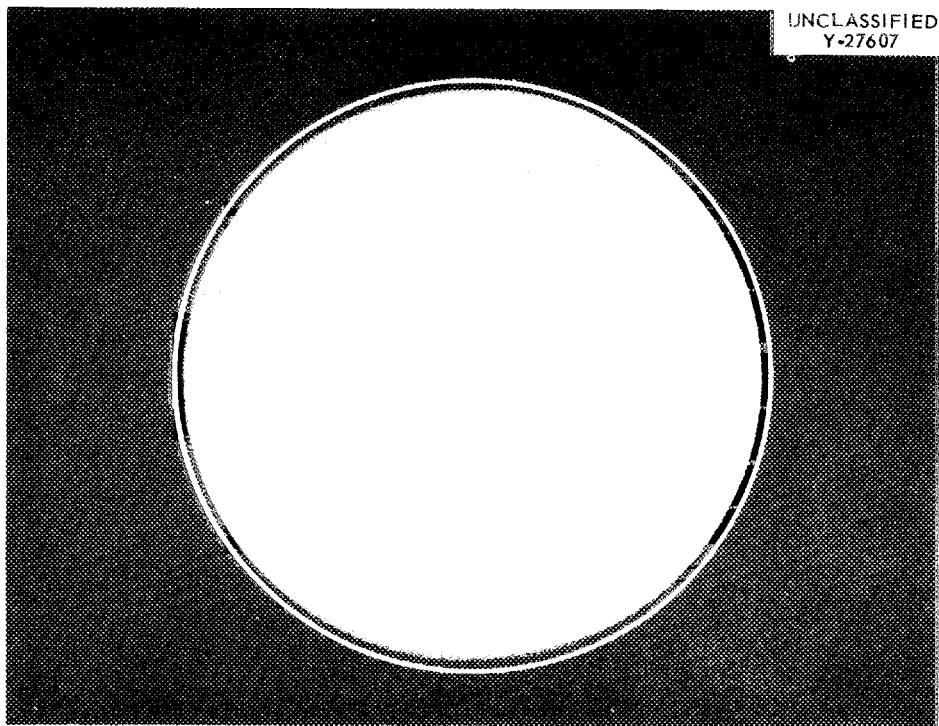
Fig. 78A. Cross Section from Interface Region Sample from Hymu 80 Corrosion Specimen (Runs L-5-L-9:8). Interior circumference of white circle indicates original size. As-polished. 5X.

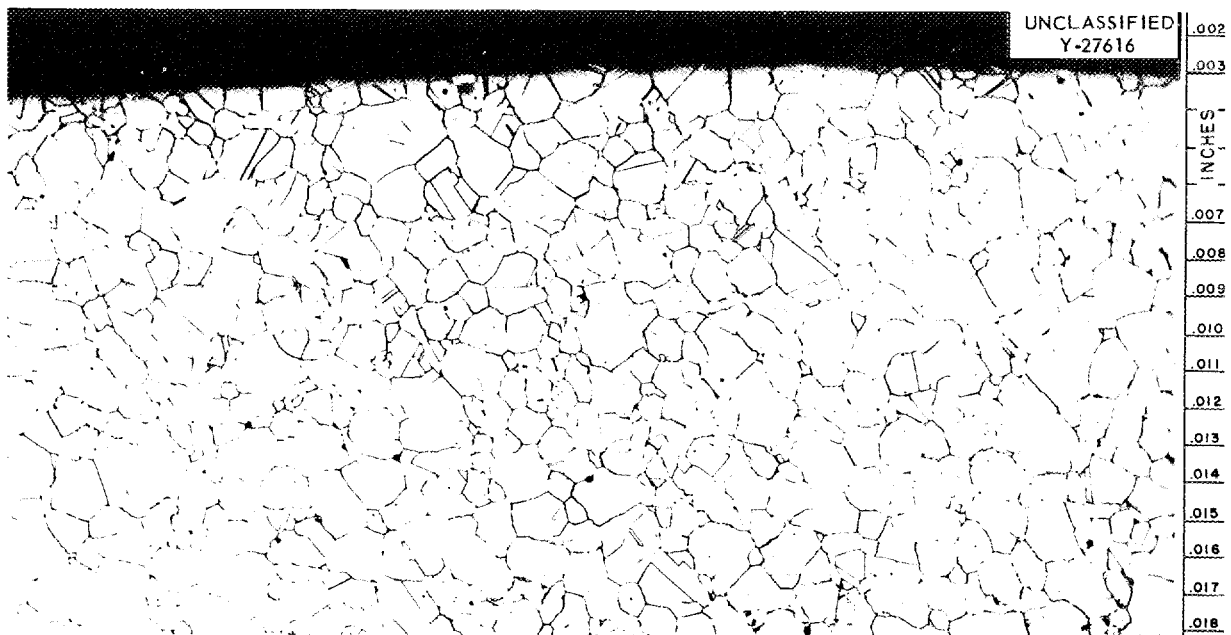
Fig. 78B. Portion of Fig. 78A. Typical Surface and Microstructure. Etchant: Aqua regia. 200X.

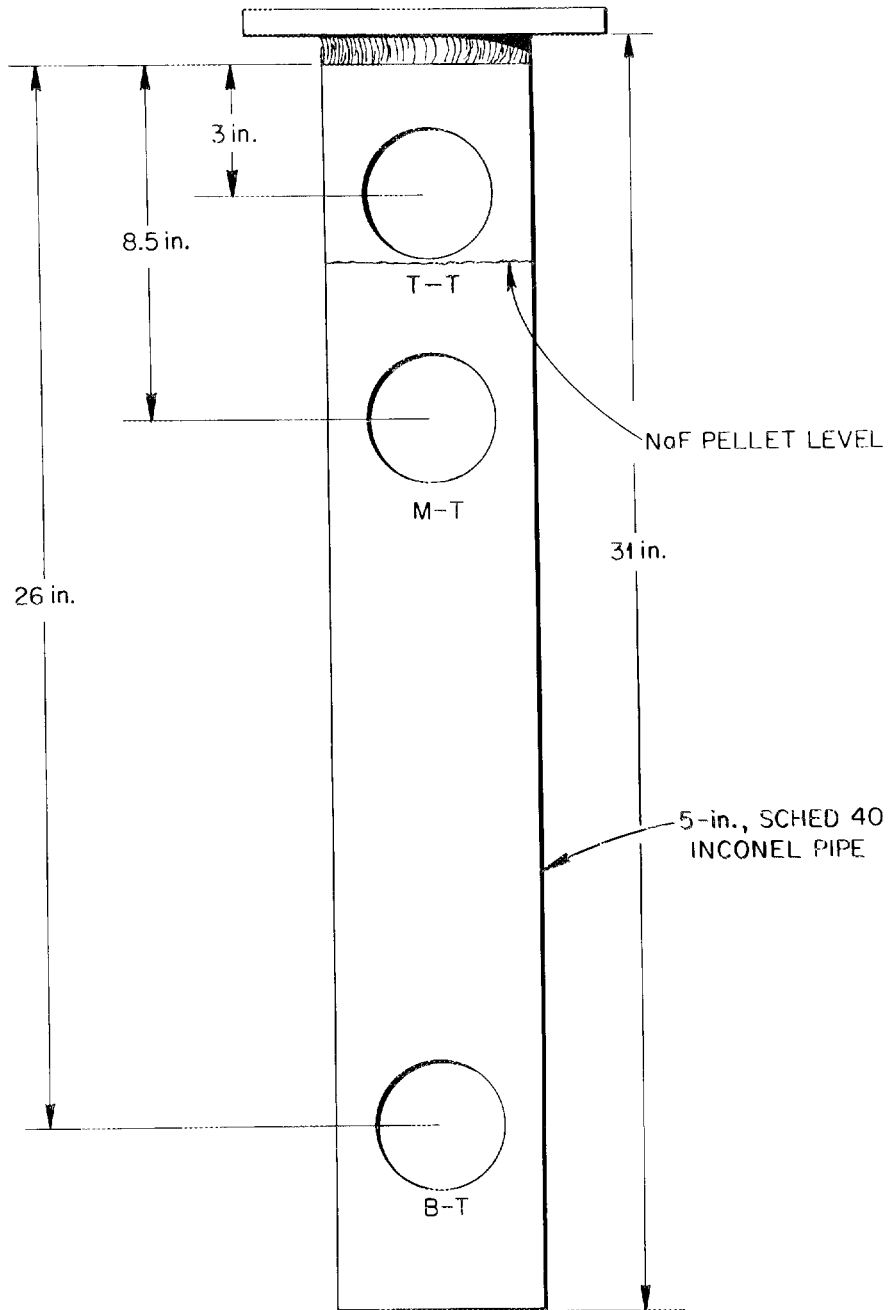
Fig. 80. . Location of Specimens Trepanned from the Inconel CRP Trap.

After the Mark II fluorinator was taken off stream, trepanned sections were removed from the CRP trap and sent to BMI for corrosion analyses. Figure 80 illustrates the sections removed.

Macroscopic examination of the samples at 20X revealed outlining of the Inconel grains and an etched surface with increased attack noted at Section B-T.

Dimensional analyses were performed on the sections as well as a microscopic examination. A summary of the corrosion losses found by BMI personnel is presented in Table XXI. Included in the table is a column converting the maximum total losses to a mils per hour rate based on fluorine exposure time at operating temperature for the vessel. A maximum total corrosion attack rate of 0.46 mils/hr occurred in the lower section of the trap which sustained the higher operating temperatures.

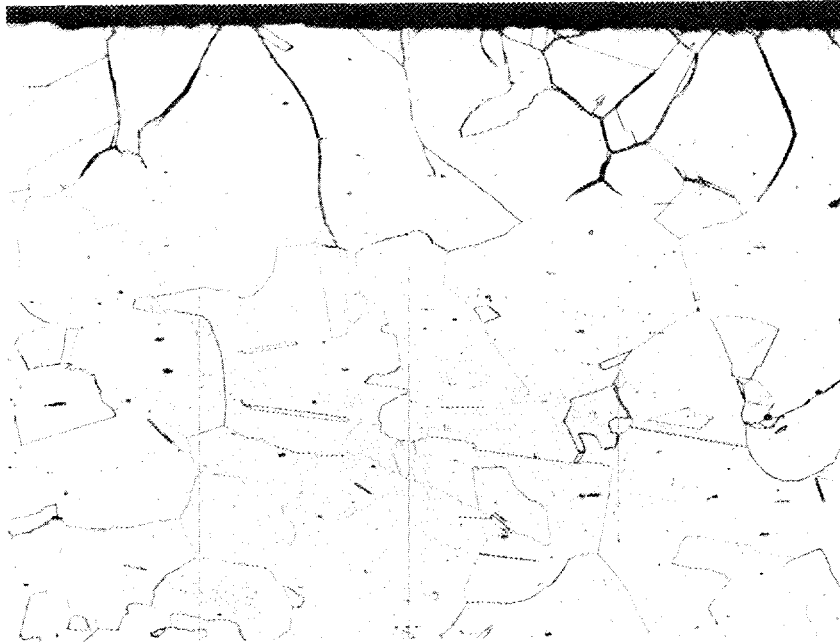
Optical microscopic examination of sections removed from the trap revealed intergranular attack on both the interior and exterior surfaces of the vessel in the lower regions. The upper region showed intergranular attack only on the vessel's interior wall. A typical cross section of the interior wall of the CRP trap is shown in Fig. 81.

Comparison of the corrosive attack on the Inconel CRP trap and the Inconel bench-scale fluorinator described in Section III indicated maximum rate losses for the trap to be approximately twice that for the bench-scale fluorination vessel. The most similar areas with respect to operating environments were the lower vapor region of the fluorinator and the lower region of the CRP trap. At those locations, similar temperatures (approx 500°C) and process gases ( $F_2$ ,  $UF_6$ ) were present. In addition, however, sodium fluoride pellets were in contact with the wall of the CRP trap. The maximum bulk metal losses in the two regions were in a ratio of 3:1 (Trap:Fluorinator) while the maximum interior intergranular penetration ratio was > 5:1. These differences are difficult to reconcile in view of the 2:1 ratio for fluorine contact time at elevated temperatures for the two vessels.

No appropriate reason can be advanced to explain the variations cited in corrosive behavior for the CRP trap and the Inconel bench-scale fluorinator. However, the results present additional evidence that Inconel should be used with caution as the construction material for certain fluoride volatility process components.

Fig. 81. Typical Microstructure of Sample B-T from the Interior Wall of the Inconel CRP Trap Showing Intergranular Attack. Etchant: Hydrochloric-nitric acid. 100X.
