CORROSION ASSOCIATED WITH FLUORINATION  
IN THE OAK RIDGE NATIONAL LABORATORY  
FLUORIDE VOLATILITY PROCESS

A. P. Litman  
A. E. Goldman

METALLURGY DIVISION

JUN - 5 1961

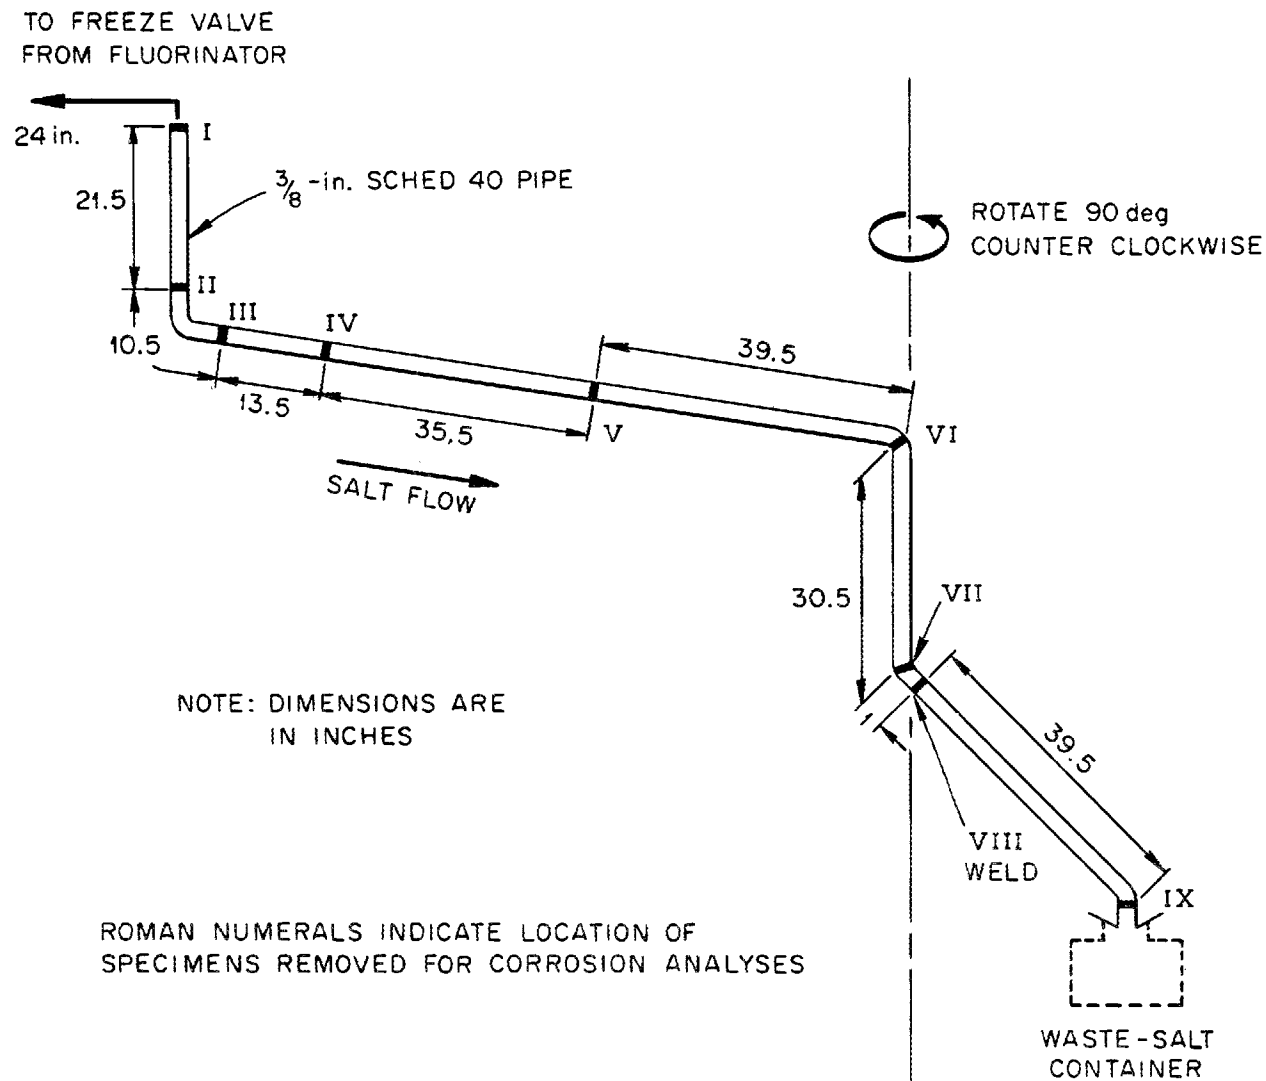
After Run M-64, the piping was removed from the pilot plant, sectioned in nine places and specimens sent to BMI for corrosion analyses. Figure 82 shows a schematic drawing of the waste line and the location of the specimens. Table XXII lists the corrosion data established at BMI by micrometer measurements and metallographic examinations. Maximum wall-thickness losses of 21 mils were found in specimen IX which was at the exit end of the waste-salt line.

Fig. 82. Schematic Drawing of Inconel Waste Salt Line from VPP Fluorinator.  
Roman numerals indicate location of specimens removed from line for corrosion analyses.

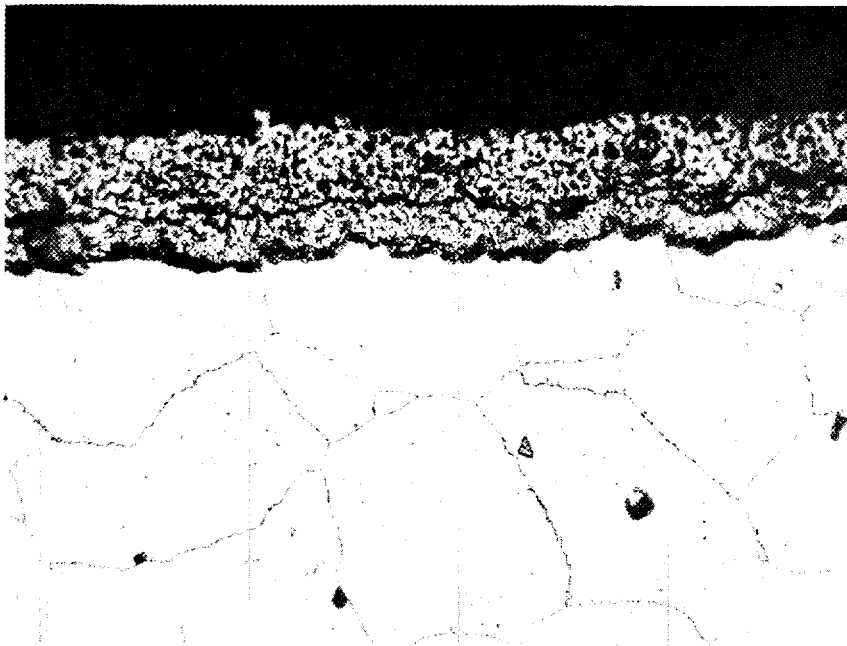
Metallographic examination of the specimens showed slight intergranular attack of 1/2-mil penetration depth had occurred on the interior wall of all the samples with the exception of specimen IX. In the latter, a 3.5-mil thick corrosion product layer was found on the interior surface of the specimen.

Figure 83 shows the corrosion product layer and the subsurface structure. The product layer was spongy in character and similar in appearance to surface layers found on sections removed from early test Inconel freeze valves which had been in contact with NaF, ZrF<sub>4</sub>, UF<sub>4</sub> (50-46-4 mole %) at 650°C. (ref 53)

Personnel at BMI suggested that the product layer might be the result of selective leaching of chromium by the fused salt. They indicated that the appearance was quite similar to layers found on Inconel in contact with hydrogen fluoride and fused fluoride salts where chromium leaching had been proven. Analyses of the metallic spongy deposit found on sections removed from the Inconel freeze valve referenced above indicated considerable losses of chromium

Fig. 83. Microstructure of Sample IX from the Interior Wall of Inconel Waste Salt Showing Corrosion Product Layer.

and iron in the corrosion product layer when compared with the nominal analysis of Inconel, i.e., 0.41% Cr and 0.46% Fe in the product layer.<sup>54</sup>

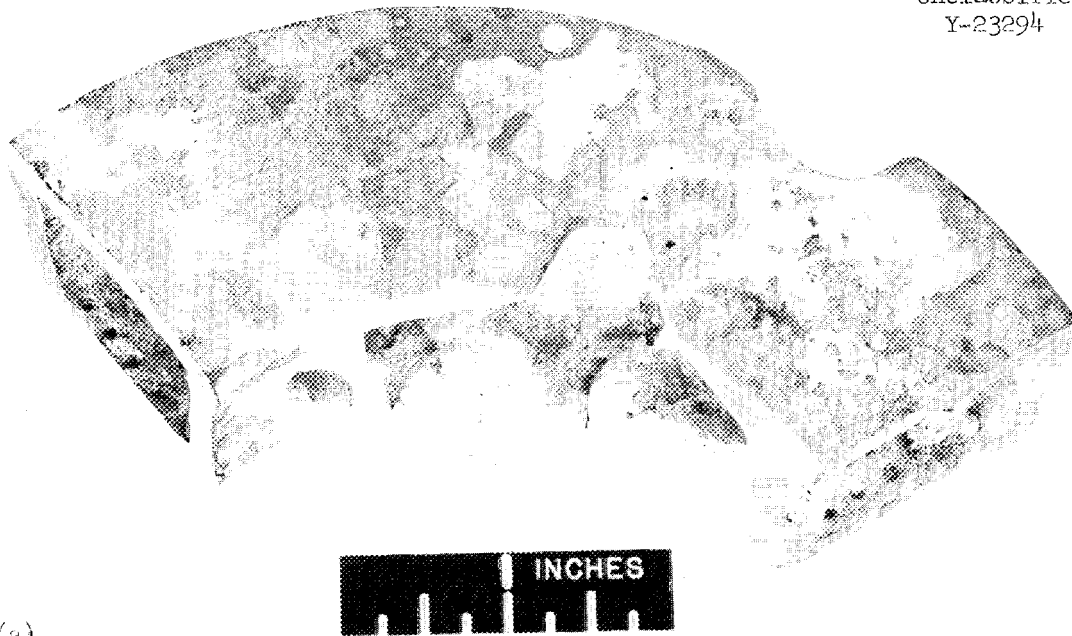
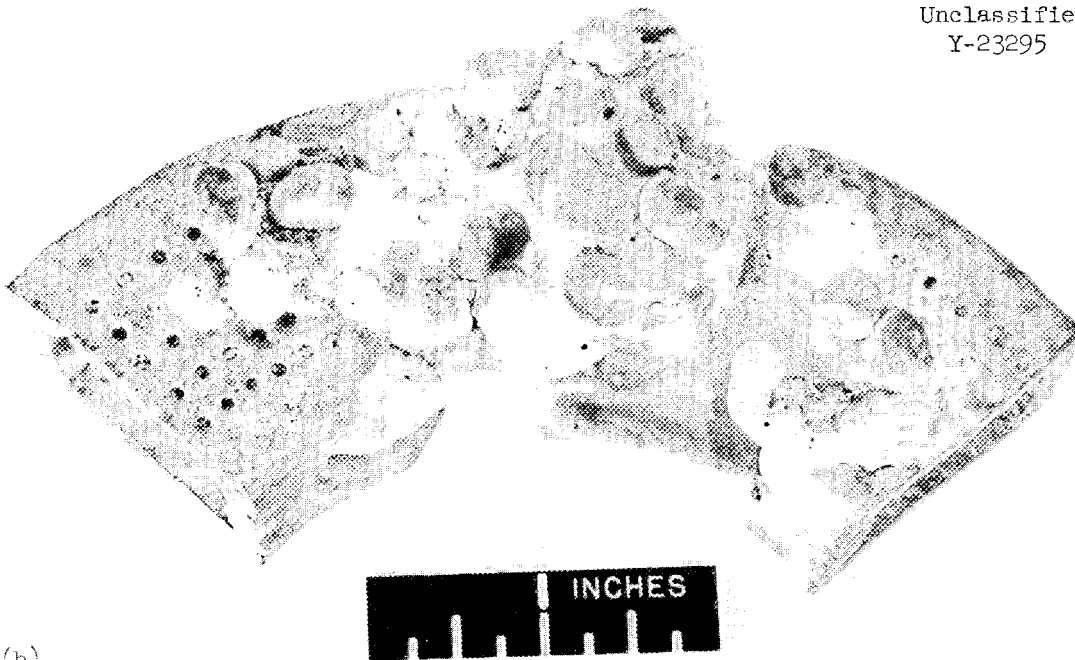
A schematic view of the absorber and the gas-distribution ring is shown in Fig. 84. As shown on the photographs, Fig. 85-a and -b, approx 3 in.<sup>3</sup> of Inconel was melted in an area roughly 180 deg from the junction of the distribution ring and the inlet pipe. The melted area was about 5 in. long and the distribution ring was nearly severed by this action.

The fused salt visible in Fig. 85-b around the metal nodules which were formed as a result of melting was found by analyses to contain 4 wt % Cr as  $\text{CrF}_3$ , 10 wt % Ni as  $\text{NiF}_2$ , and 3 wt % U as  $\text{UF}_4$ . Process chemicals normally

Fig. 85. Photographs of Failed Region from the Inconel Gas-Distribution Ring of Absorber, (a) Top View (b) Bottom View, Showing Molten and Recast Nodules and Adhering Salt.

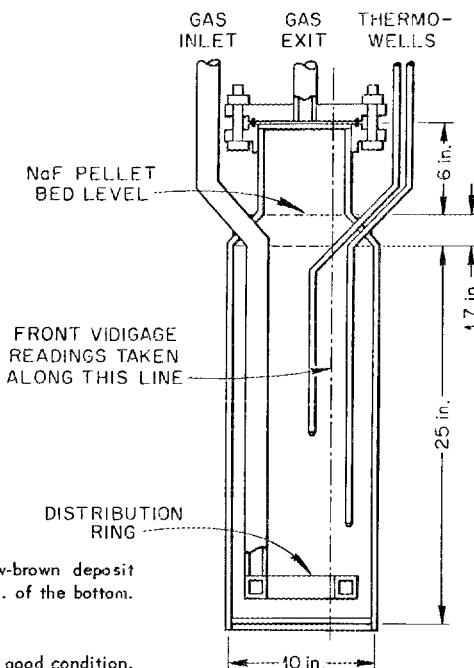
Inspection of Absorbers. Following fluorination Run L-9, the absorbers were visually inspected and thickness measurements taken with a "Vidigage." The ultrasonic device was operated by members of the Nondestructive Testing Group of the Metallurgy Division. Results of those examinations are cited in Figs. 86 and 87. The maximum detectible losses found were approx 30 mils in the upper regions of the vessel, a rate of approx 0.06 mils/hr, based upon fluorine residence time.

Fig. 86. Results of Visual and Vidigage Inspection on VFP First Absorber.

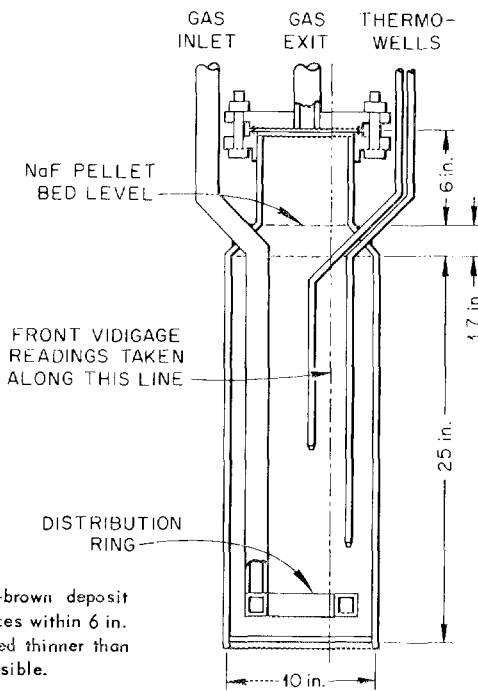
Fig. 87. Results of Visual and Vidigage Inspection on VPP Second Absorber.
