POSTIRRADIATION EXAMINATION OF MATERIALS FROM THE MSRE

H. E. McCoy
B. McNabb

METALS AND CERAMICS DIVISION

DECEMBER 1972

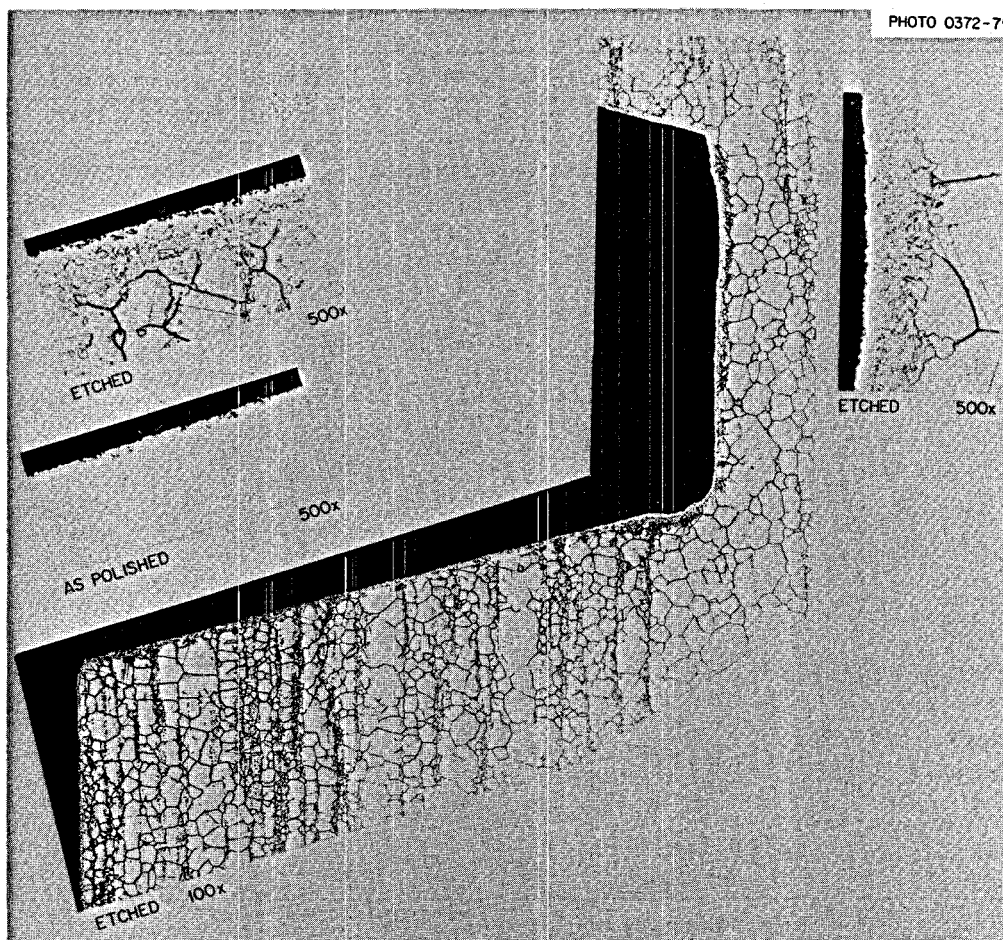
A cross section of the INOR-8 lifting stud in contact with the graphite is shown in Fig. 9. There appears to be little if any reaction with the graphite. There is a surface modified layer about 1 or 2 mils deep similar to that observed on surveillance samples and attributed to cold working of the surface and subsequent heat treatment during service. There appears to be very little difference in the side of the thread in contact with the graphite and the root of the thread, which probably was not in intimate contact.

Fig. 9. INOR-8 thread that was in contact with graphite for about three years at 650°C . The modified layer is likely due to working effects from machining the thread. Reduced 35%.

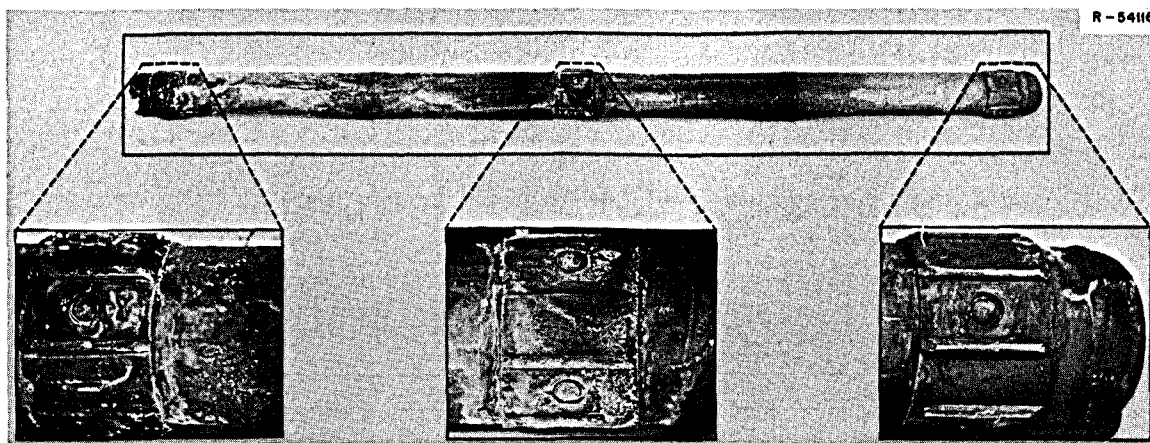
Fig. 12. Portion of control rod thimble examined after operation of MSRE was terminated. The thimble is made of 2-in.-OD \times 0.065-in.-wall INOR-8 tubing (heat Y-8487). The electric arc cut on the left was near the center line of the core.

the variations in light and dark areas are due to uneven lighting for the several photographs that make up Fig. 12.

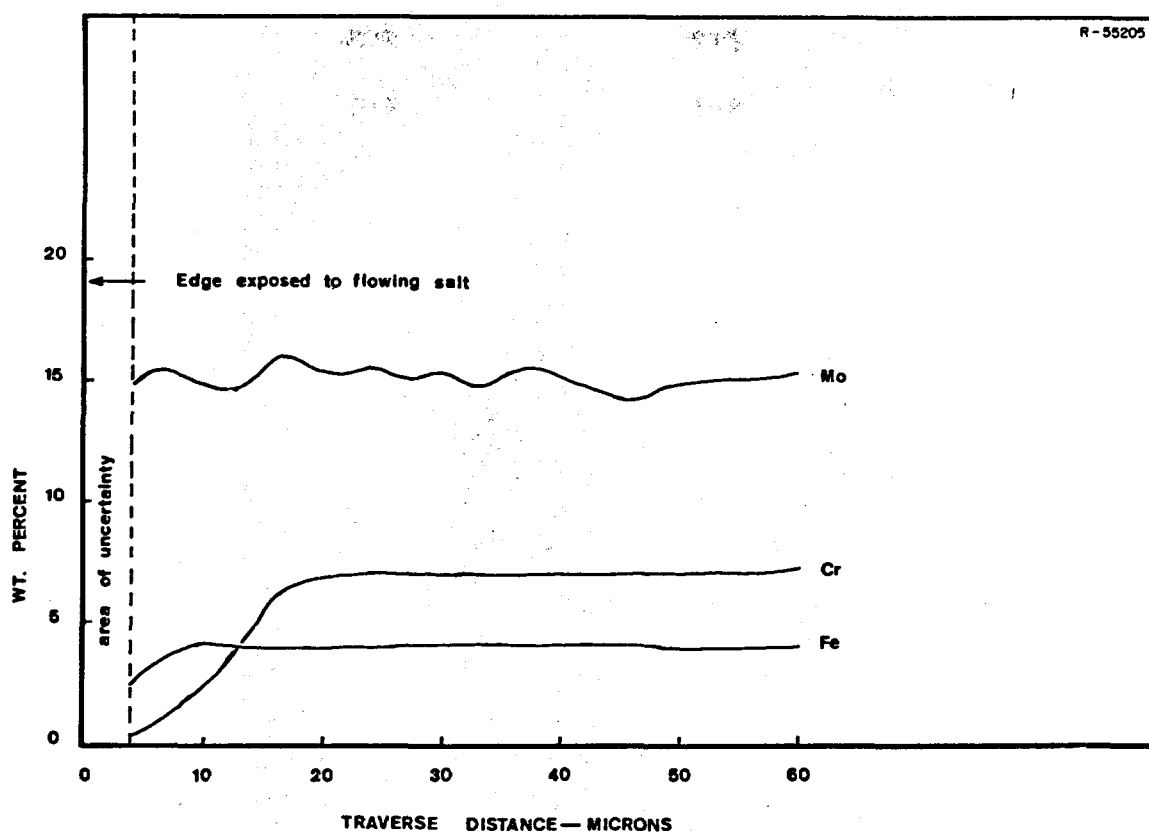
Microprobe scans were run on the thimble samples that were taken from under the sleeve and outside the sleeve. In the first case the thimble wall was exposed to almost static fuel salt, and no gradients in iron and chromium concentration could be detected within the 3- μ m region of uncertainty near the surface. The sample outside the sleeve, which was exposed to flowing fuel salt, was depleted in chromium to a depth of almost 20 μ m and in iron to a depth of 10 μ m (Fig. 18). Thus the amount of corrosion that occurred varied considerably in the two regions. Measurements were not actually made, but we would expect similar results for the spacer sleeve. The inside surface was exposed to almost static salt and was likely not corroded detectably. The outside surface was exposed to flowing salt and probably was depleted in iron and chromium.

Fig. 18. Electron microprobe scan of INOR-8 sample from control rod thimble. Thimble had been exposed to fuel salt for 21,040 hr and had been above 500°C for 30,807 hr.

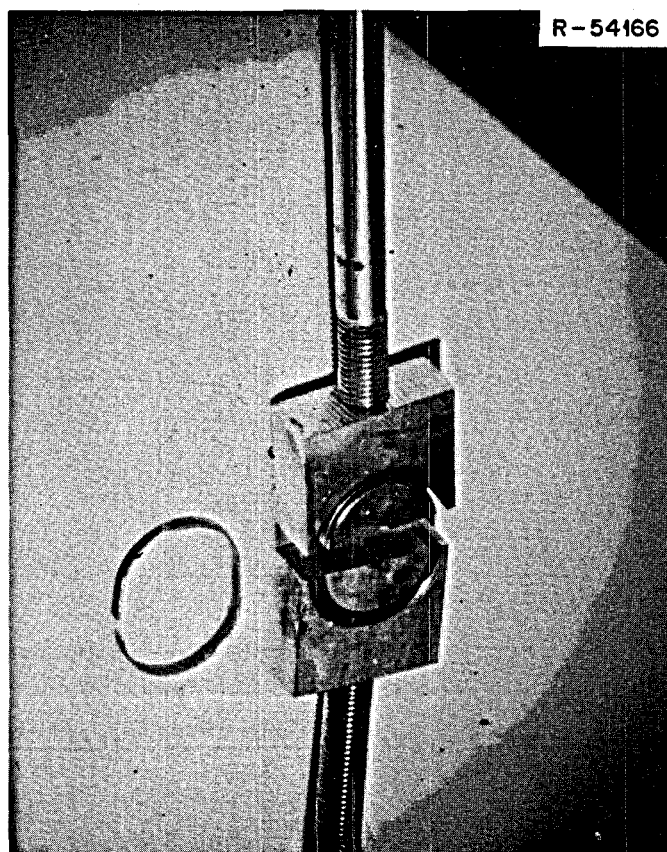
Fig. 19. Fixture for testing rings of control rod thimble and spacer sleeve. A tested sample is shown on the left.

However, the side exposed to the salt exhibited profuse intergranular cracking. Almost every grain boundary cracked, and the cracks generally propagated to a depth of one grain, although there are several instances where the crack depth exceeded a depth of one grain. Several photomicrographs were combined and rephotographed to obtain Fig. 21. This sample had 192 cracks per inch, with average and maximum depths of 5.0 and 8.0 mils respectively. Many of the cracks shown in Figs. 20 and 21 have blunt tips, indicating that they did not propagate into the metal as the specimen was strained.

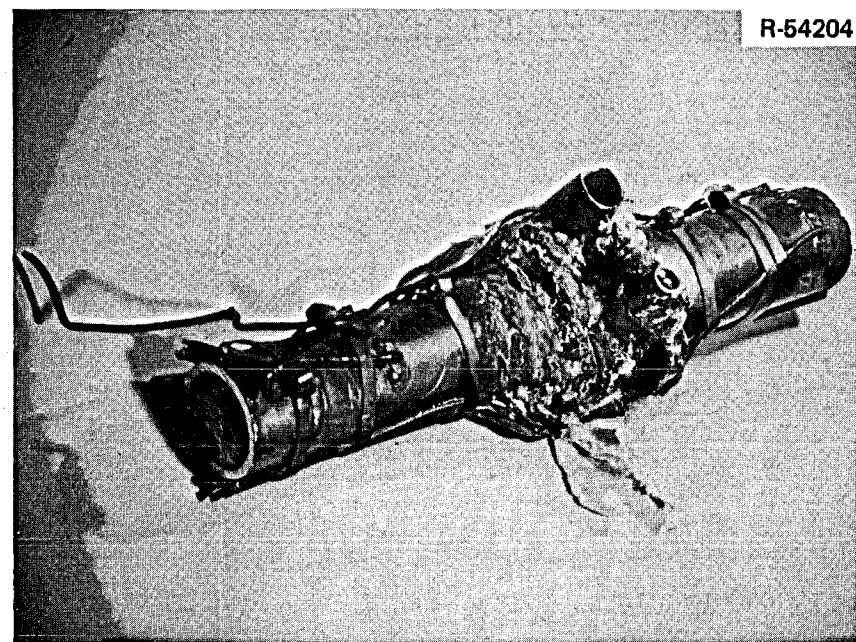
The salt was partially removed to reveal the crack shown in Figs. 30 through 32. The crack begins at the spot on the weld and proceeds about 1 in. parallel to the weld.

Fig. 30. Bottom portion of freeze valve 105.

Parts of three tubes are visible in Figs. 30 and 31. The large tube in relatively good condition is the type 304 stainless steel air inlet tube, the center tube is the original INOR-8 air outlet tube with two thermocouples visible, and the hole is the remains of the type 304 stainless steel outlet tube. The original INOR-8 air inlet line was capped off and is hidden by the salt. Attack of the type 304 stainless steel by salt when air was present is as expected. The relative nobility of INOR-8 in this environment is a strong argument for the use of INOR-8 where salt may be present.

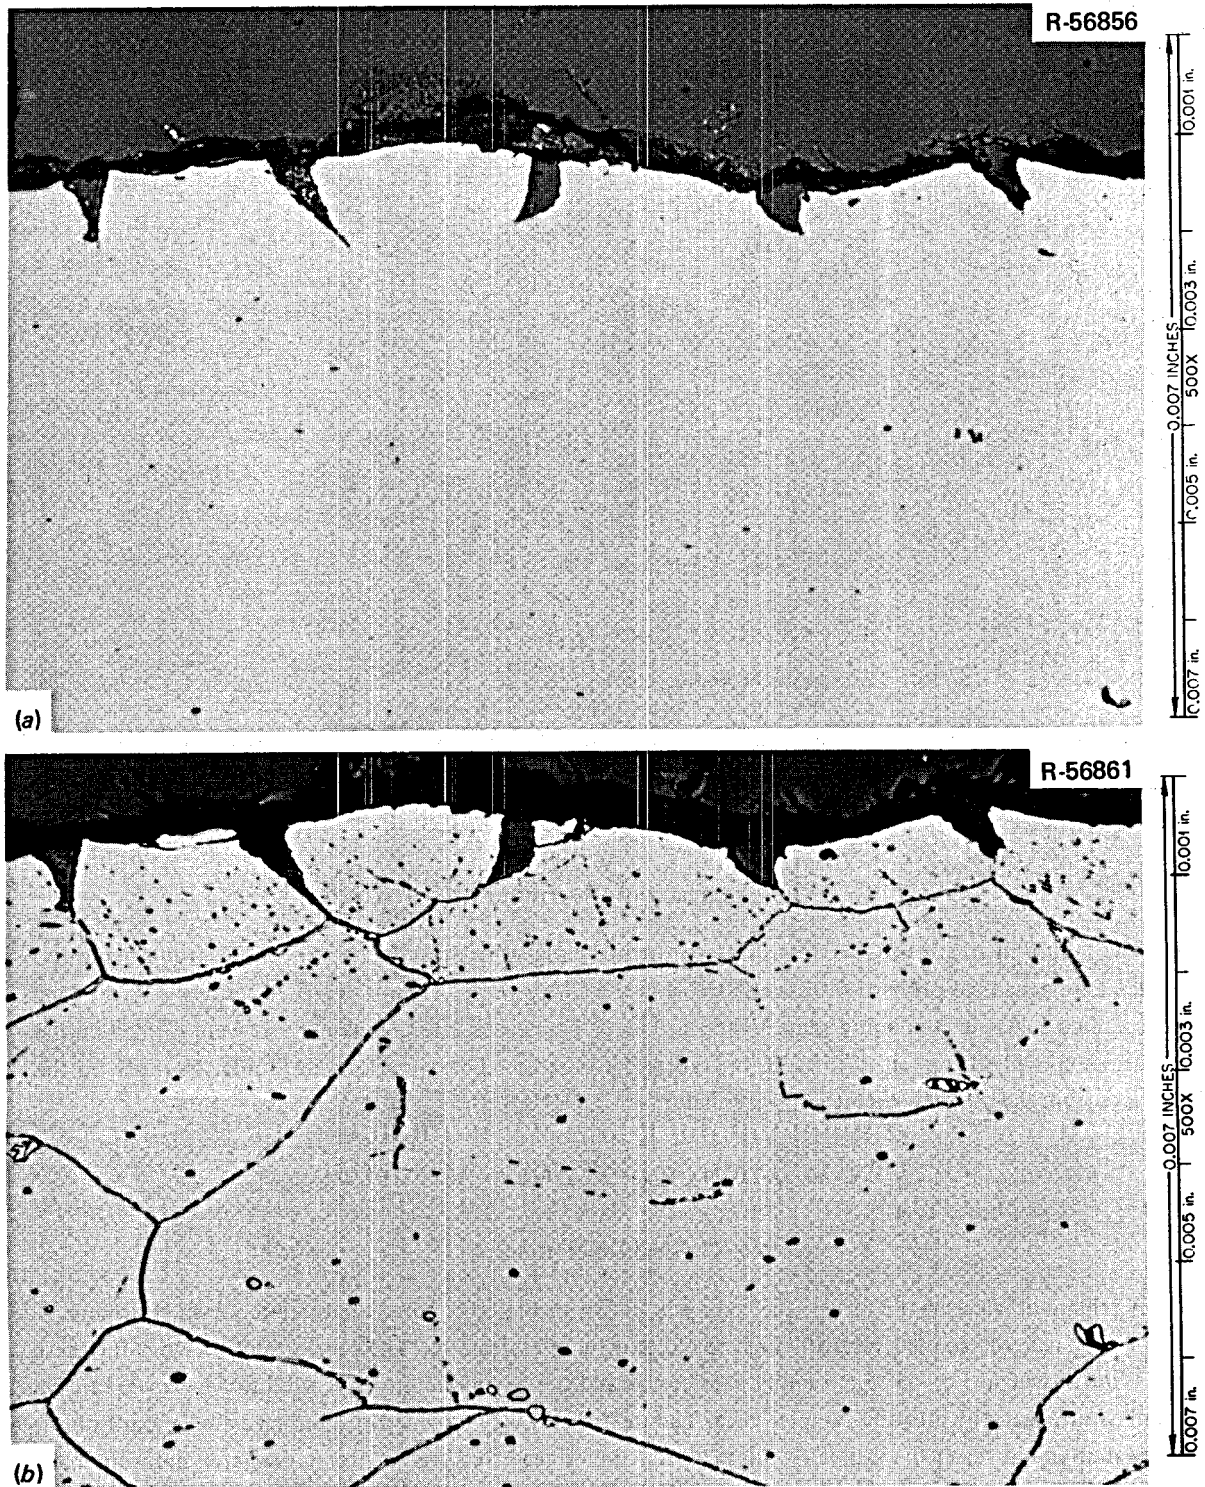
Fig. 38. Salt side of an INOR-8 tensile specimen from freeze valve 105. (a) As polished; (b) etched with lactic acid, HNO_3 , HCl .

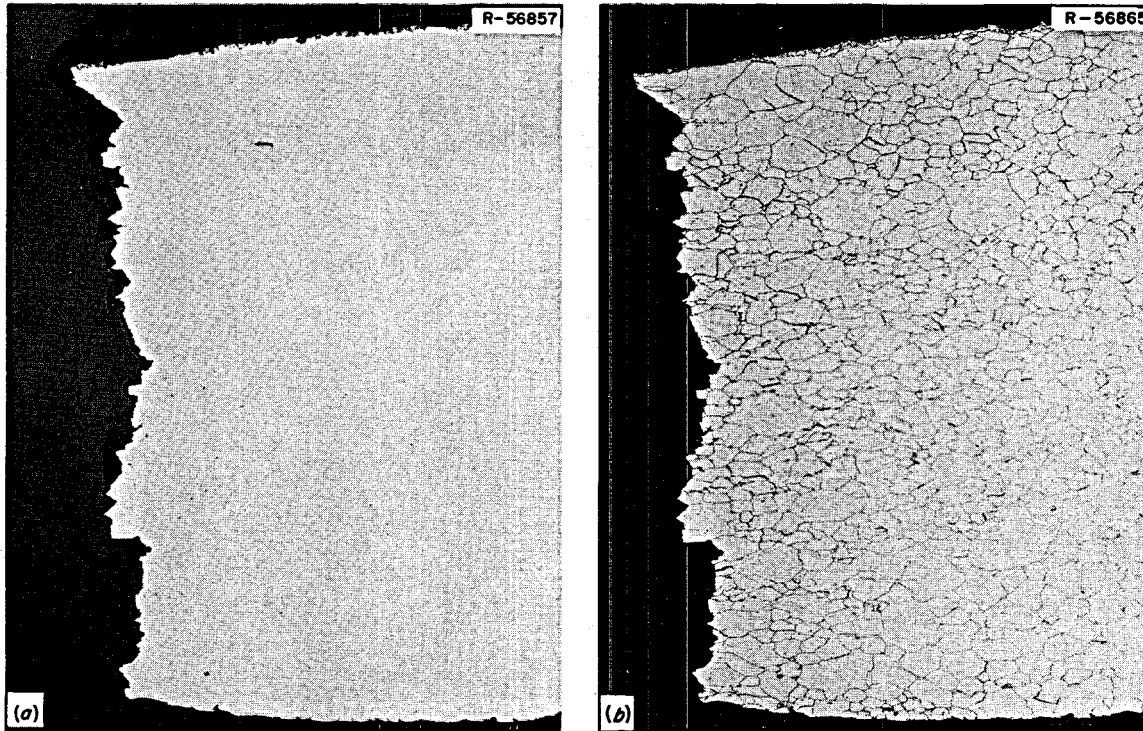
Fig. 39. Fracture of an INOR-8 ring specimen from freeze valve 105 that was deformed at 25°C. (a) As polished; (b) etched with lactic acid, HNO₃, HCl. 40X. Reduced 29.5%.

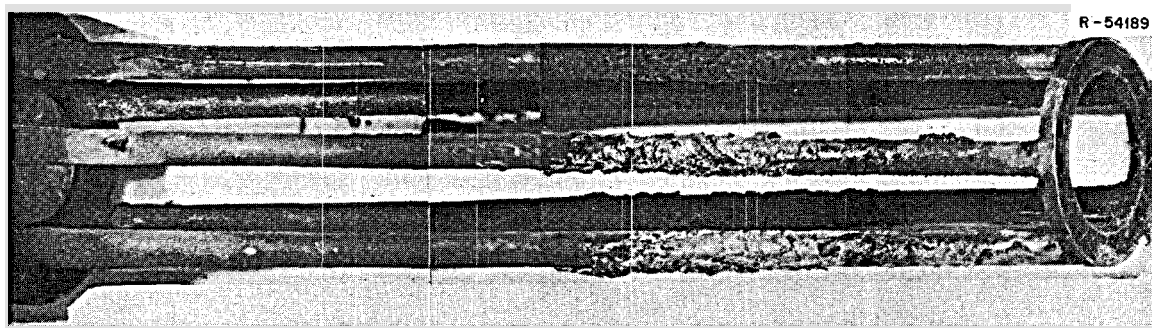
Fig. 42. Sampler cage. The assembly is 8.5 in. high. The salt-vapor interface corresponds with the region of highest material deposition.

The general appearance of the sampler cage is shown in Fig. 42. The salt normally stayed at a level near the center of the cage, but the level fluctuated slightly. The amount of material deposited on the surface is much greater below the liquid interface than above. A gross gamma scan had a similar profile with a maximum near the liquid interface. A carbonaceous deposit was present at the top of the sampler. The mist shield had some deposits, which were heavier below the liquid level and on the outer surface of the shield.

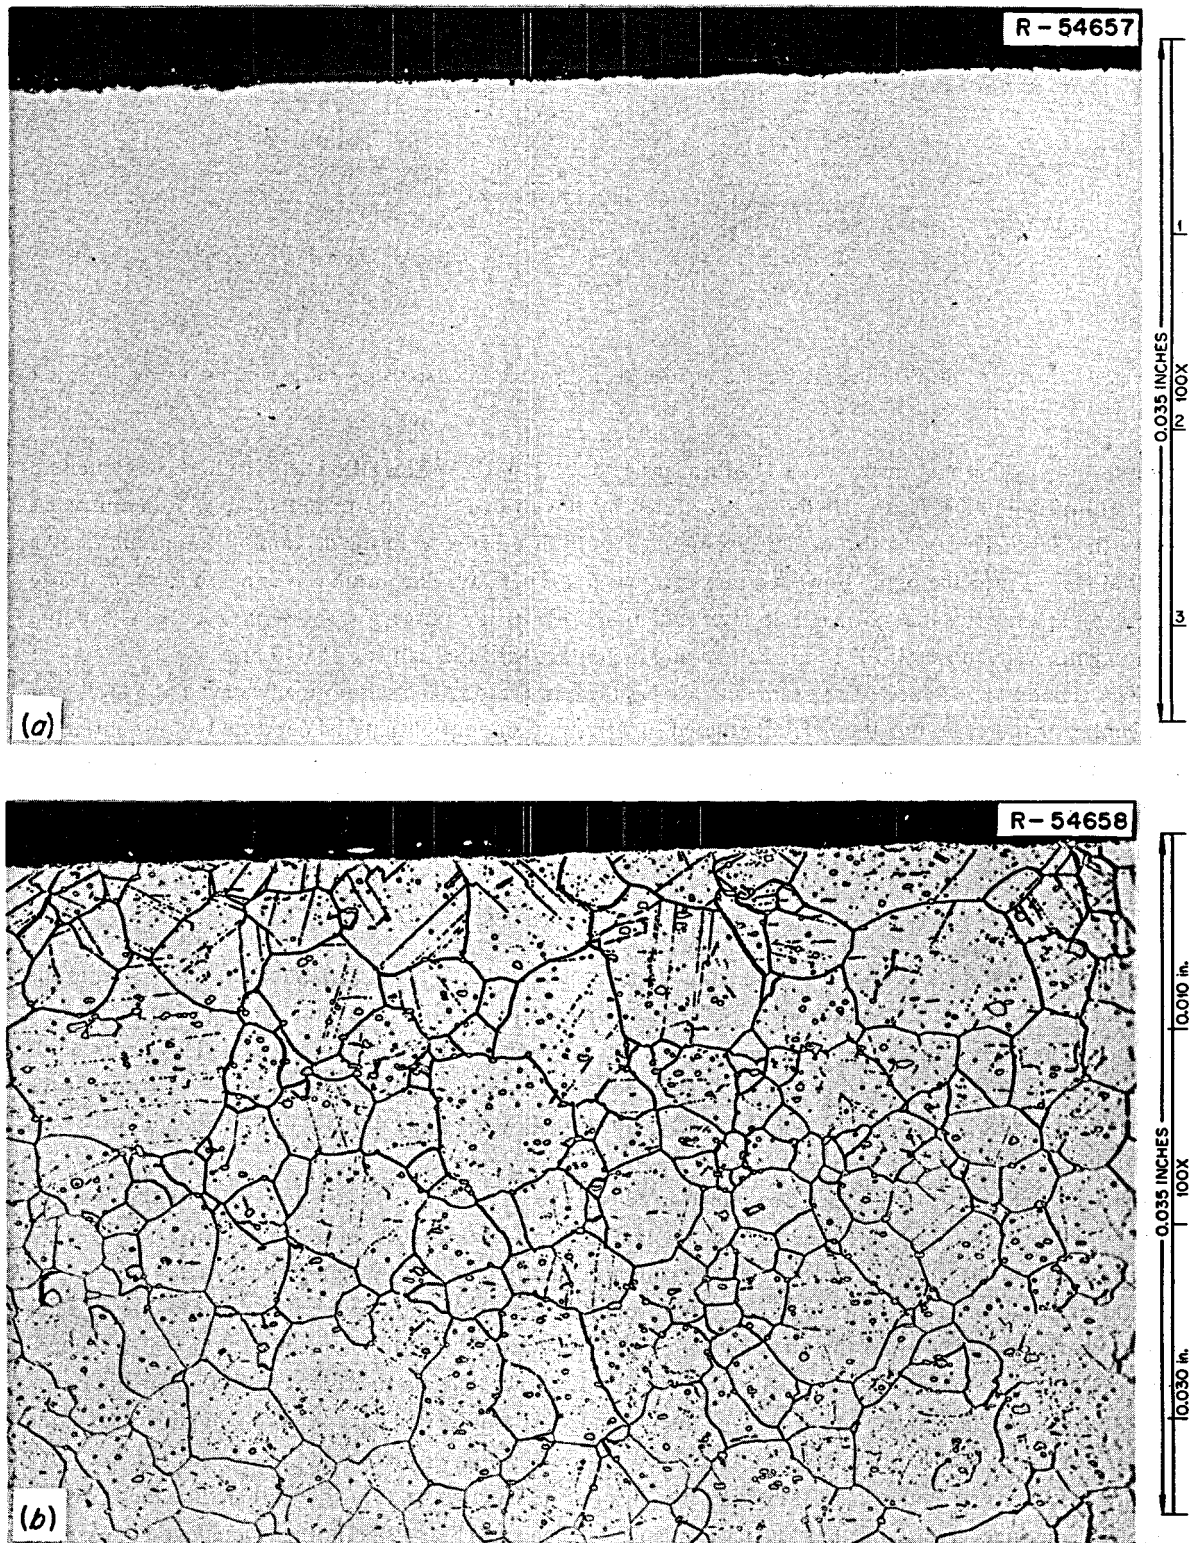
One of the sampler cage rods was examined metallographically. Photomicrographs of samples from the vapor and liquid regions are shown in Figs. 43 and 44 respectively. No intergranular penetration is visible at this magnification. A heavy surface deposit was on the sample from the liquid region. This deposit was examined by the electron microprobe analyzer. It contained some salt but had regions that were high in the elements of INOR-8: Ni, Cr, Fe, and Mo. This is illustrated by the x-ray displays in Figs. 45 and 46, which also show that the deposits were very inhomogeneous.

Fig. 43. INOR-8 rod from sampler assembly located above normal salt level. (a) As polished; (b) etched with aqua regia.

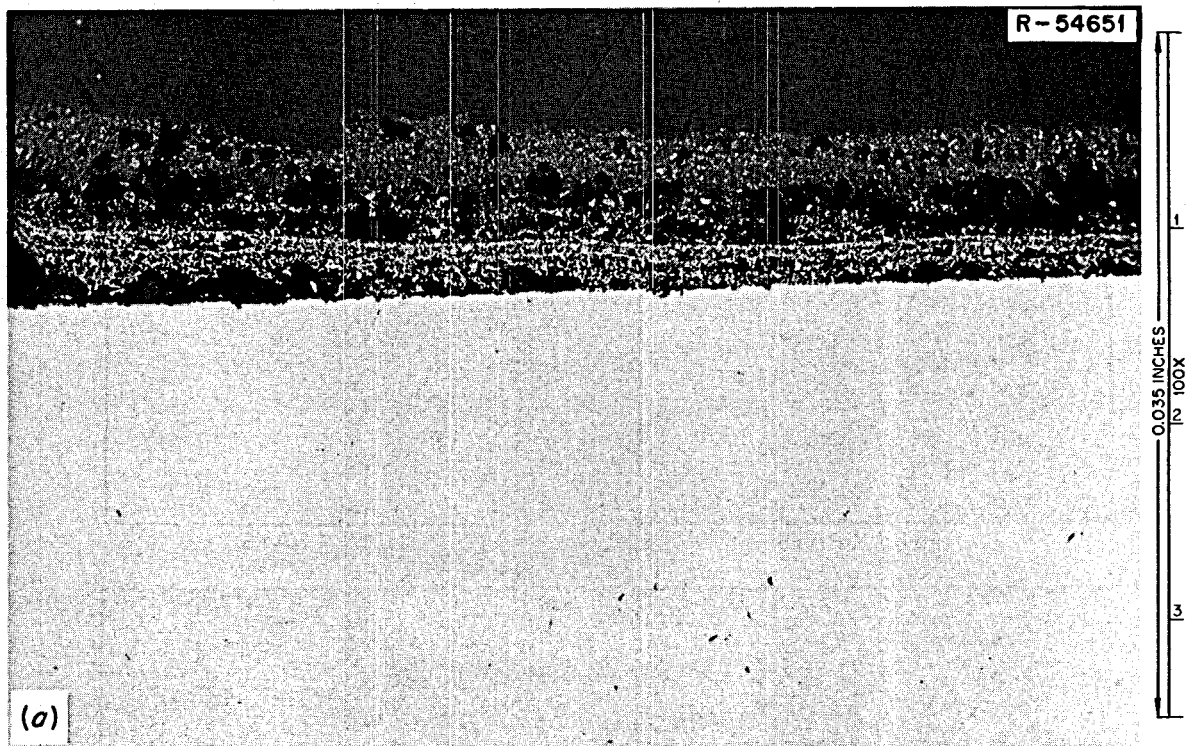
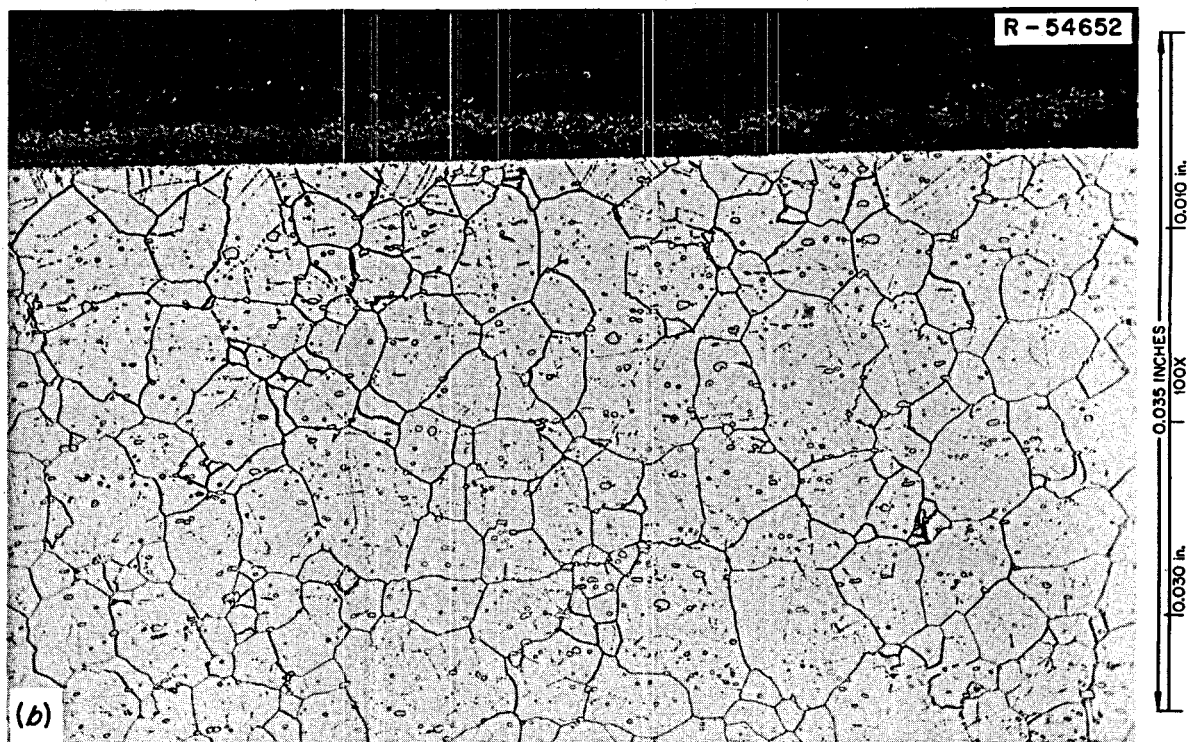
Fig. 44. INOR-8 rod from the sampler assembly. Normally located below the salt level. (a) As polished; (b) etched with aqua regia.

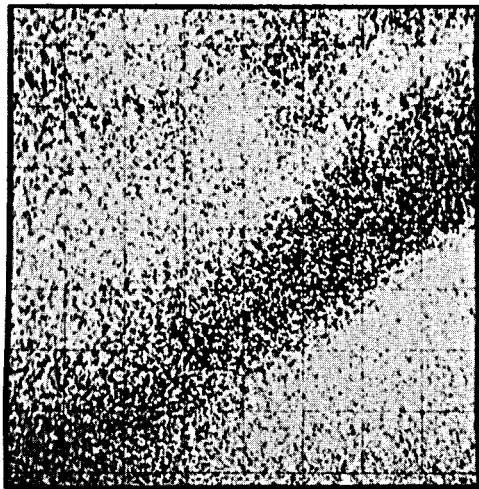
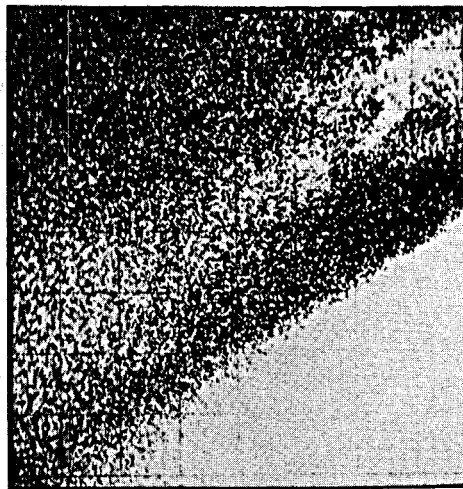
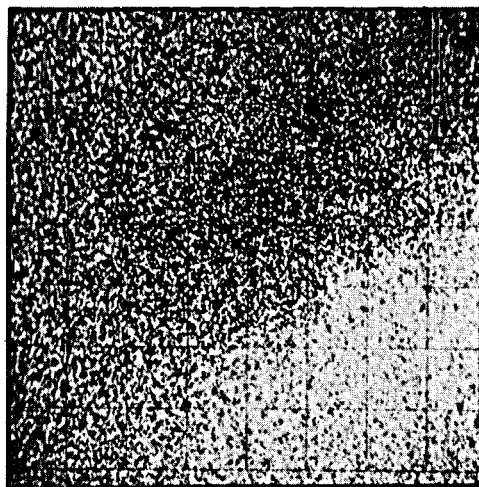
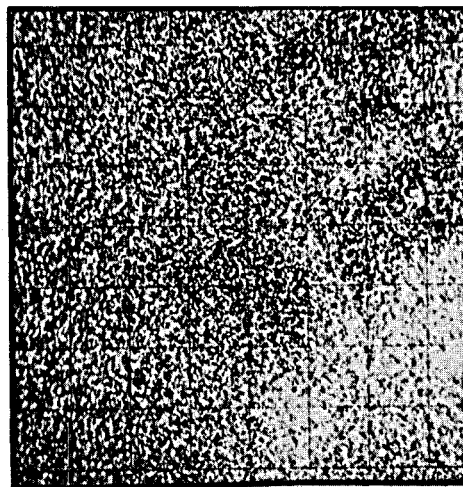
Fig. 45. X-ray displays from the surface deposit on a sampler cage rod immersed in fuel salt in the pump bowl. 400X.

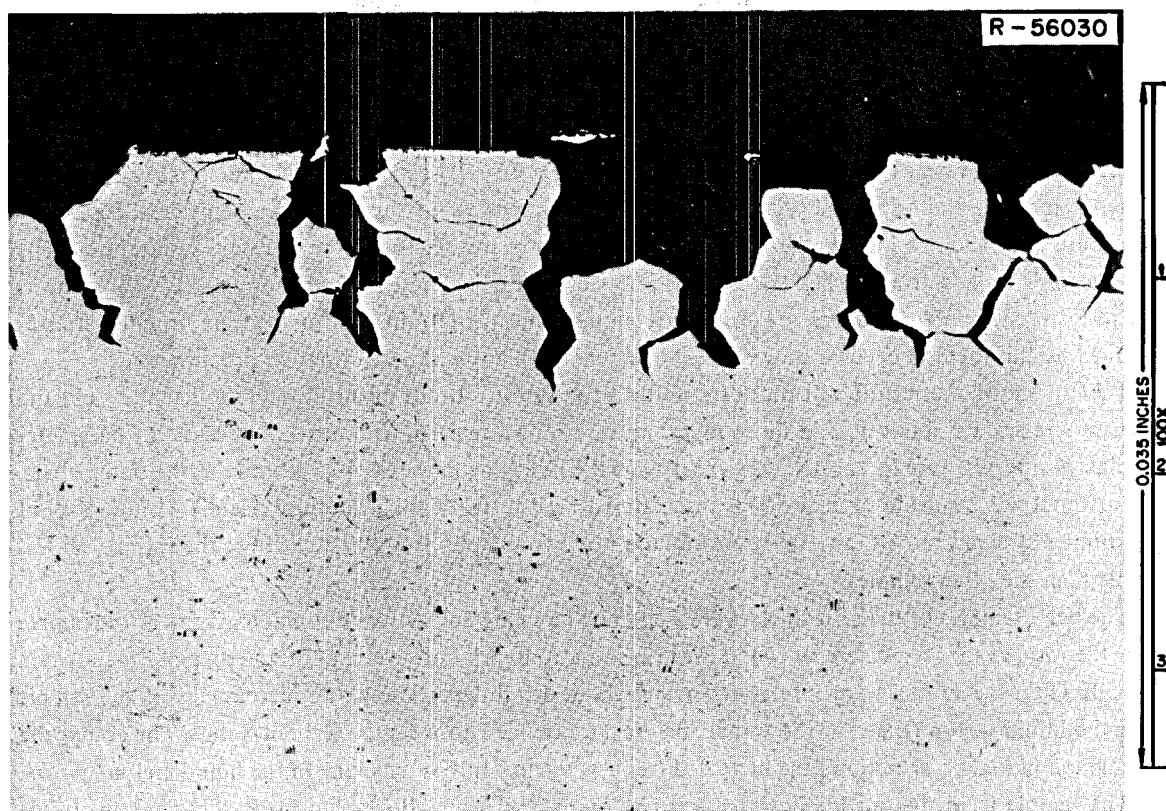
Fig. 49. Deformed INOR-8 sampler cage rod near the fracture. As polished.

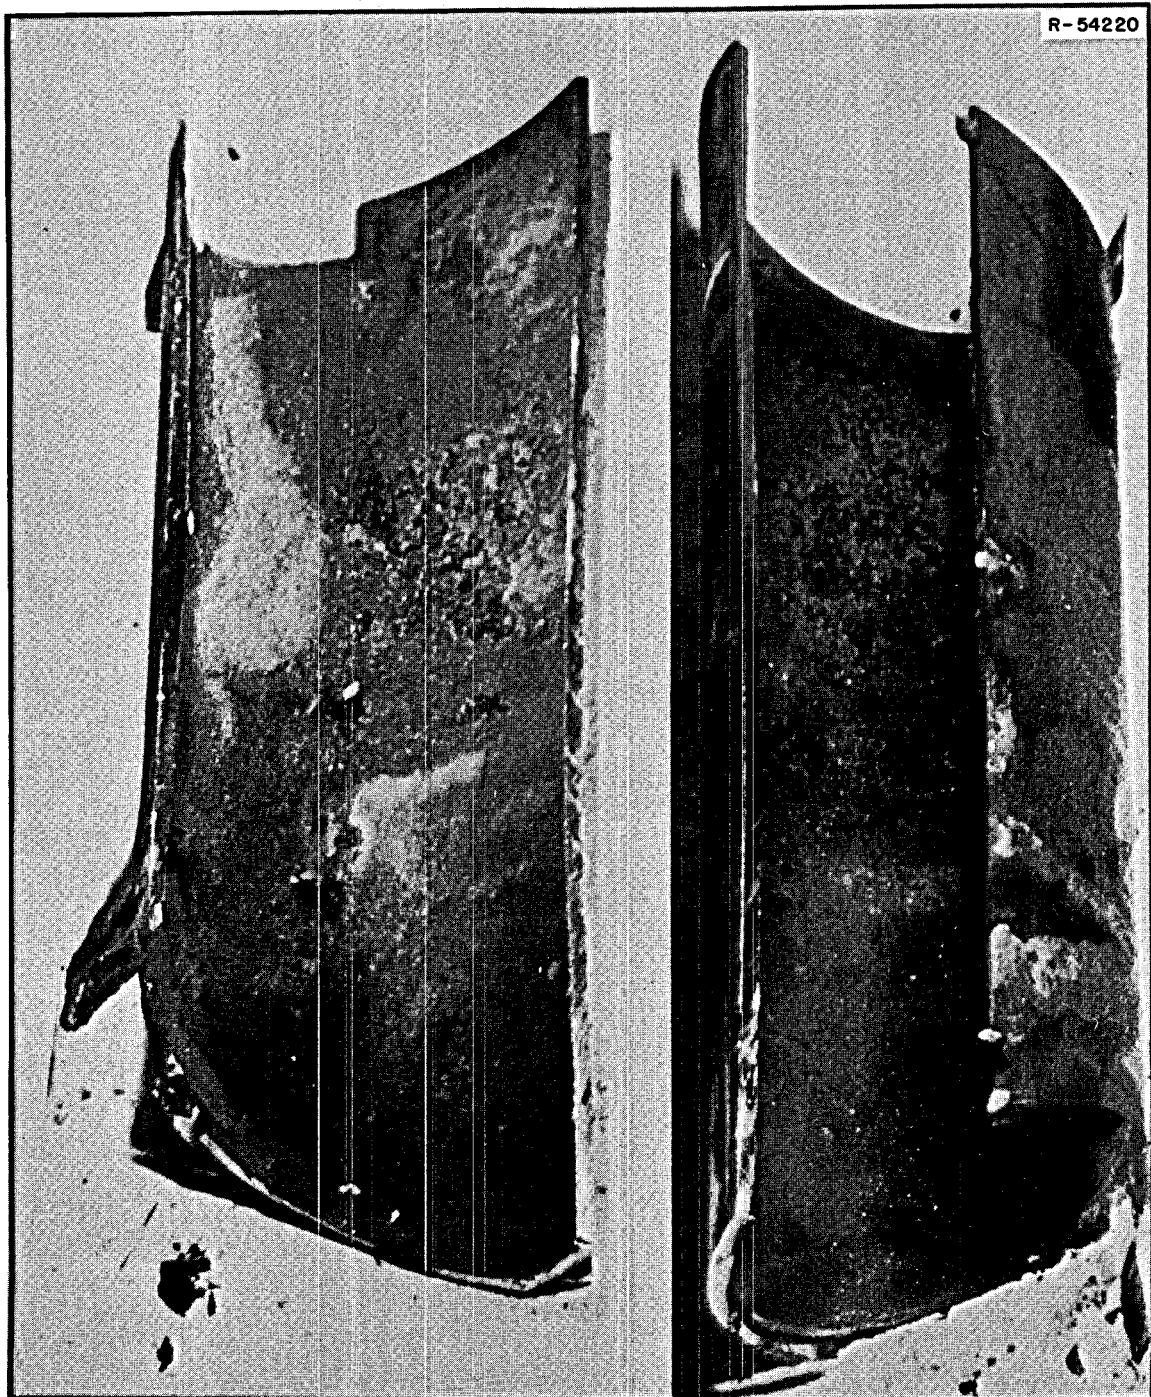
Fig. 51. Interior of INOR-8 mist shield. Right part of right segment overlapped left part of segment on left.

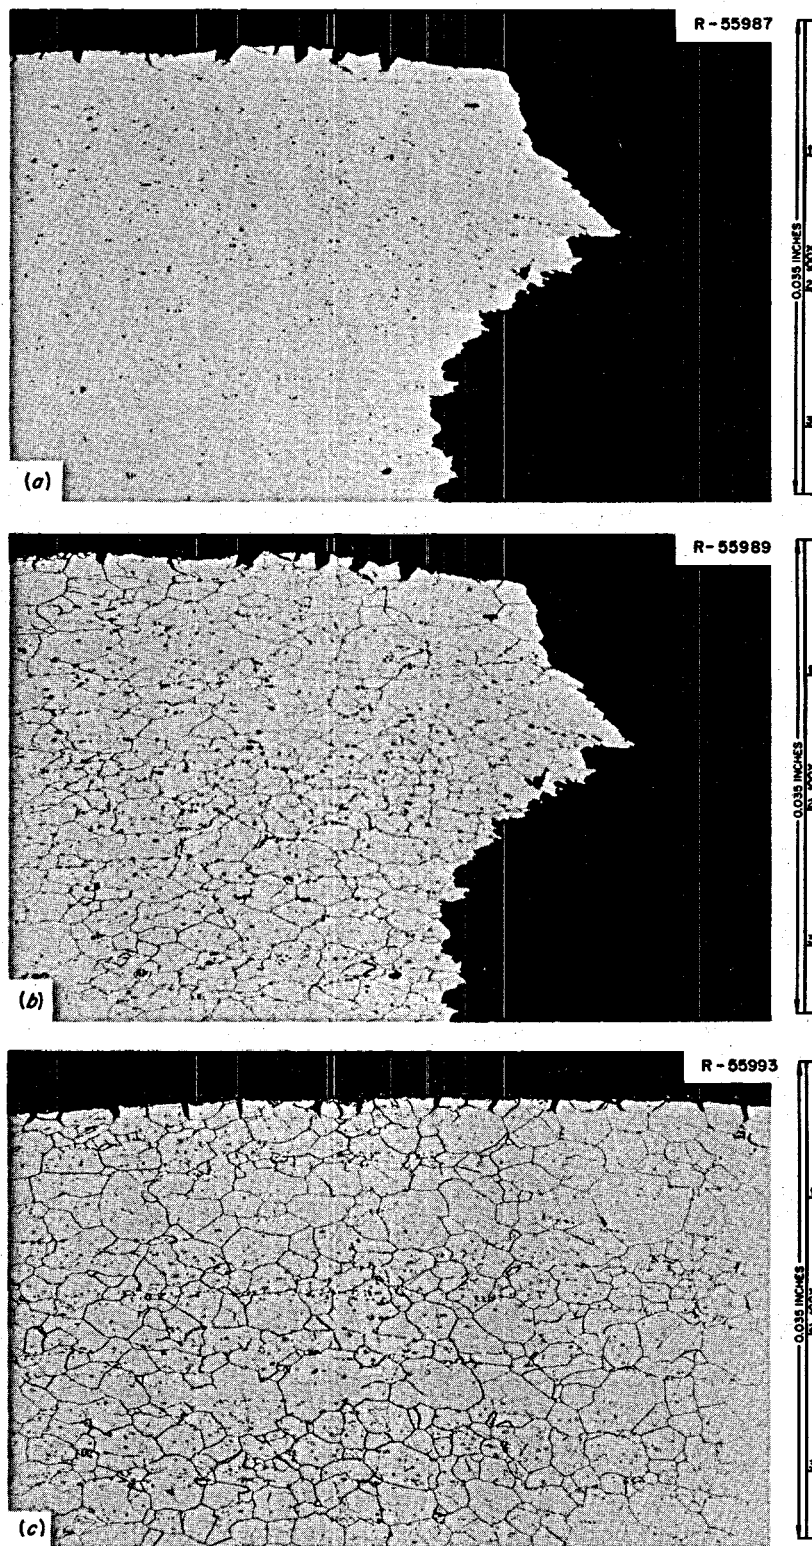
The bend samples of the mist shield were examined metallographically. Photomicrographs of the sample from the inside vapor region are shown in Fig. 52, and a composite of several photomicrographs is shown in Fig. 53. The edge cracks were intergranular and about 1 mil deep. The photomicrographs of the sample from the liquid region (Fig. 54) show that the cracks extended to a depth of about 8 mils. The composite photograph in Fig. 55 also shows the increased frequency and depth of cracking in the liquid region.

Fig. 52. Bend specimen of INOR-8 mist shield from inside vapor region. (a) Fracture and tension side, as polished. (b) Fracture and tension side, etched. (c) Tension side, etched. Etchant: aqua regia. Reduced 31%.

The reduced ductility of these samples remains unexplained. The maximum crack depth in the liquid region was only 8 mils, and it is quite unlikely that an 8-mil reduction in a sample thickness of 125 mils would cause much embrittlement. The embrittlement may have been partially due to the extensive carbide precipitation shown in Figs. 53, 55, 56, 58, and 59. However, the outside and inside of the shield received identical thermal treatments, but the samples from the outside had lower ductilities. Thus, attributing the embrittlement solely to carbide formation does not seem appropriate.

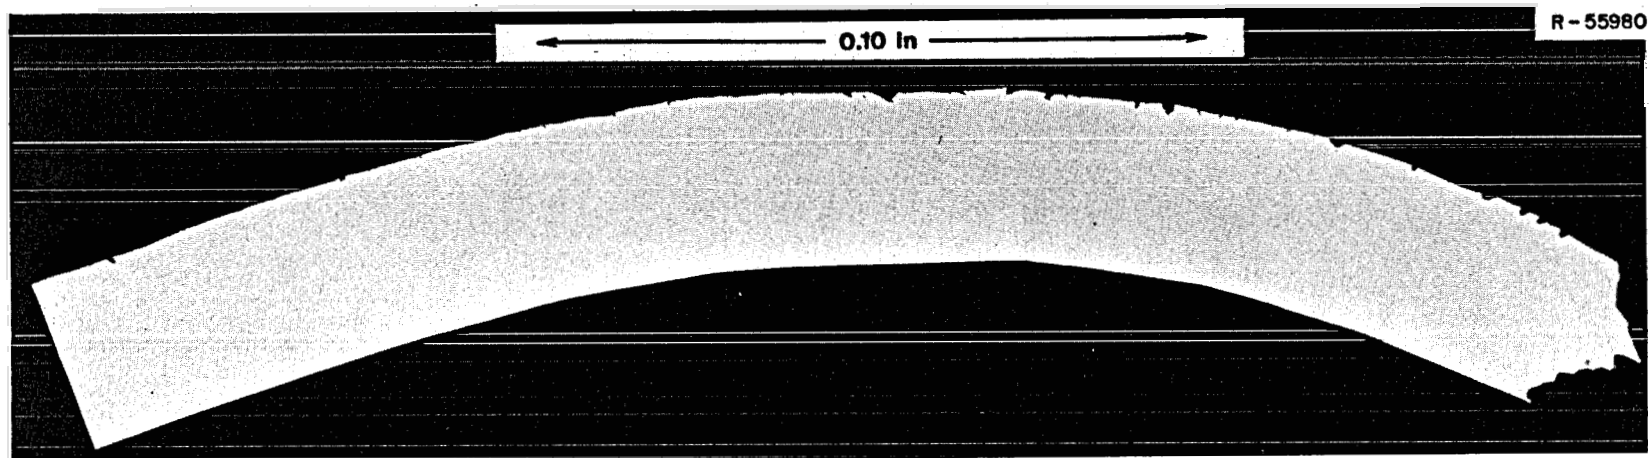
Fig. 53. Composite photograph of tension side of bend sample from inside vapor region of INOR-8 mini shield. Lower edge is not the compression side of the sample.

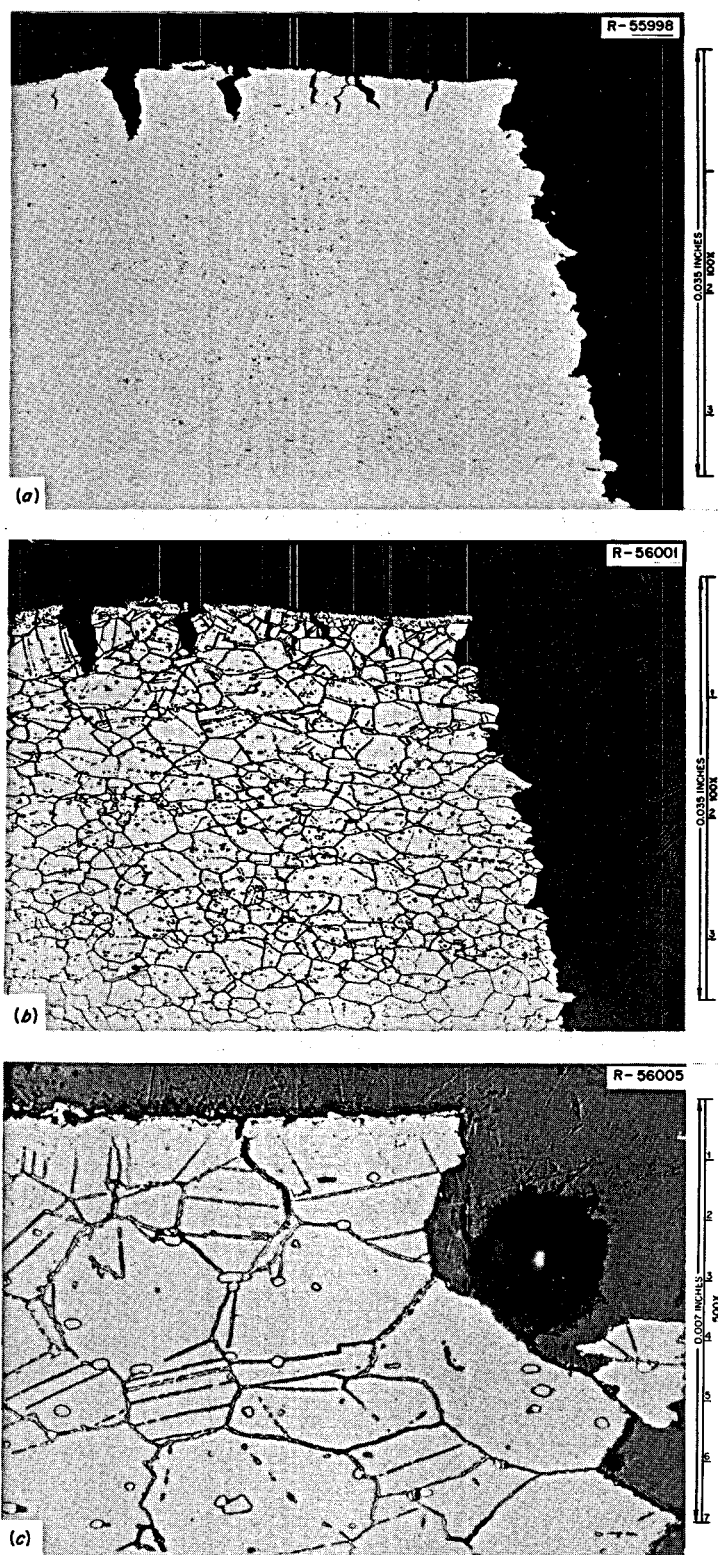
Fig. 54. Bend specimen of INOR-8 mist shield from inside liquid region. Fracture and tension side (a) as polished, (b) and (c) etched with aqua regia.

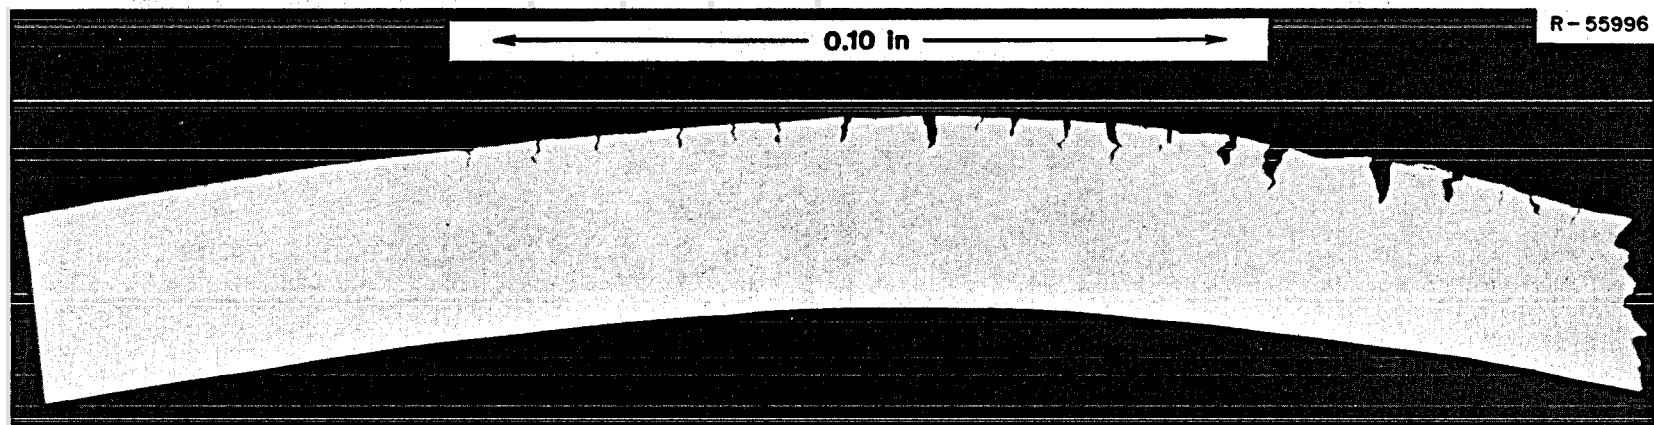
Fig. 55. Composite photograph of tension side of bend sample from inside liquid region of INOR-8 mist shield. Lower edge is not the compression side of sample.

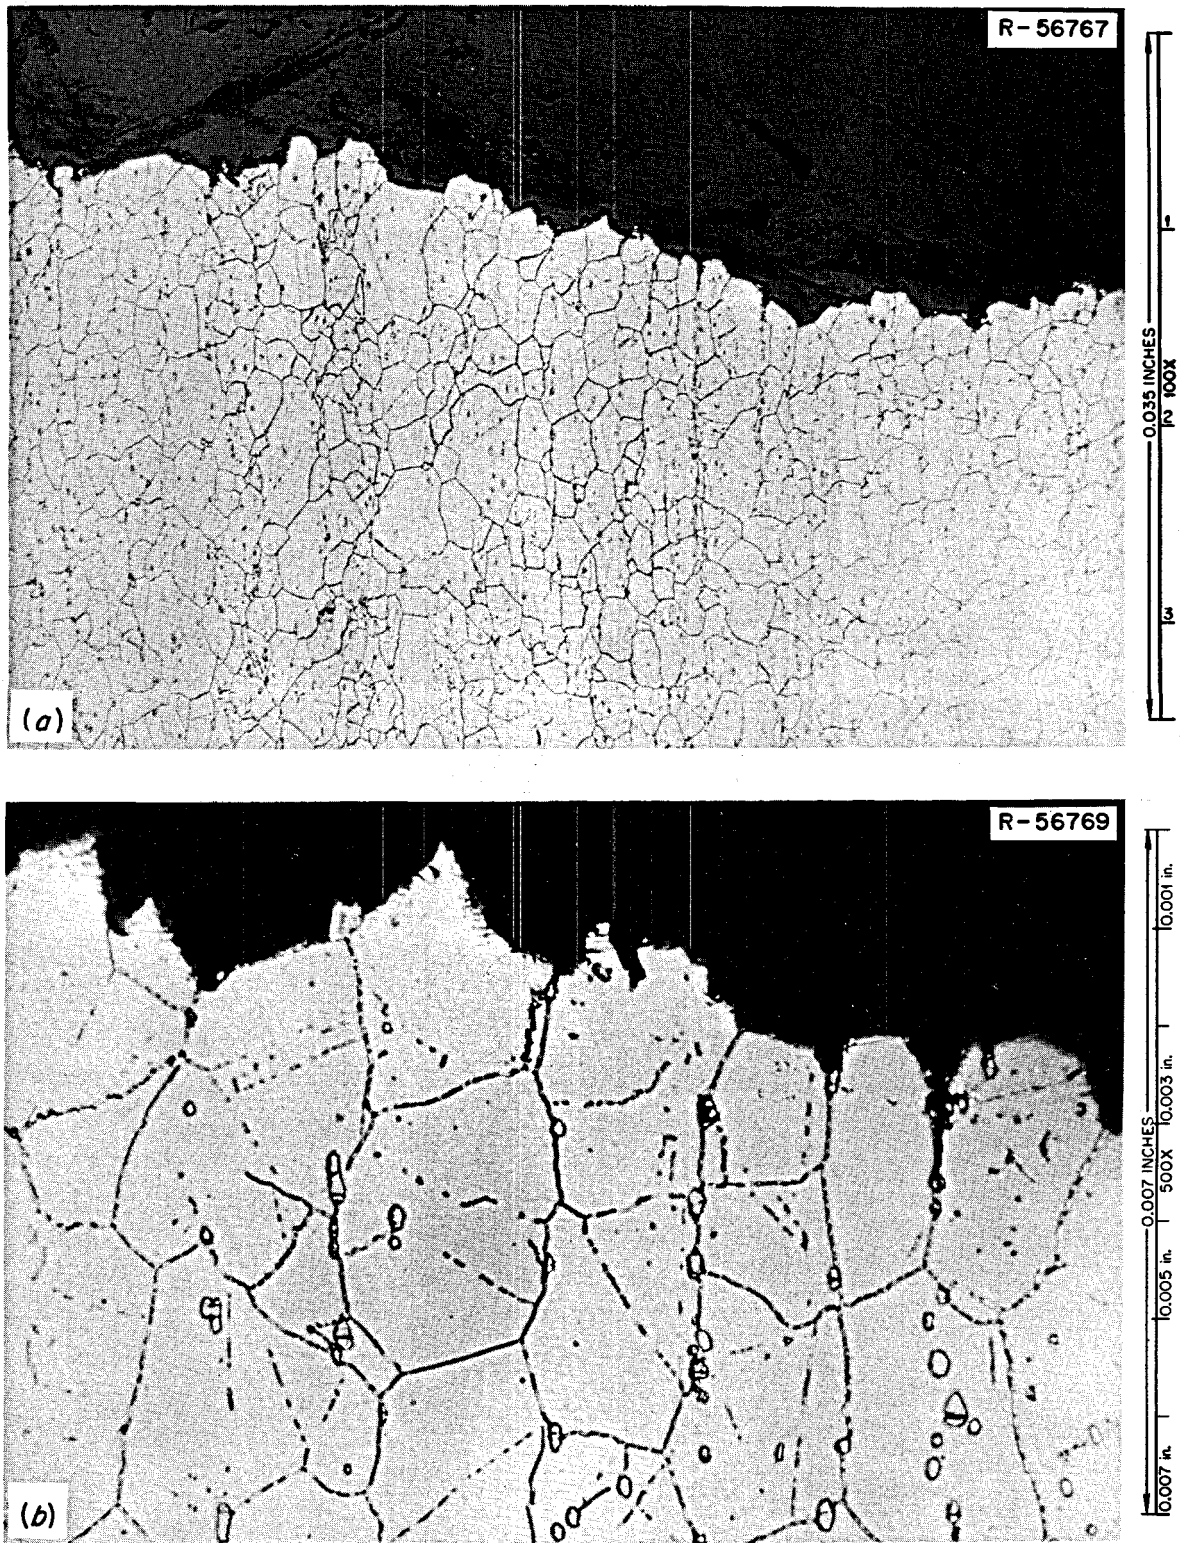
The sample from the outside liquid region was quite similar metallographically to that from the inside liquid region. Photomicrographs of the fracture and a typical region of the tension side near the fracture are shown in Figs. 56 and 57 respectively. A composite of several photomicrographs is shown in Fig. 58.

Fig. 56. Fracture of bend specimen from outside liquid region of INOR-8 mist shield. (a) 100X; (b) 500X. Etchant: lactic acid, HNO_3 , HCl .
