POSTIRRADIATION EXAMINATION OF MATERIALS FROM THE MSRE

H. E. McCoy
B. McNabb

METALS AND CERAMICS DIVISION

DECEMBER 1972

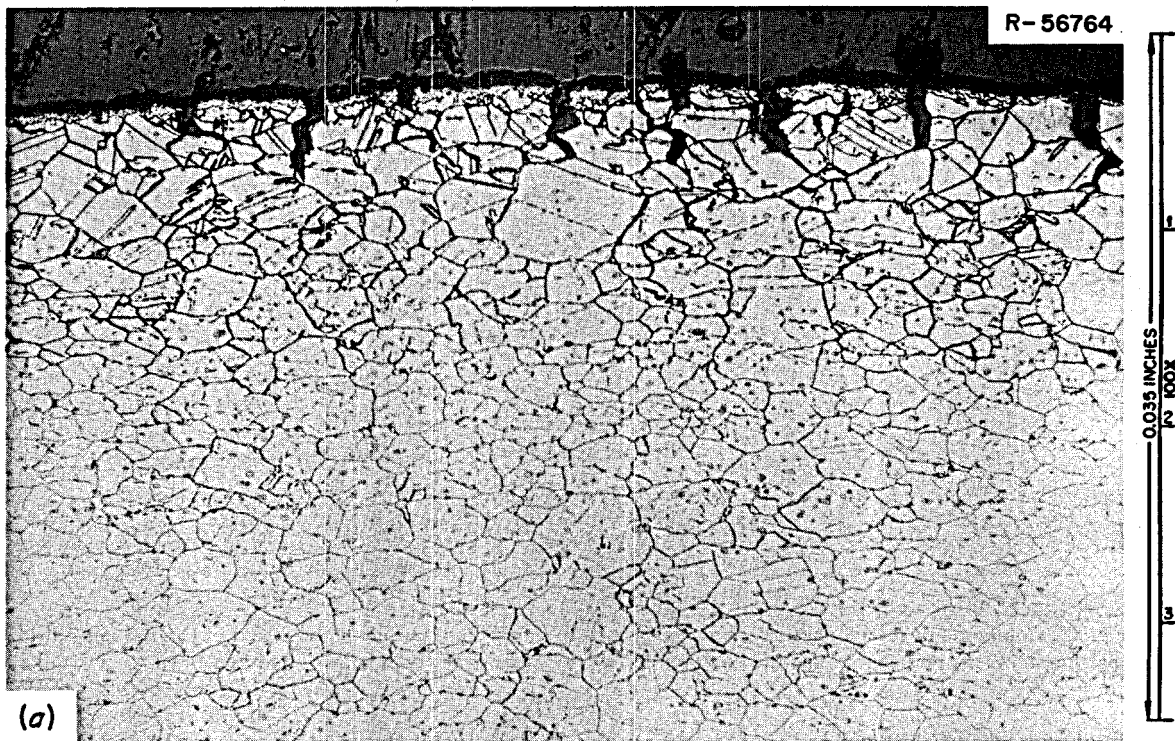
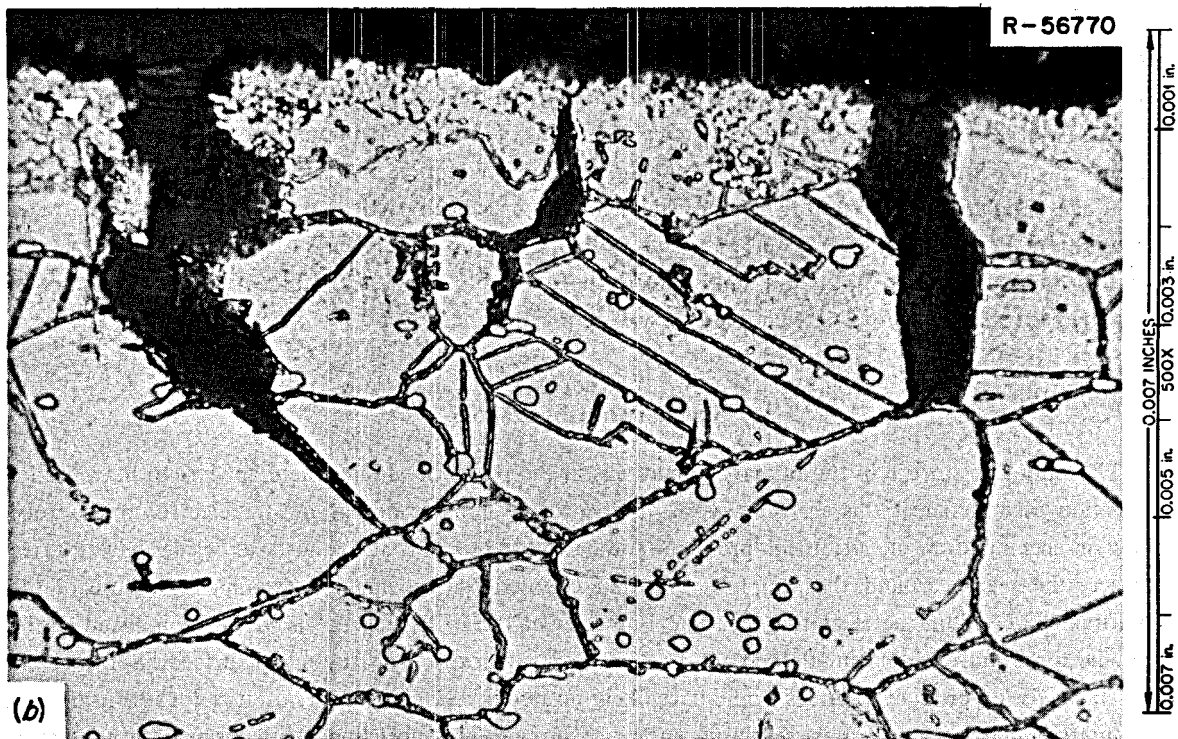
The sample from the outside liquid region was quite similar metallographically to that from the inside liquid region. Photomicrographs of the fracture and a typical region of the tension side near the fracture are shown in Figs. 56 and 57 respectively. A composite of several photomicrographs is shown in Fig. 58.

Fig. 57. Tension side near fracture of bend specimen from outside liquid region of INOR-8 mist shield. (a) 100X; (b) 500X. Etchant: lactic acid, HNO_3 , HCl .

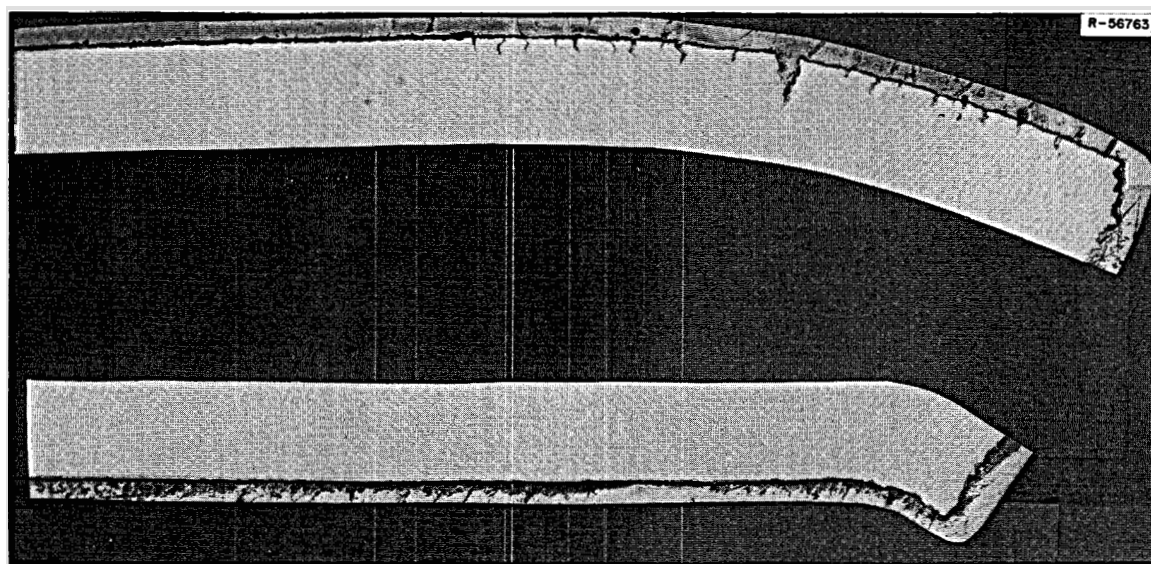
Fig. 58. Composite of several photomicrographs of bend specimen from outside liquid region of INOR-8 mist shield. Top portion shows the tension side, and the lower portion shows the compression side. 24X. Reduced 44%.

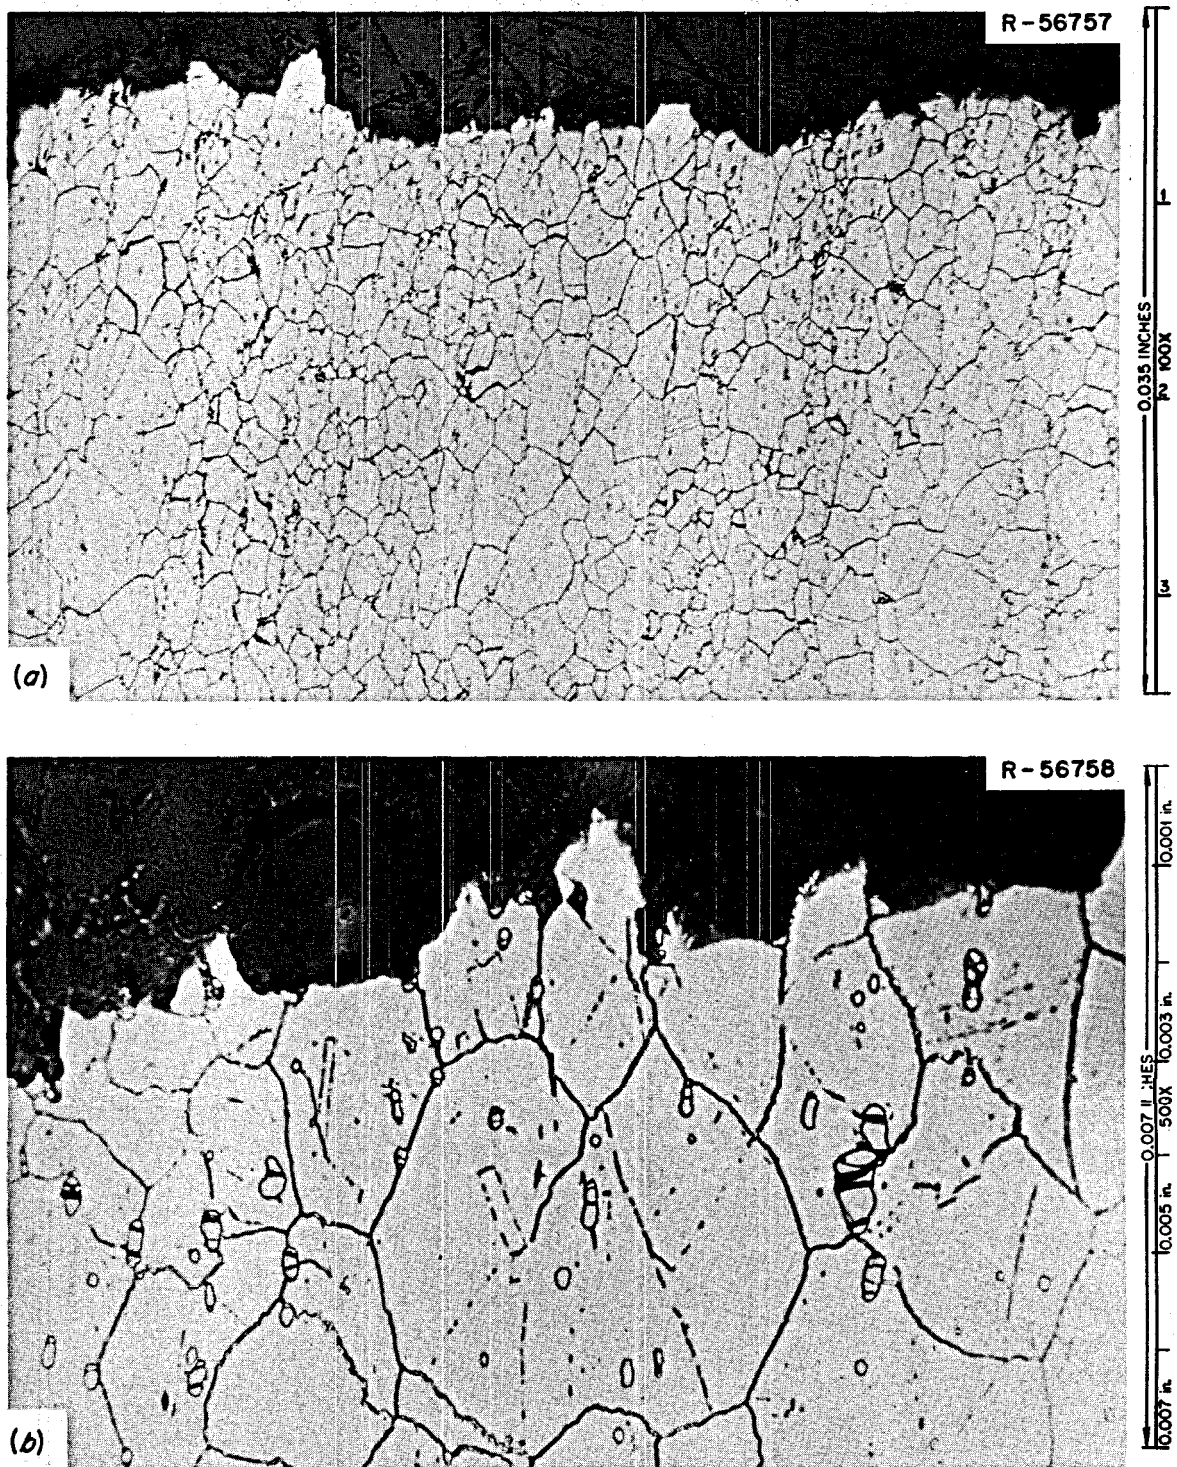
Photomicrographs of the outside vapor (salt spray) bend specimen at the fracture and on the tension side near the fracture are shown in Figs. 59 and 60 respectively. The composite of several photomicrographs in Fig. 61 shows that the cracks are not much deeper nor more frequent than in the liquid regions (compare Figs. 55, 58, and 61), but the tendency for grains to fall out is much greater. This is even more significant when one notes that the strain was the least in the sample from the outside vapor region (Table 7).

Fig. 59. Fracture of a bend specimen from outside vapor portion of INOR-8 mist shield. (a) 100X; (b) 500X. Etchant: lactic acid, HNO_3 , HCl .

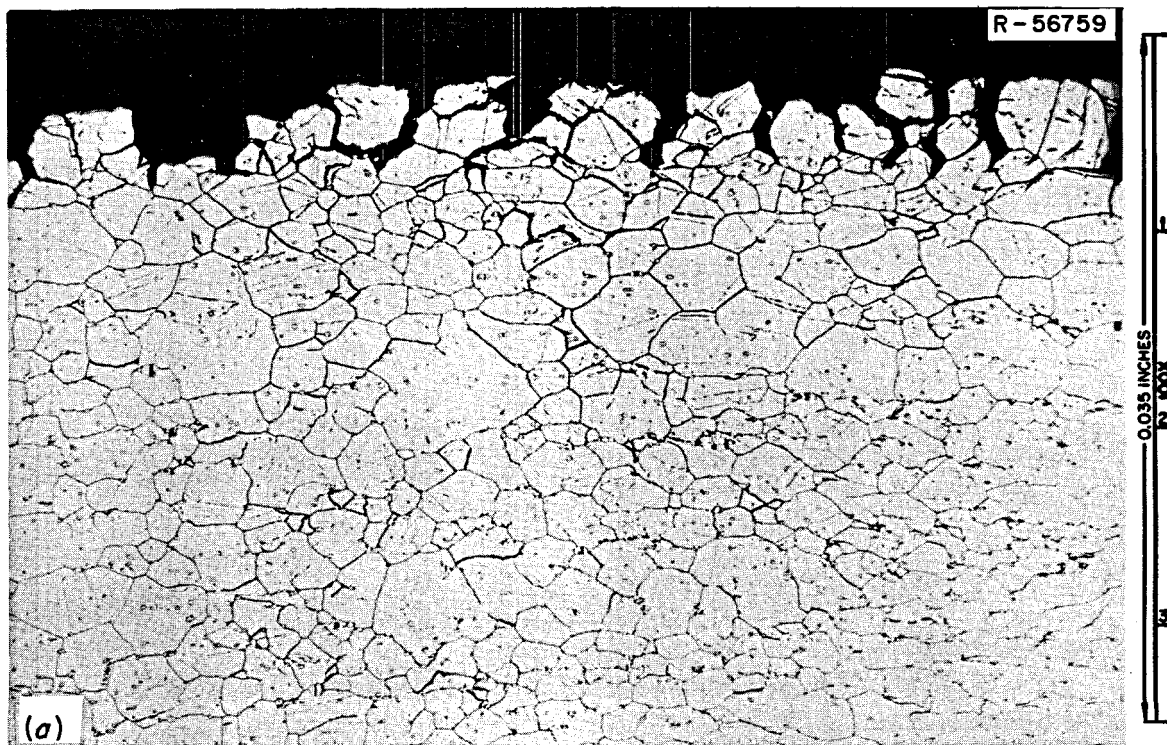
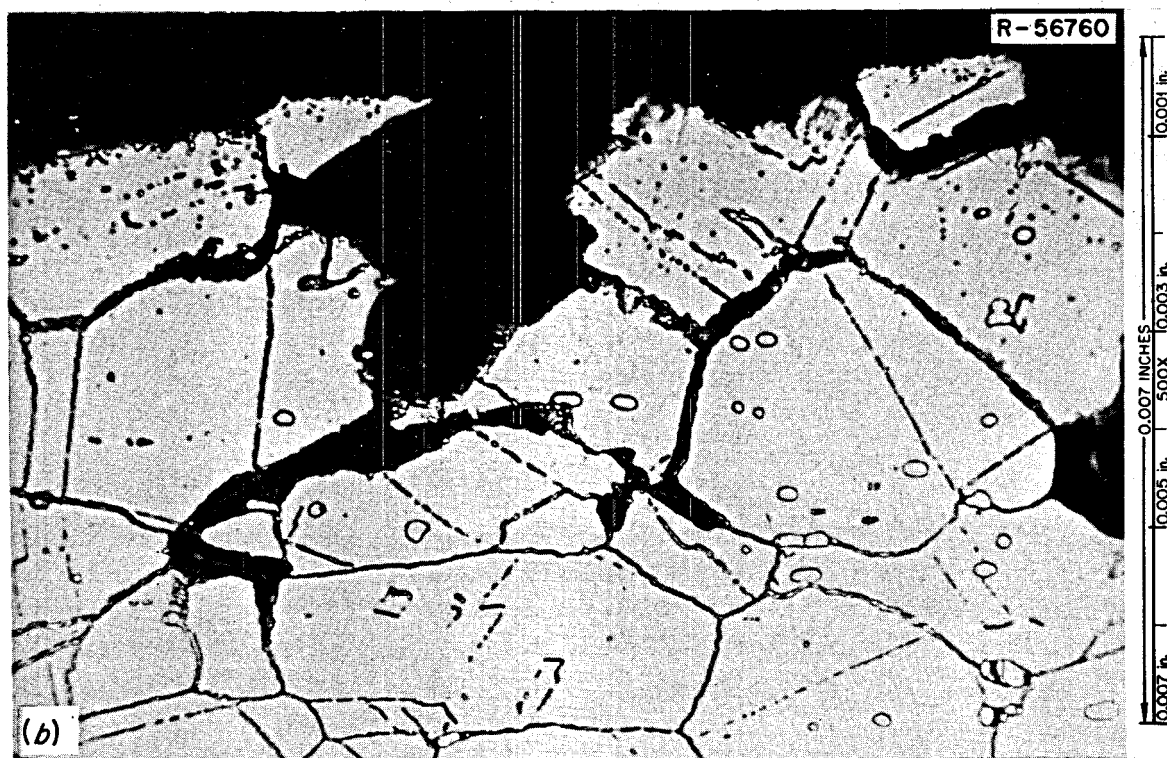
Fig. 60. Edge near fracture of bend specimen from outside vapor portion of INOR-8 mist shield. (a) 100X; (b) 500X. Etchant: lactic acid, HNO_3 , HCl .

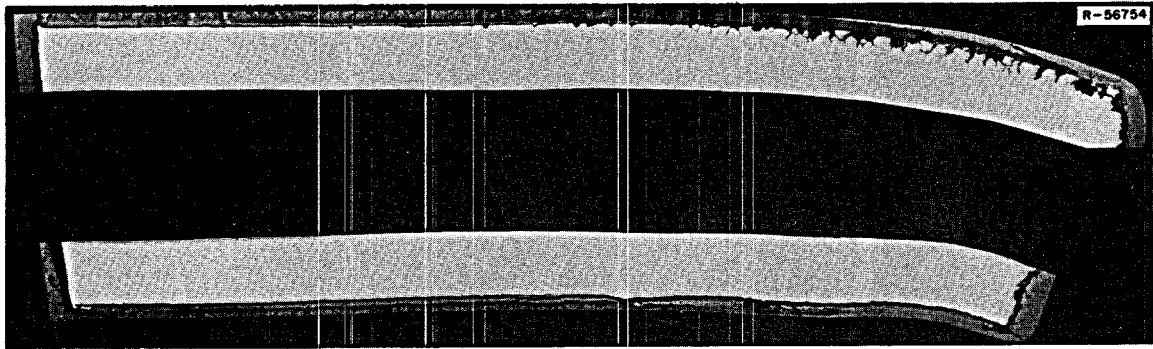
Fig. 61. Composite of several photomicrographs of bend specimen from outside vapor region of INOR-8 mist shield. Top portion is tension side, and lower part is compression side. 15X. Reduced 44%.

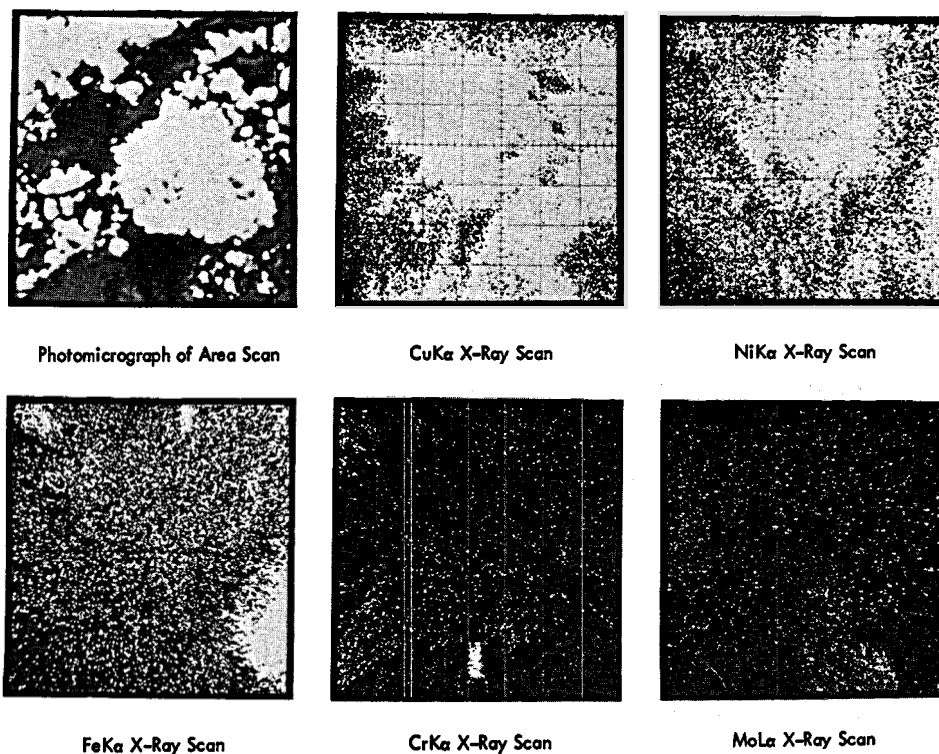
Fig. 66. Views of the surface of the copper sampler in the electron-probe microanalyzer. The upper left picture is an optical photomicrograph showing deposited metal crystals. The other pictures show the intensity of x-ray fluorescence for various elements. These displays are a mirror image of the first optical picture. Note that certain areas are enriched in Ni, Fe, Cr, and Mo. Some copper from the capsule is present in the deposited material. Approx 200X.

An electron-probe microanalysis of the material in the grain boundaries and x-ray scans for the distribution of Ni, Fe, Cr, and Cu in the surface layer in the area around the large metallic particle on the outer surface were made. Figure 66 shows the distribution of these elements, and it appears that the surface layers were made up mostly of copper and nickel, with some areas containing high concentrations of chromium and molybdenum. The inner and outer surfaces of the capsule appear similar. The grain-boundary precipitate was only 28% Cu, and no other element could be detected. This observation indicates that the remainder is a light element, perhaps beryllium or lithium, that could not be detected by the instrument.

Although copper is generally accepted as being compatible with fuel salt, this capsule was severely embrittled in its 13,000-hr exposure to MSRE fuel salt. Heavy deposits quite similar to those noted on the sample cage and shield were present on the surfaces of the copper capsule. Some of the constituents of these deposits may have caused the embrittlement, but we were unable to identify the responsible element.

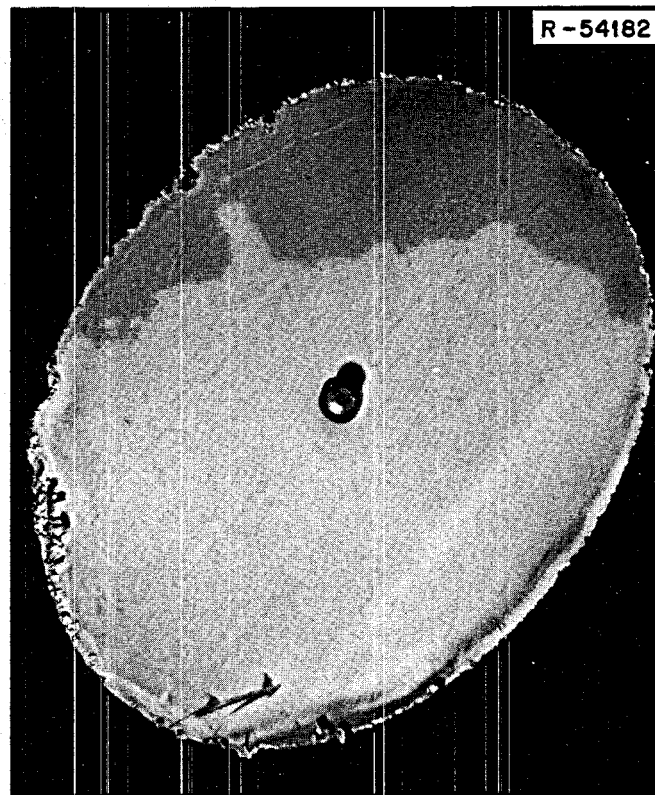
The heat exchanger was above 500°C for 30,807 hr and was exposed to fuel salt for 21,040 hr. An oval piece of the shell 10 × 13 in. was cut by plasma torch near the outlet end of the heat exchanger. This same cut severed a piece of one tube, and pieces of five others were cut by an abrasive wheel. These parts are shown in Figs. 68 and 69. The outside of the shell had a dark adherent oxide; the inside surfaces were discolored slightly and had a thin bluish-gray coating, probably caused by the plasma cutting operation. Some of this powder was brushed off and found by gamma scanning to contain ^{106}Ru and ^{125}Sb .

Fig. 68. Section 10 x 13 in. cut from the primary heat exchanger shell. The piece was cut with a plasma torch, and the center stud was used for guiding the torch.

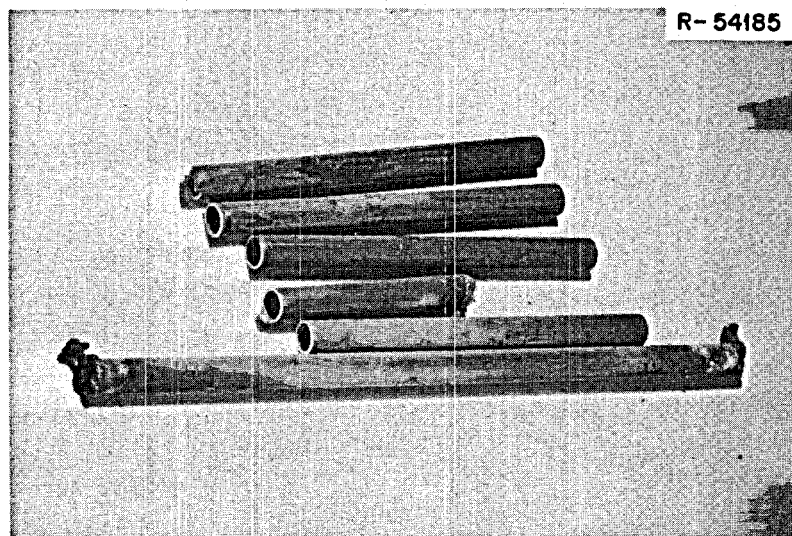
Fig. 69. The $\frac{1}{2}$ -in.-OD INOR-8 tubes from the primary heat exchanger. The different shades arise from a dark film thought to have been deposited when the shell was being cut. The film was deposited on the side of the tubes facing the shell.

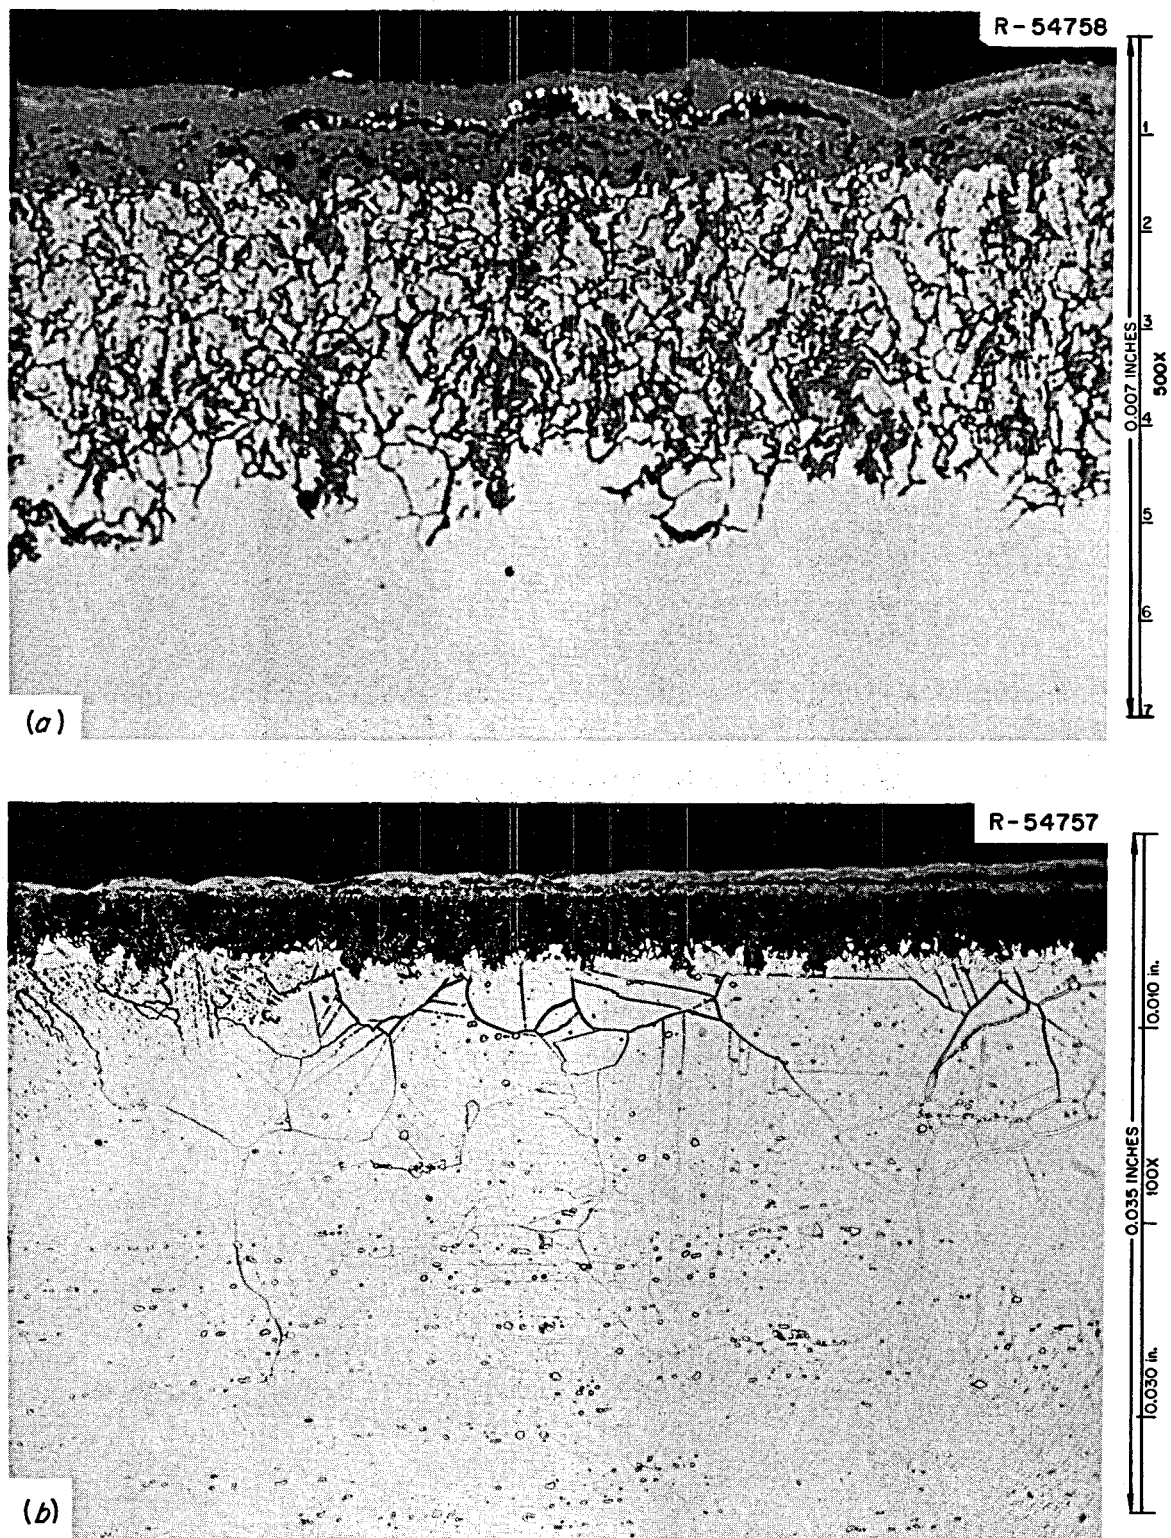
Photomicrographs of a cross section through the outer surface of the shell are shown in Fig. 70. The oxide on the outside surface is typical of that observed on INOR-8 at this temperature and extends to a depth of about 5 mils. Etching attacks the metal in the oxidized layer and etches the grain boundaries near the surface more rapidly than those in the interior. The inside surface of the shell (Fig. 71) shows some structural modifications to a depth of about 1 mil. No samples of the shell were deformed.

Fig. 70. Outside edge of INOR-8 primary heat exchanger shell. This surface was exposed to 2 to 5% O_2 in nitrogen. (a) As polished, showing selective oxidation. (b) Etched view showing that metal in oxidized layer was completely removed. Etchant: aqua regia.

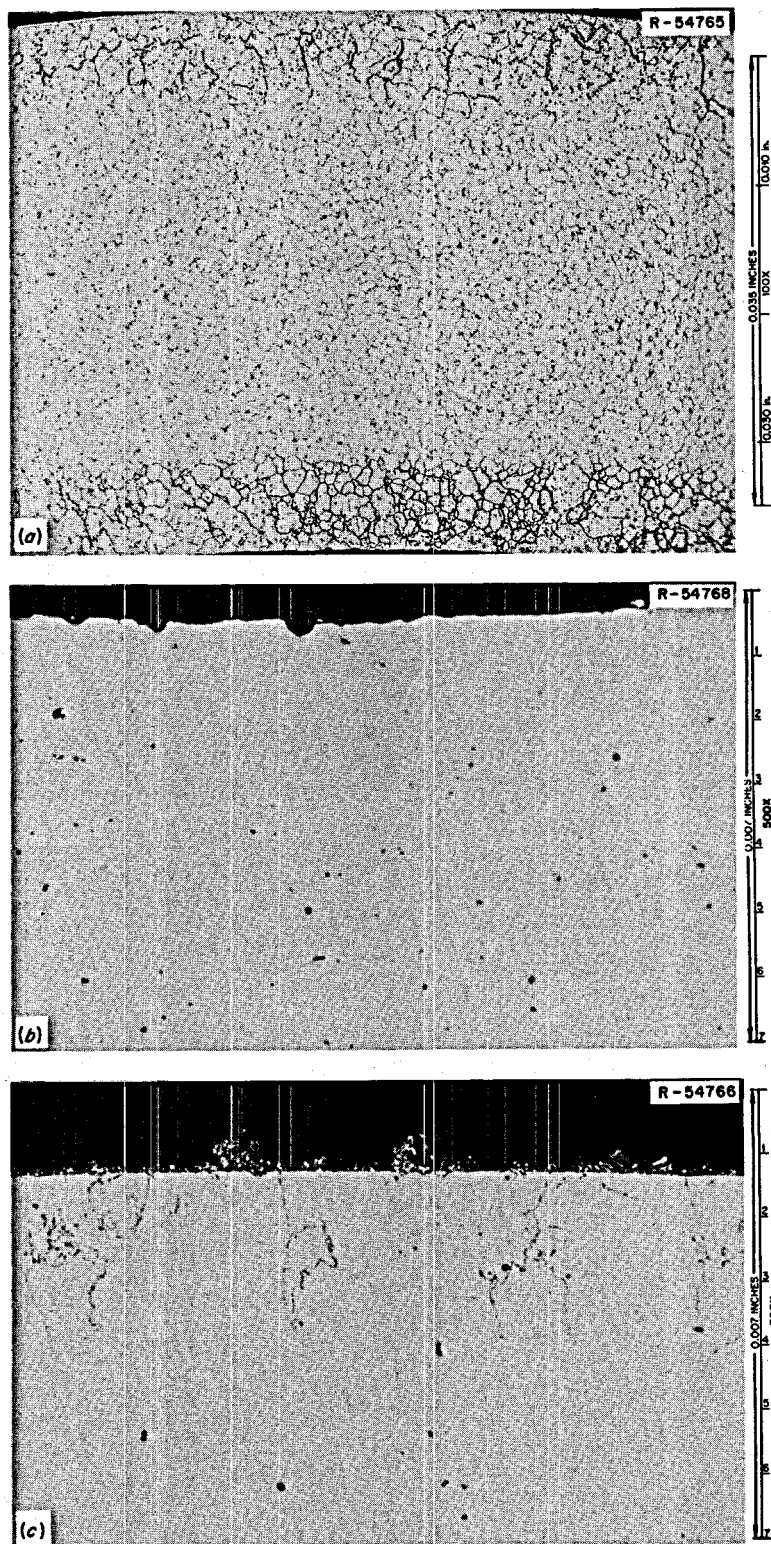
Photomicrographs of a typical cross section of the heat exchanger tubing are shown in Fig. 72. The overall view shows that both sides etch more rapidly than the center to a depth of about 7 mils. This is not unusual for a tubular product and is often attributed to impurities (primarily lubricants) that are worked into the metal surface during repeated steps of deformation and annealing. The higher magnification views in the as-polished condition show that grain boundary attack (or cracking) occurred on the surface exposed to fuel salt (outer) but not on the coolant side (inner). The temperatures under normal operating conditions were such that the fuel salt side would have been in compression.

Fig. 72. Cross section of INOR-8 heat exchanger tube. (a) Etched with glyceric acid. (b) Inside surface in the as-polished condition after exposure to coolant salt. (c) Outside surface in the as-polished condition after exposure to fuel salt. Reduced 34%.

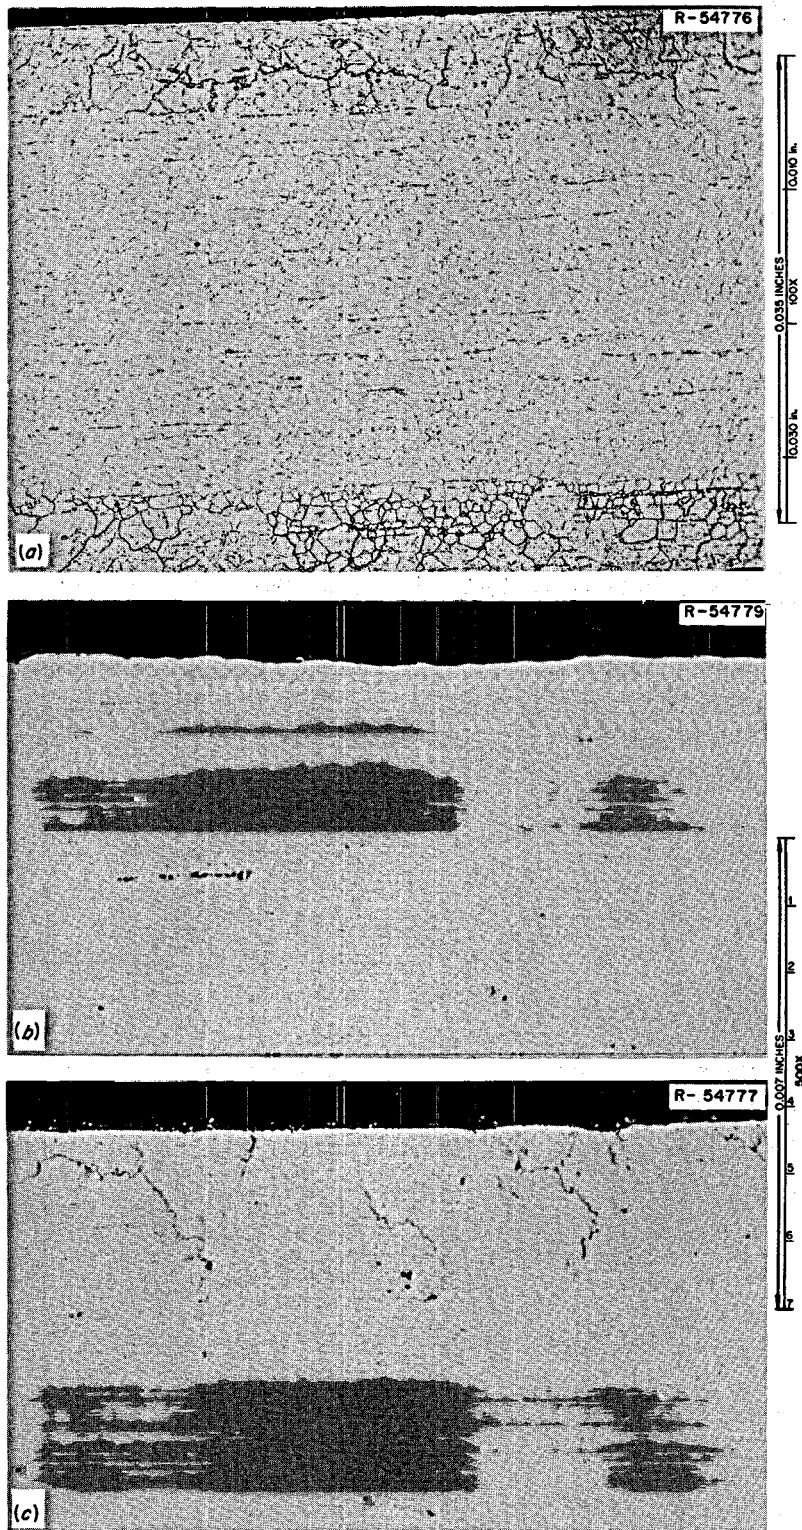
Similar photomicrographs of a longitudinal section of tubing are shown in Fig. 73. The features are quite similar to those discussed for Fig. 72. Both figures show some metallic deposits on the outside surface, which was exposed to fuel salt. These deposits are extremely small and could not be analyzed with much accuracy with the in-cell microprobe. However, they seemed to be predominately iron. Scanning across the tubing detected no concentration gradients of the major alloying elements in INOR-8.

Fig. 73. Longitudinal section of INOR-8 heat exchanger tube. (a) Etched with glyceria regia. (b) Inside surface in the as-polished condition after exposure to coolant salt. (c) Outside surface in the as-polished condition after exposure to fuel salt. Reduced 31%.

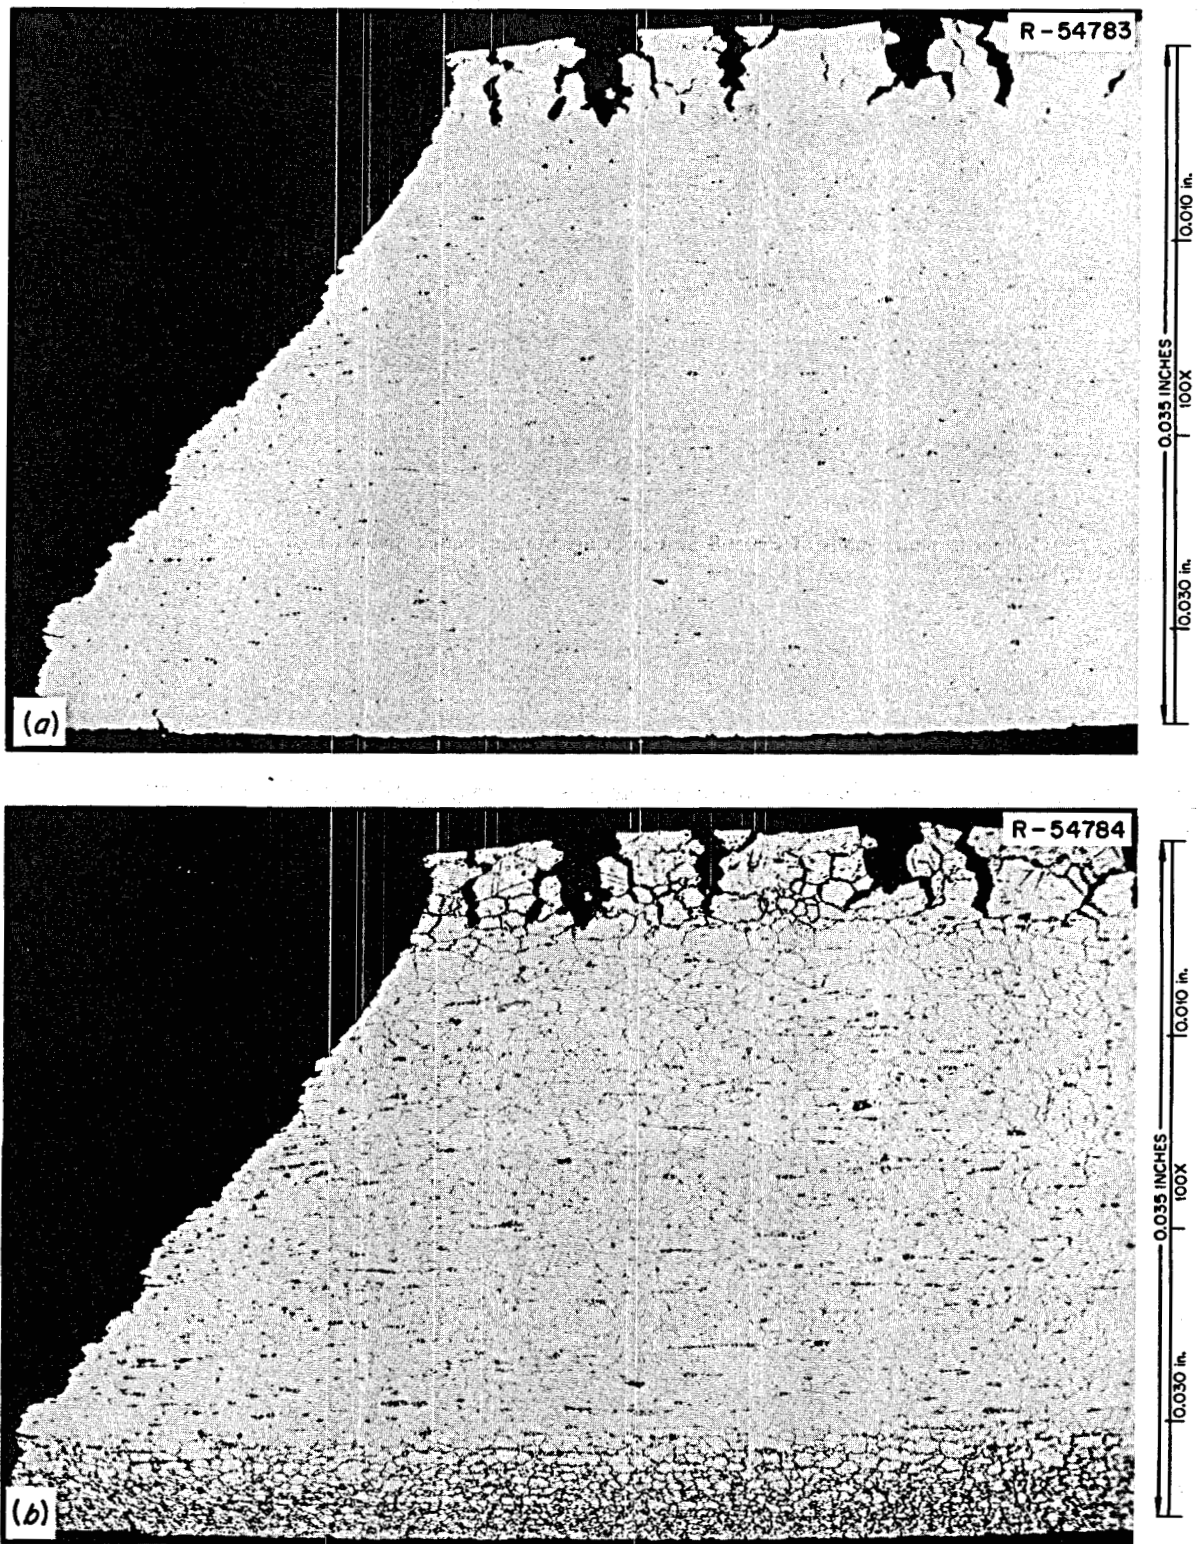
Photomicrographs of one of the tubes deformed at 25°C are shown in Fig. 74. Profuse intergranular cracks were formed to a depth of about 5 mils on the side exposed to fuel salt, but none were formed on the coolant salt side. Etching again revealed the abnormal etching characteristics near the surface, but whatever caused this abnormality did not result in grain-boundary embrittlement.

Fig. 74. INOR-8 heat exchanger tube deformed to fracture at 25°C. (a) As polished; (b) etched with aqua regia.

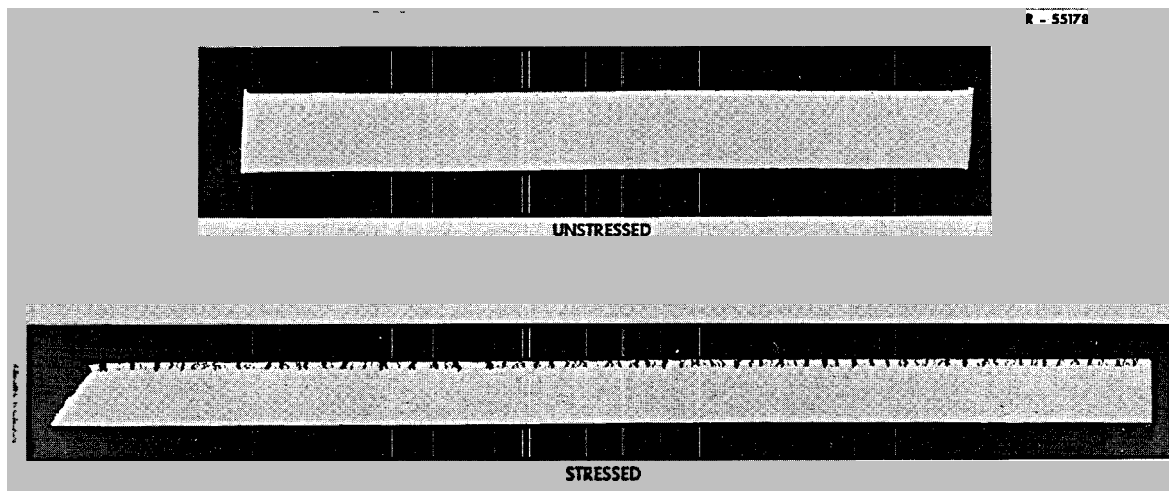
Unstressed and stressed sections of tubing were photographed over relatively large distances to get more accurate statistics on crack numbers and depths. Composite photographs of the two samples are shown in Fig. 75. The cracks are readily visible in the stressed sample but may not be apparent in

Fig. 75. Composite photographs of INOR-8 heat exchanger tubing before and after stressing. Width of unstressed sample is 0.042 in.

the unstressed sample. A higher magnification print used in making the composite is shown in Fig. 76; the cracks can be more easily seen. The stressed sample had 262 cracks per inch with an average depth of 5.0 mils. Two counts were made on the unstressed sample. In the first count only those features that unequivocally were cracks were counted. This gave a crack count of 228 per inch with an average depth of 2.5 mils. In another count, we included some features that were possibly cracks, and this gave a crack frequency of 308 per inch. Thus the number of cracks present before straining was about equivalent to that noted after straining. Straining did increase the *visible* depth. Some indirect evidence that the cracks were present initially and only spread open further during the tensile test was obtained from examination of the sample in Fig. 75. The sample length shown deformed 39% (Table 9), and the combined widths of the cracks account for 35% strain. Thus, the crack widths very closely account for the total strain and indicate that the cracks formed with little or no deformation and spread open as the sample was deformed.

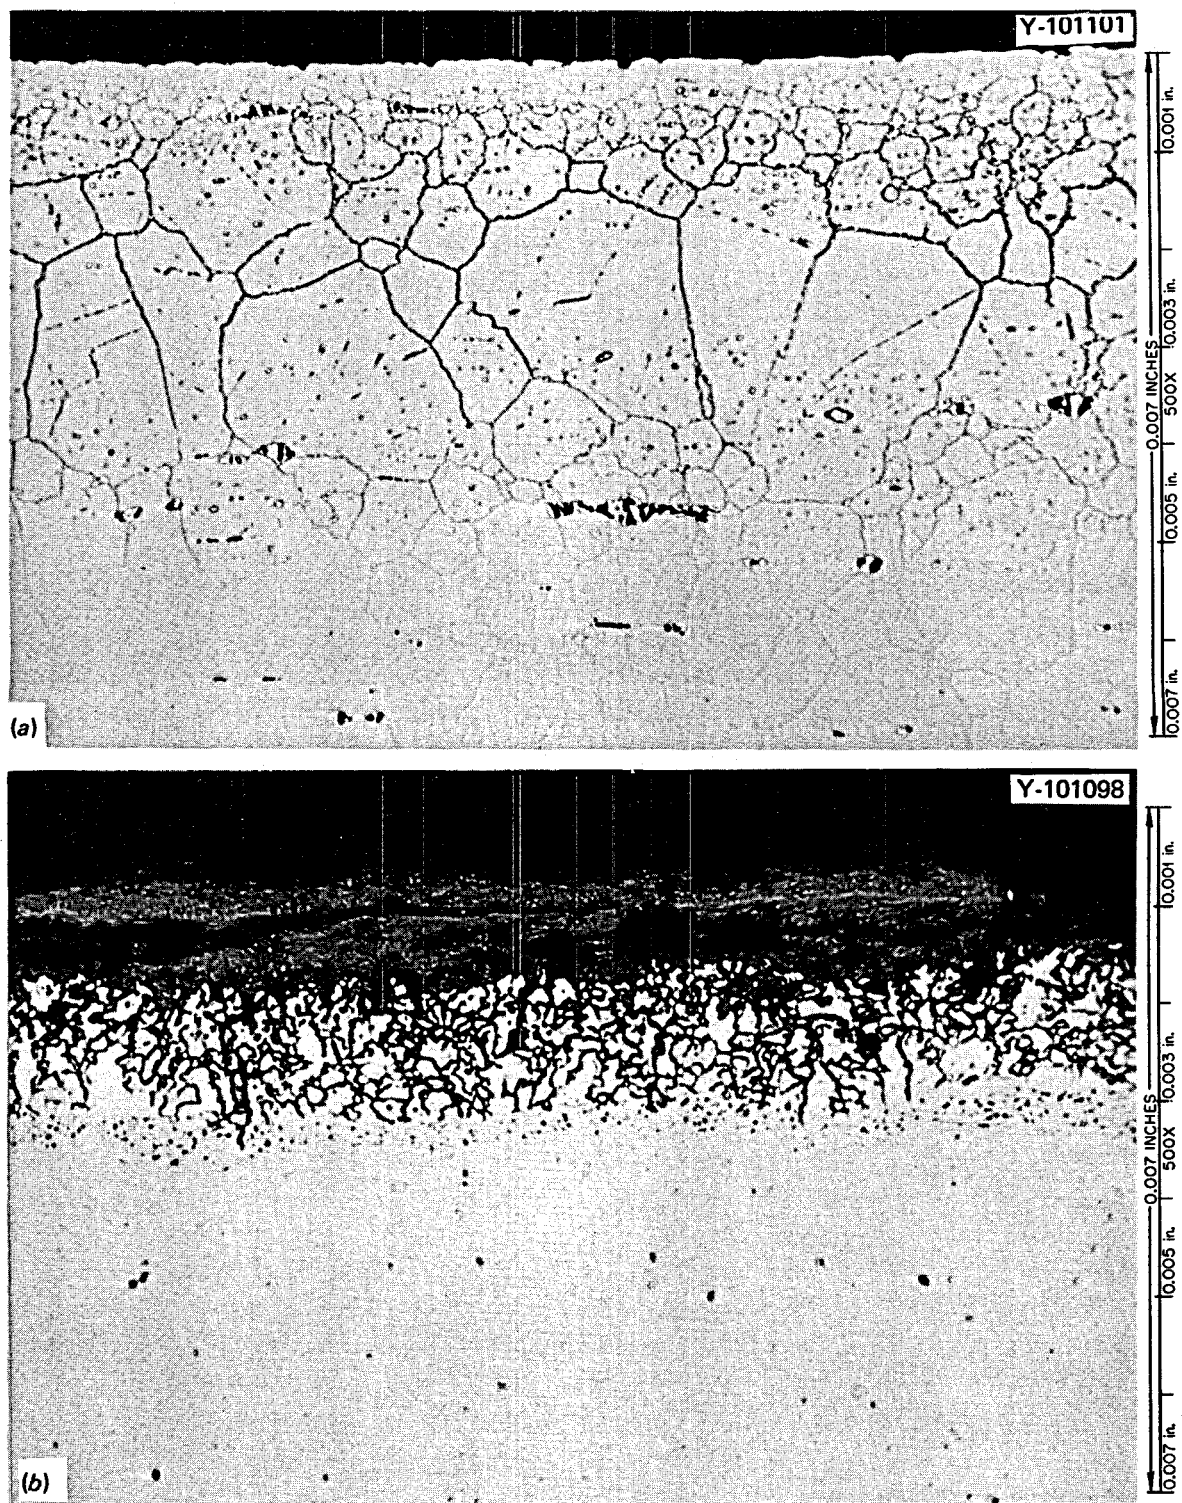
The microstructure of the tubing was altered two ways during service. The outside of the tubing was oxidized, and the inside of the tubing etched more rapidly to a depth of about 5 mils. These changes are shown in Fig. 80 for tubing at the inlet end and in Fig. 81 for the outlet end. The oxidation is not excessive, and the penetration of the oxide front is typical for nickel alloys with chromium content as low as that in INOR-8.

Fig. 80. Microstructures of a longitudinal section of INOR-8 tubing from the inlet end of the MSRE radiator. (a) Inside of pipe wall, etched with glyceric acid; (b) outside of pipe wall, as polished.

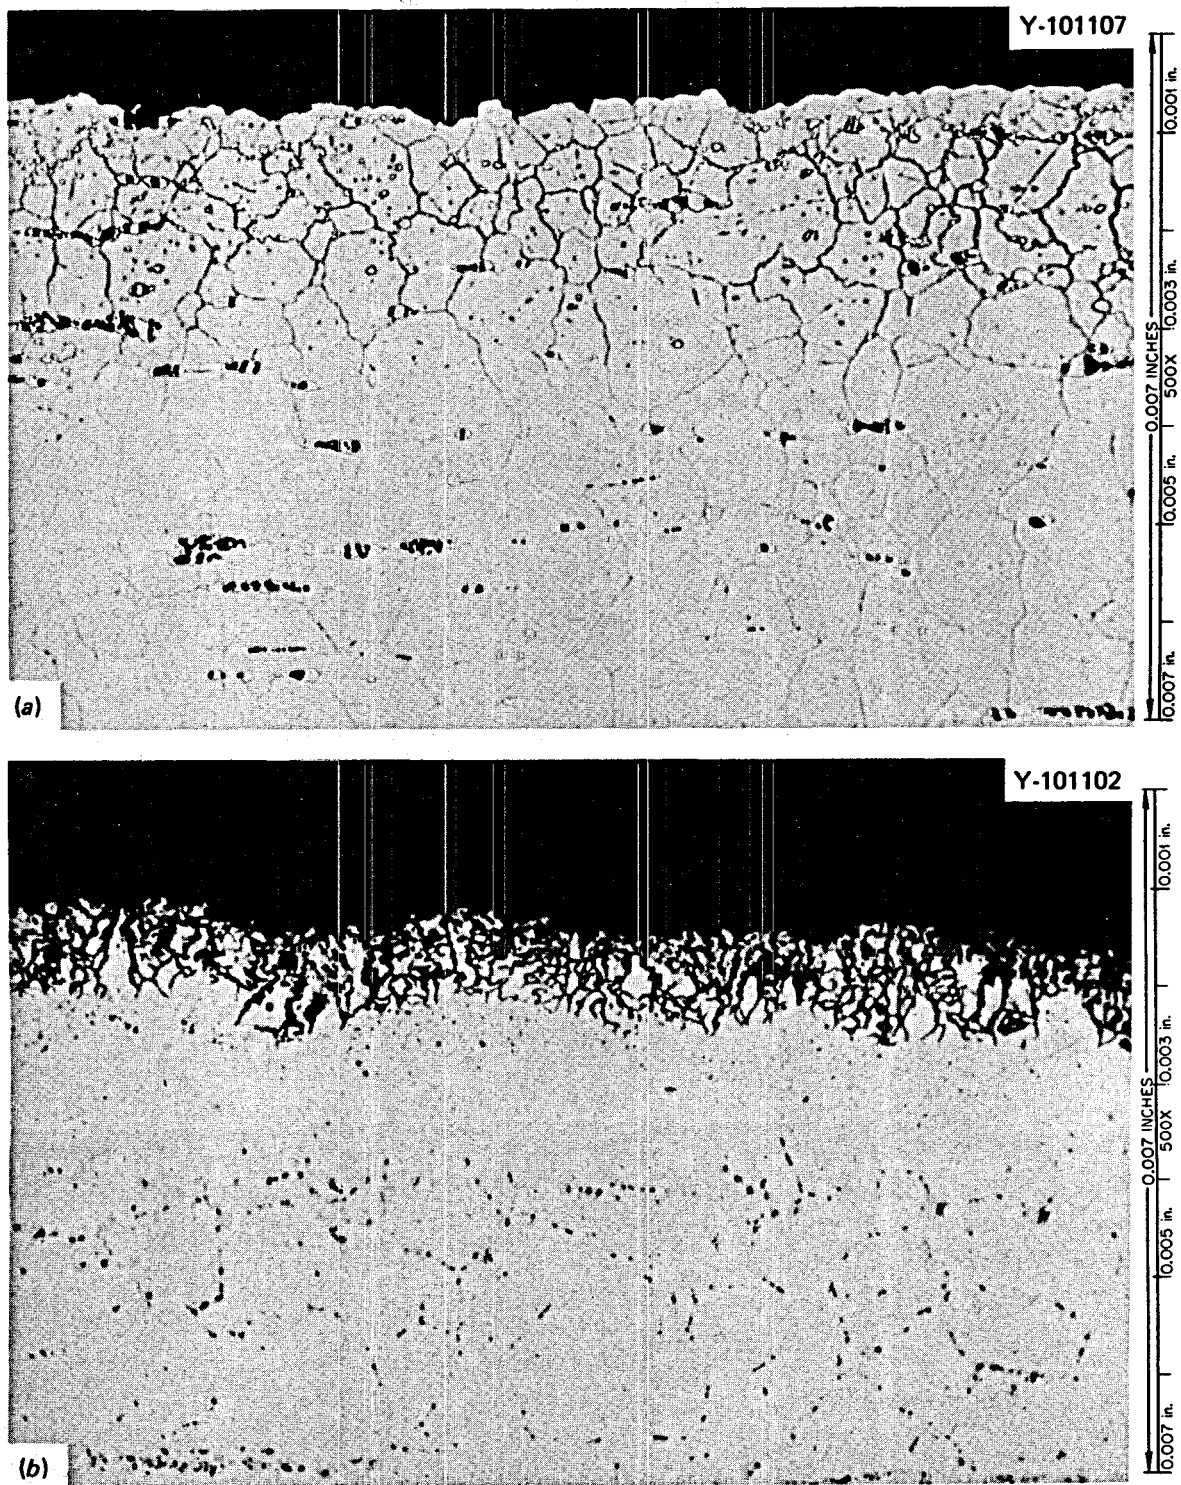
Fig. 81. Microstructures of a longitudinal section of INOR-8 tubing from the outlet end of the MSRE radiator. (a) Inside of pipe wall, etched with glyceric acid; (b) outside of pipe wall, as polished.

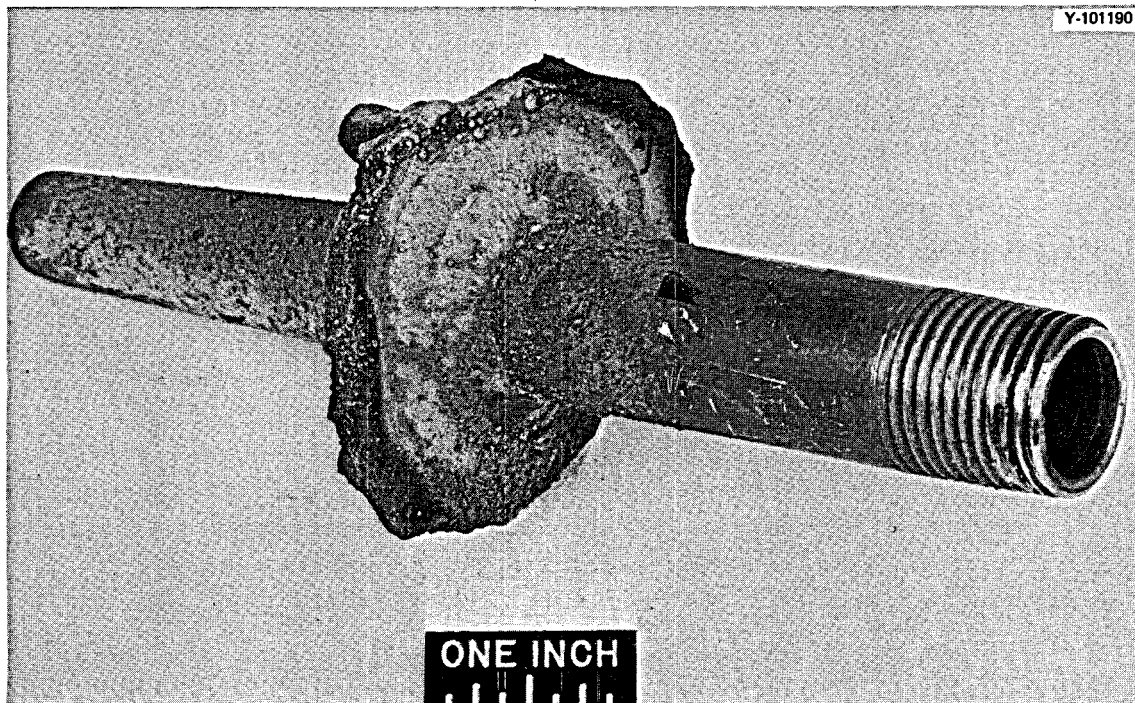
The inlet thermocouple well after it was cut off with a coated welding electrode is shown in Fig. 84. The oxidized appearance and the metal fragments on the part arose from the cutting operation. The circular piece of material is part of the 5-in. pipe wall. The thermocouple well was machined from bar stock and extended about 3 in. into the flowing salt stream. The cross-sectional view of part of the inlet well in Fig. 85 makes the geometry more evident. The pipe wall, the welds, and the thermocouple well are evident.

Fig. 84. INOR-8 thermocouple well removed from the inlet line to the radiator of the MSRE. Much of the discoloration and the fragments of metal resulted from cutting the part out with a coated welding electrode.

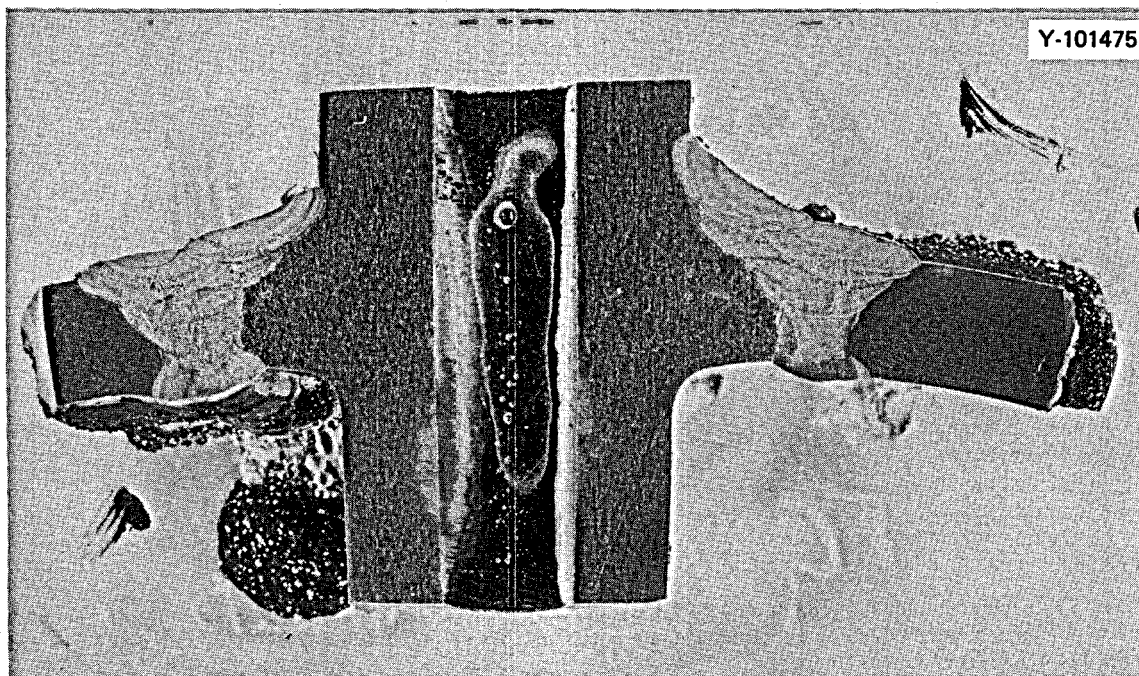
Fig. 85. Cross section of INOR-8 thermocouple well from the inlet line to the MSRE radiator. From left to right the components are the 5-in. coolant line, the weld, and the thermocouple well. The side having the most weld metal was exposed to air, and the other side was exposed to coolant salt.

Metallographic examination of the mounted cross section shown in Fig. 85 revealed that the weld had cracked on the salt side of the pipe. The cracks on both of the polished surfaces in Fig. 85 are shown in Fig. 86. In the worst case the cracks penetrated to a depth of about 3 mils. The remaining half of the well was cleaned by acid etching to remove the metal left from the cutting operation, and the weld was checked with dye penetrant. A photograph of the weld with dye still present is shown in Fig. 87. Note that the crack, as indicated by the dark color, extends almost completely around the weld. There is also an area where penetration of the root pass was incomplete. We propose that the cracks formed as the weld was made, because of the poor fit-up of the parts to be welded. The welds were not stress relieved, and the fact that the cracks did not penetrate further attests to the lack of stress and crevice corrosion by lithium-beryllium fluoride salts.
