POSTIRRADIATION EXAMINATION OF MATERIALS FROM THE MSRE

H. E. McCoy
B. McNabb

METALS AND CERAMICS DIVISION

DECEMBER 1972

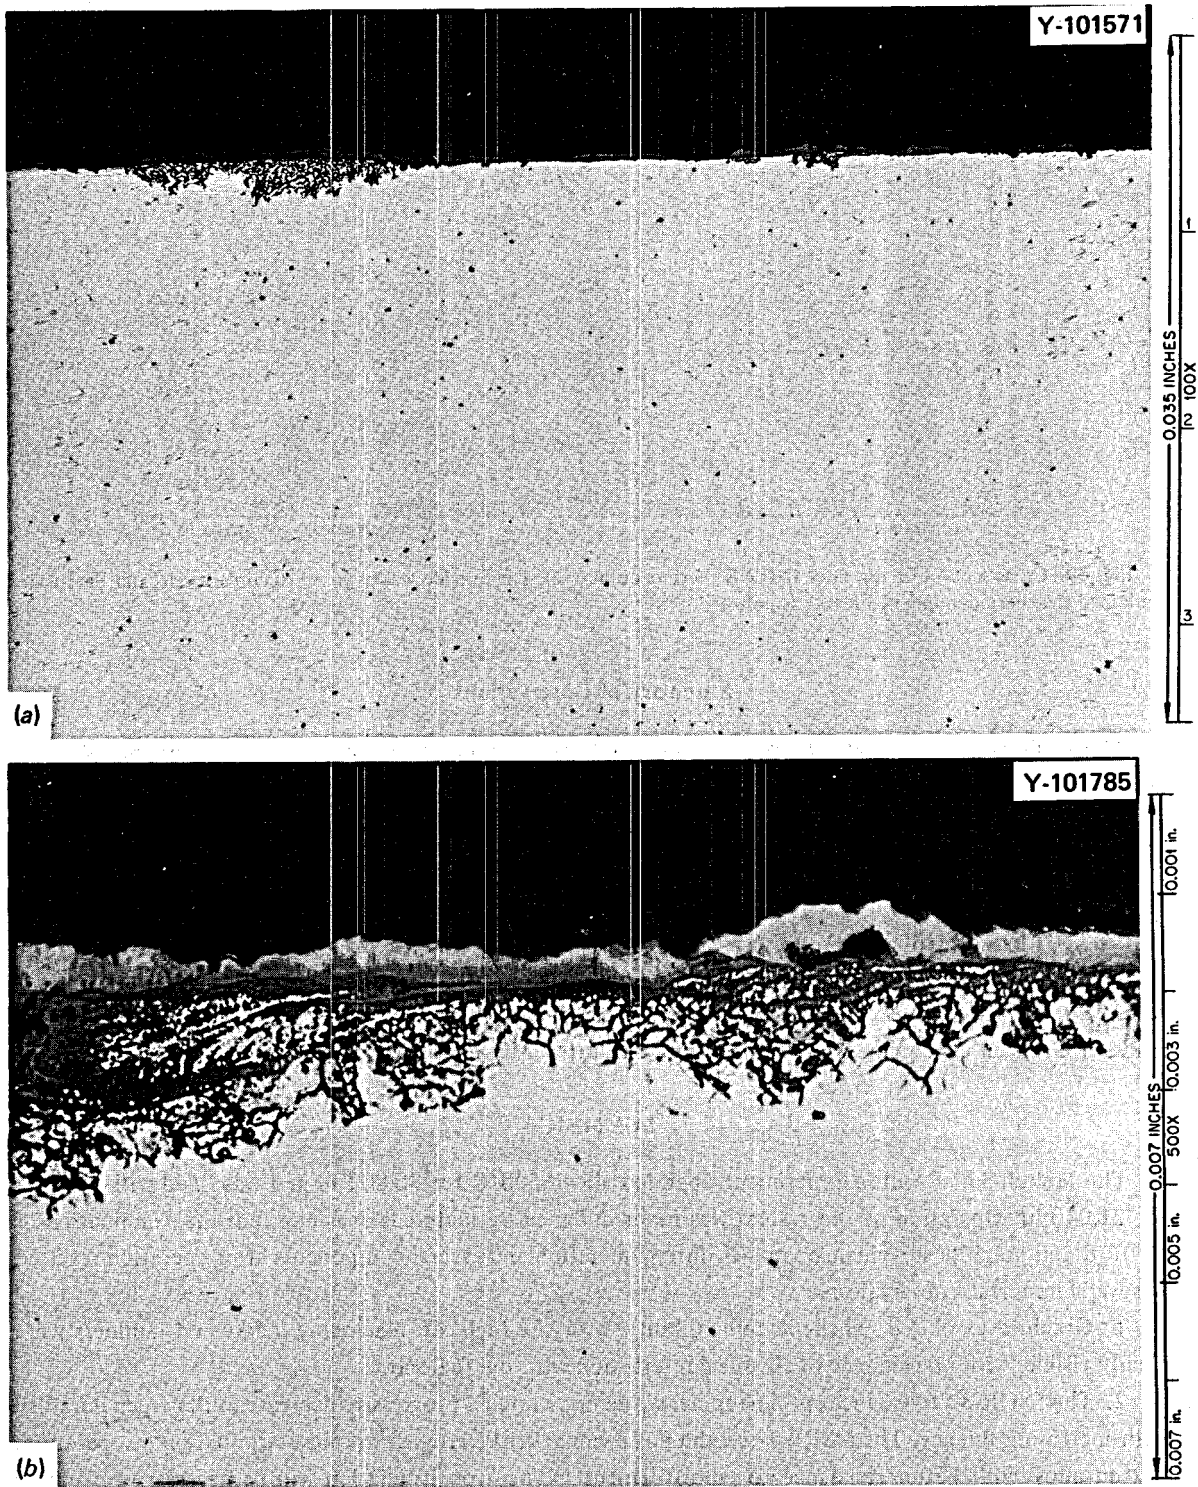
Fig. 88. Oxide formed on the outside of the 5-in. INOR-8 coolant line. As polished. (a) 100X; (b) 500X.

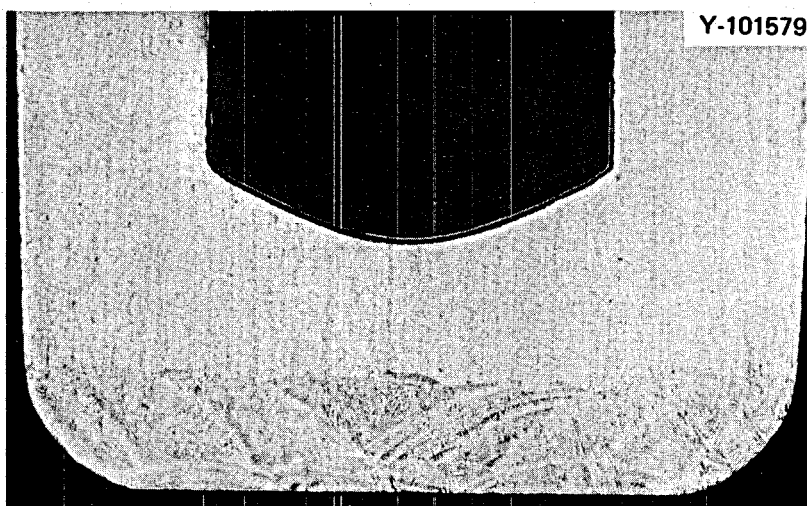
A cross section from the bottom of the well was examined. A macroscopic view of this section is shown in Fig. 89. The inside of the well was prepared by drilling, and the pointed shape of the drill is still apparent at the bottom. The weld metal deposit on the bottom was made to ensure that salt did not leak along the carbide stringers. The amount of oxidation was greater at the bottom of the well than further up. The transition to the thinner oxide about $\frac{1}{8}$ in. from the bottom is apparent in Fig. 89. Figure 90(a) shows the oxide layer of about 5 mils at the bottom of the well, and Fig. 90(b) shows the abrupt transition about $\frac{1}{8}$ in. from the bottom. Since lubricant would have been used during drilling, we suggest that this difference may have been due to the bottom of the well not being as clean as the sides.

Fig. 89. Cross section of the inlet INOR-8 thermocouple well. The outside was exposed to coolant salt, and the inside contained the thermocouple in air. 8X; as polished.

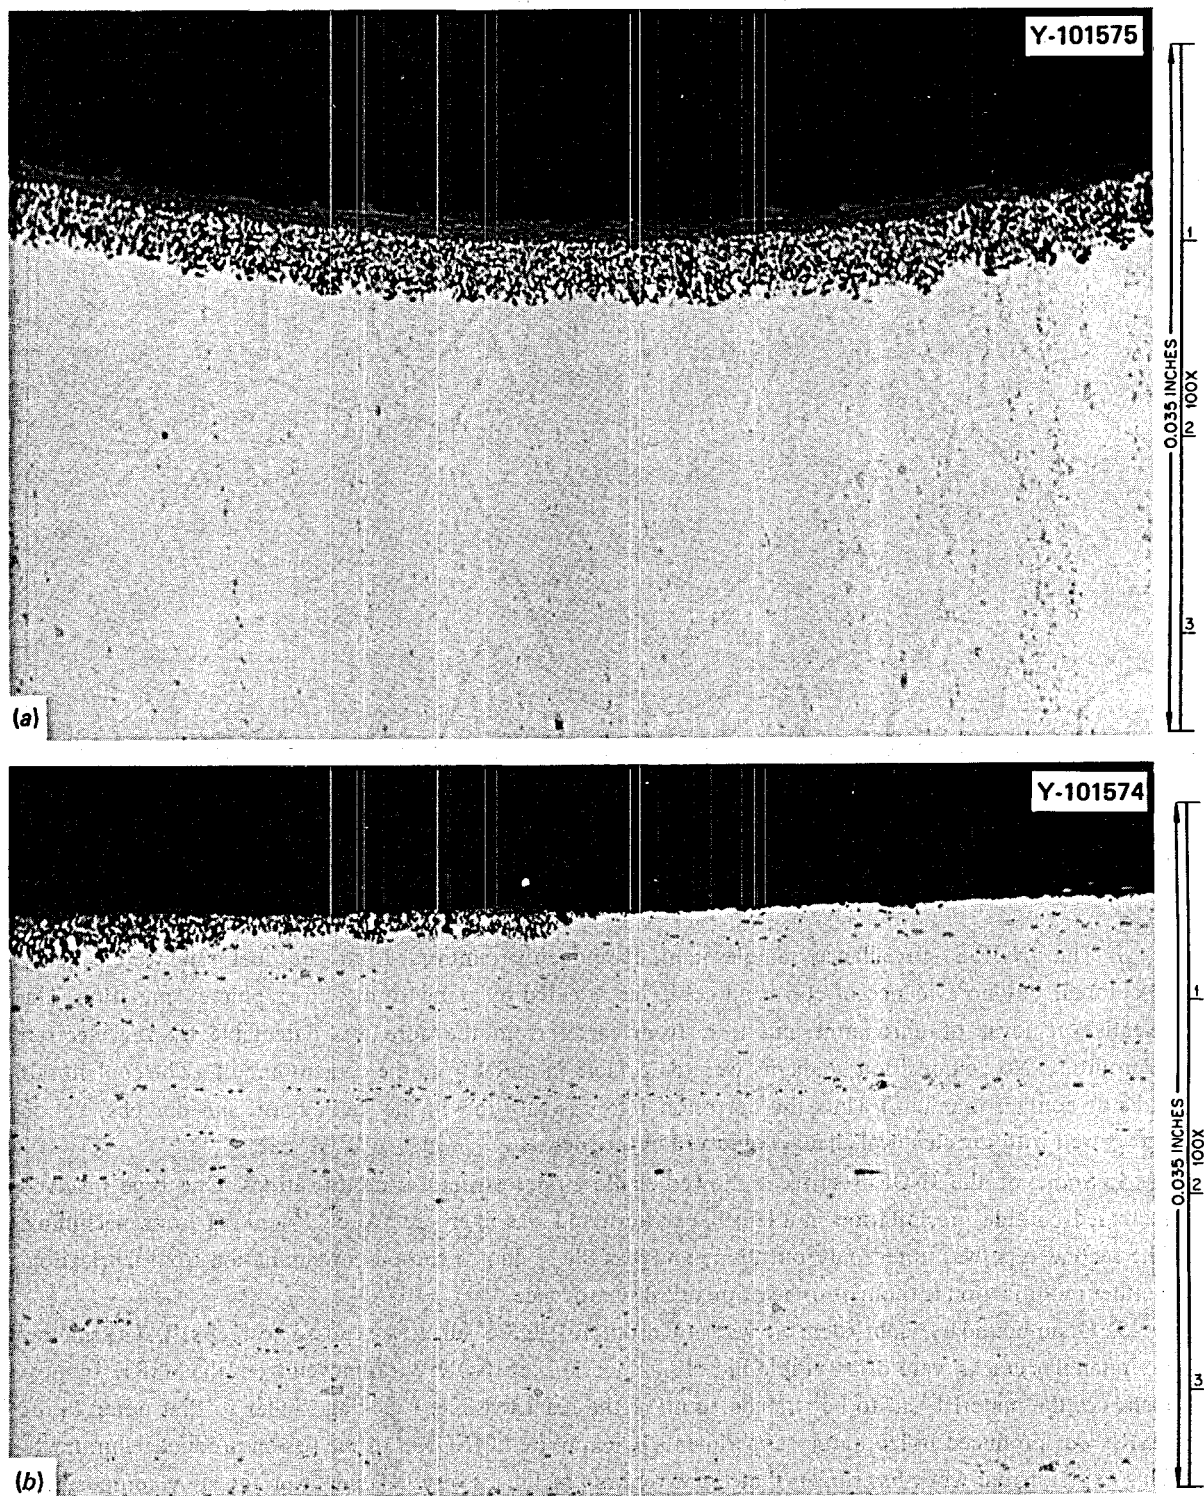
Fig. 90. Oxide inside the inlet INOR-8 thermocouple well. As polished. (a) At the bottom; (b) transition in depth about $\frac{1}{8}$ in. from bottom of well.

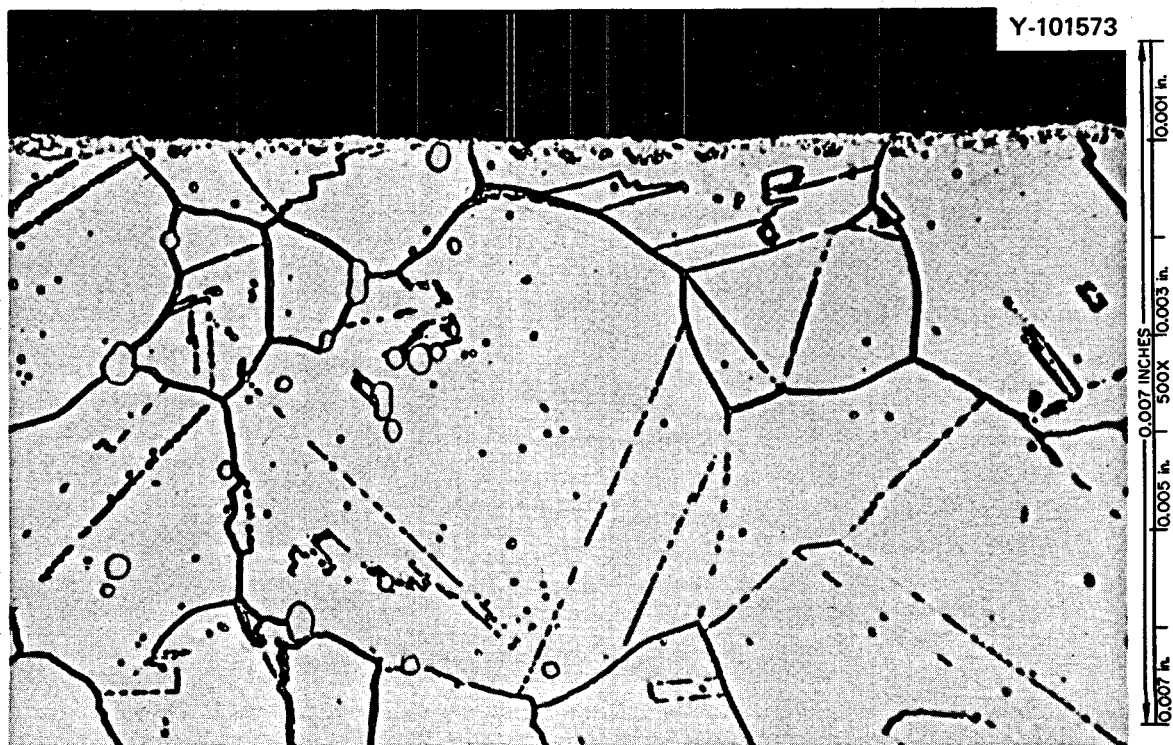
A further significant observation was that the surfaces of the well exposed to the salt looked quite similar to those of surveillance samples removed from the MSRE (Fig. 91). We have previously attributed this modified surface structure to cold working from machining and have shown that it can be produced in the absence of salt. The structure likely results from carbide forming on the slip bands produced by machining. Thus there is no evidence of corrosion of this part.

Fig. 91. The outside of the inlet INOR-8 thermocouple well that was exposed to coolant salt. Note the modified layer near the outer surface. Etchant: glyceria regia.
